Jeffery and Katauskas Pty Ltd

17 March 2008
Ref:18724ZR2let

GEOTECHNICAL QUARRY SLOPE STABILITY ASSESSMENT EXISTING QUARRY, ARCHBOLD ROAD, EASTERN CREEK

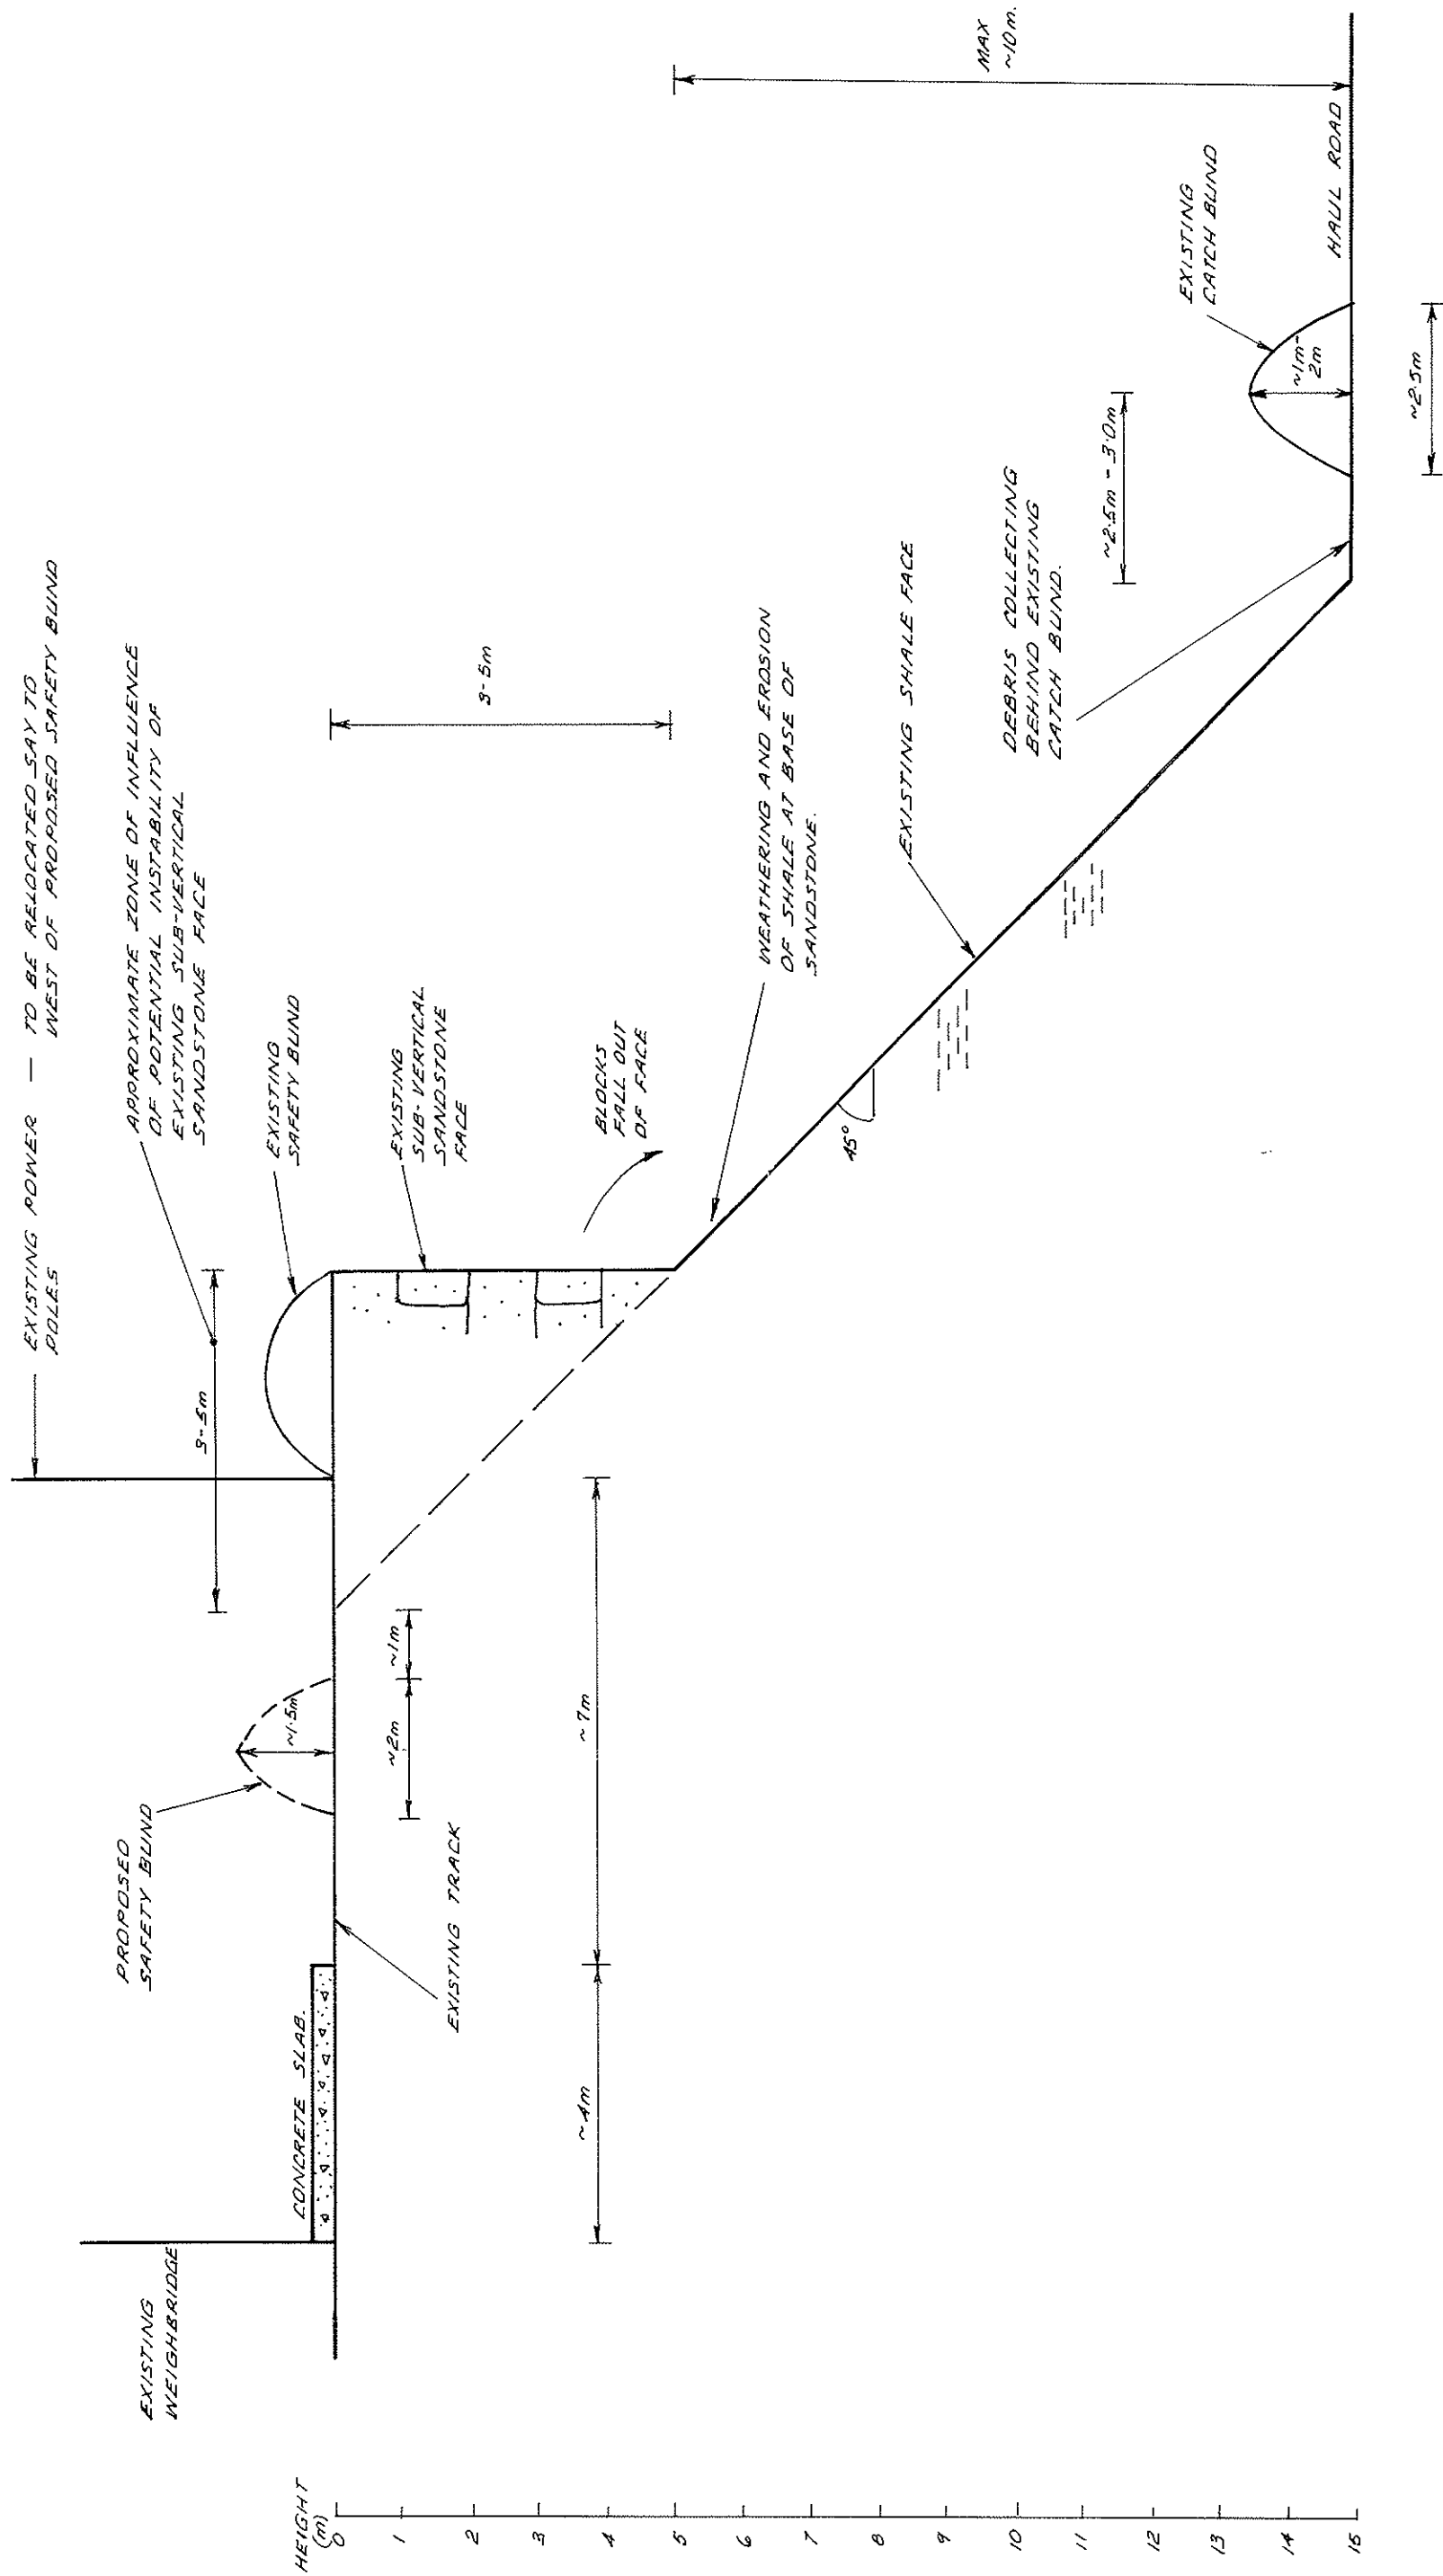
Over the western and south-eastern corners of the quarry crest, sandstone capping to shale slopes is likely to collapse over time. The impact on the crest areas of such collapses may be controlled in one of two ways (see Figure 1):

CROSS SECTIONAL SKETCH (LOOKING NORTH)
 SUMMARISING RECOMMENDED STABILISATION MEASURES –
 EXISTING WEIGHBRIDGE ABOVE CREST OF WESTERN QUARRY FACE

- Lay back the sub-vertical sandstone face to an angle of about 45°. Provide a new safety bund set-back about 1m from the crest of the new slope.
- Provide a new safety bund set-back about 1m from the trace of a zone of influence line projected up from the base of the sandstone face at an angle of about 45°.

Figure 1 also indicates that existing power poles would also need to be re-located. Further, such works would prevent use of the existing road to the east of the weighbridge. However, the existing weighbridge may remain in its current location.

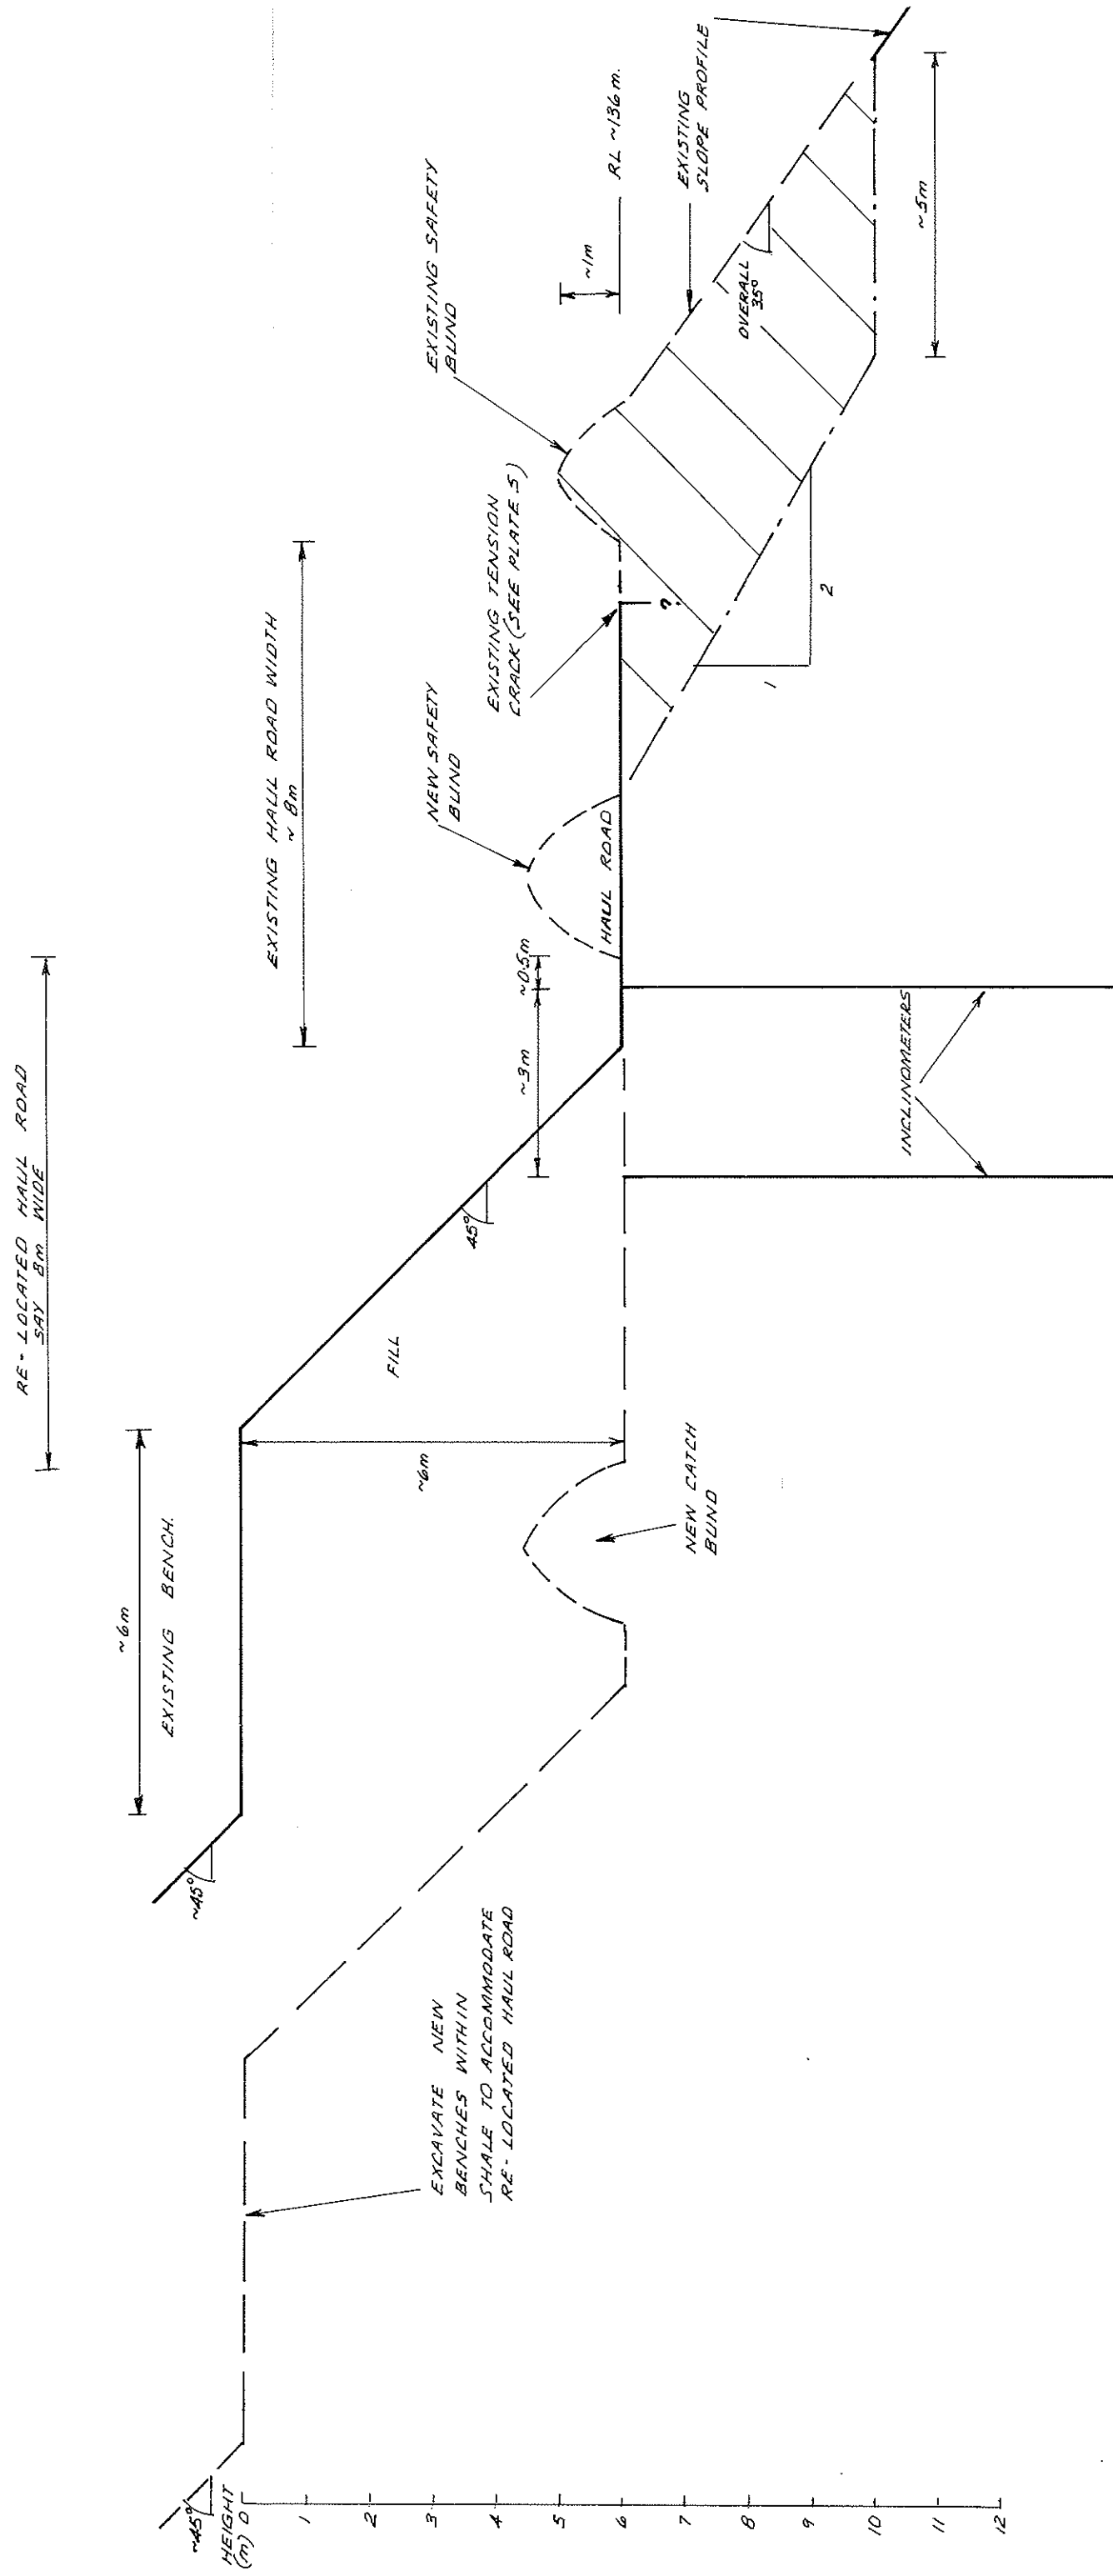
In addition to the previously described clean out of the RL85m berm below the landslip, the crest area of the landslip should also be re-profiled (see Figure 2). The purpose of the re-profiling is to remove material surcharging the upper portion of the landslip and to control potential regression of the backscar.

CROSS SECTIONAL SKETCH (LOOKING EAST)
SUMMARISING RECOMMENDED STABILISATION MEASURES –
UPPER PORTION OF LANDSLIP WITHIN NORTHERN QUARRY FACE

The re-profiling would impact on the existing fill slope to the north, the shale and soil slopes above and the proposed access road into the quarry leading down from the re-processing centre (north-western corner of the site). New cut batters and benches will need to be provided.

The expected on-going movement of the landslip will need to be monitored. We recommend that two inclinometers are installed in boreholes at the approximate locations indicated on Figure 2 and monitored on, say, a monthly basis and after prolonged or heavy rainfall. The inclinometers should be installed following the above described re-profiling works. The purpose of the inclinometer monitoring is to provide an early warning of landslip movement and to better understand the rate of movement, particularly in response to rainfall events. In addition, on-going optical surveying of various features of the landslip should also be maintained. We understand that such monitoring has previously been carried out by Hanson and a similar regime would seem to be appropriate. However, we note that we have no details of the monitoring regime and recommend that details be provided for review.

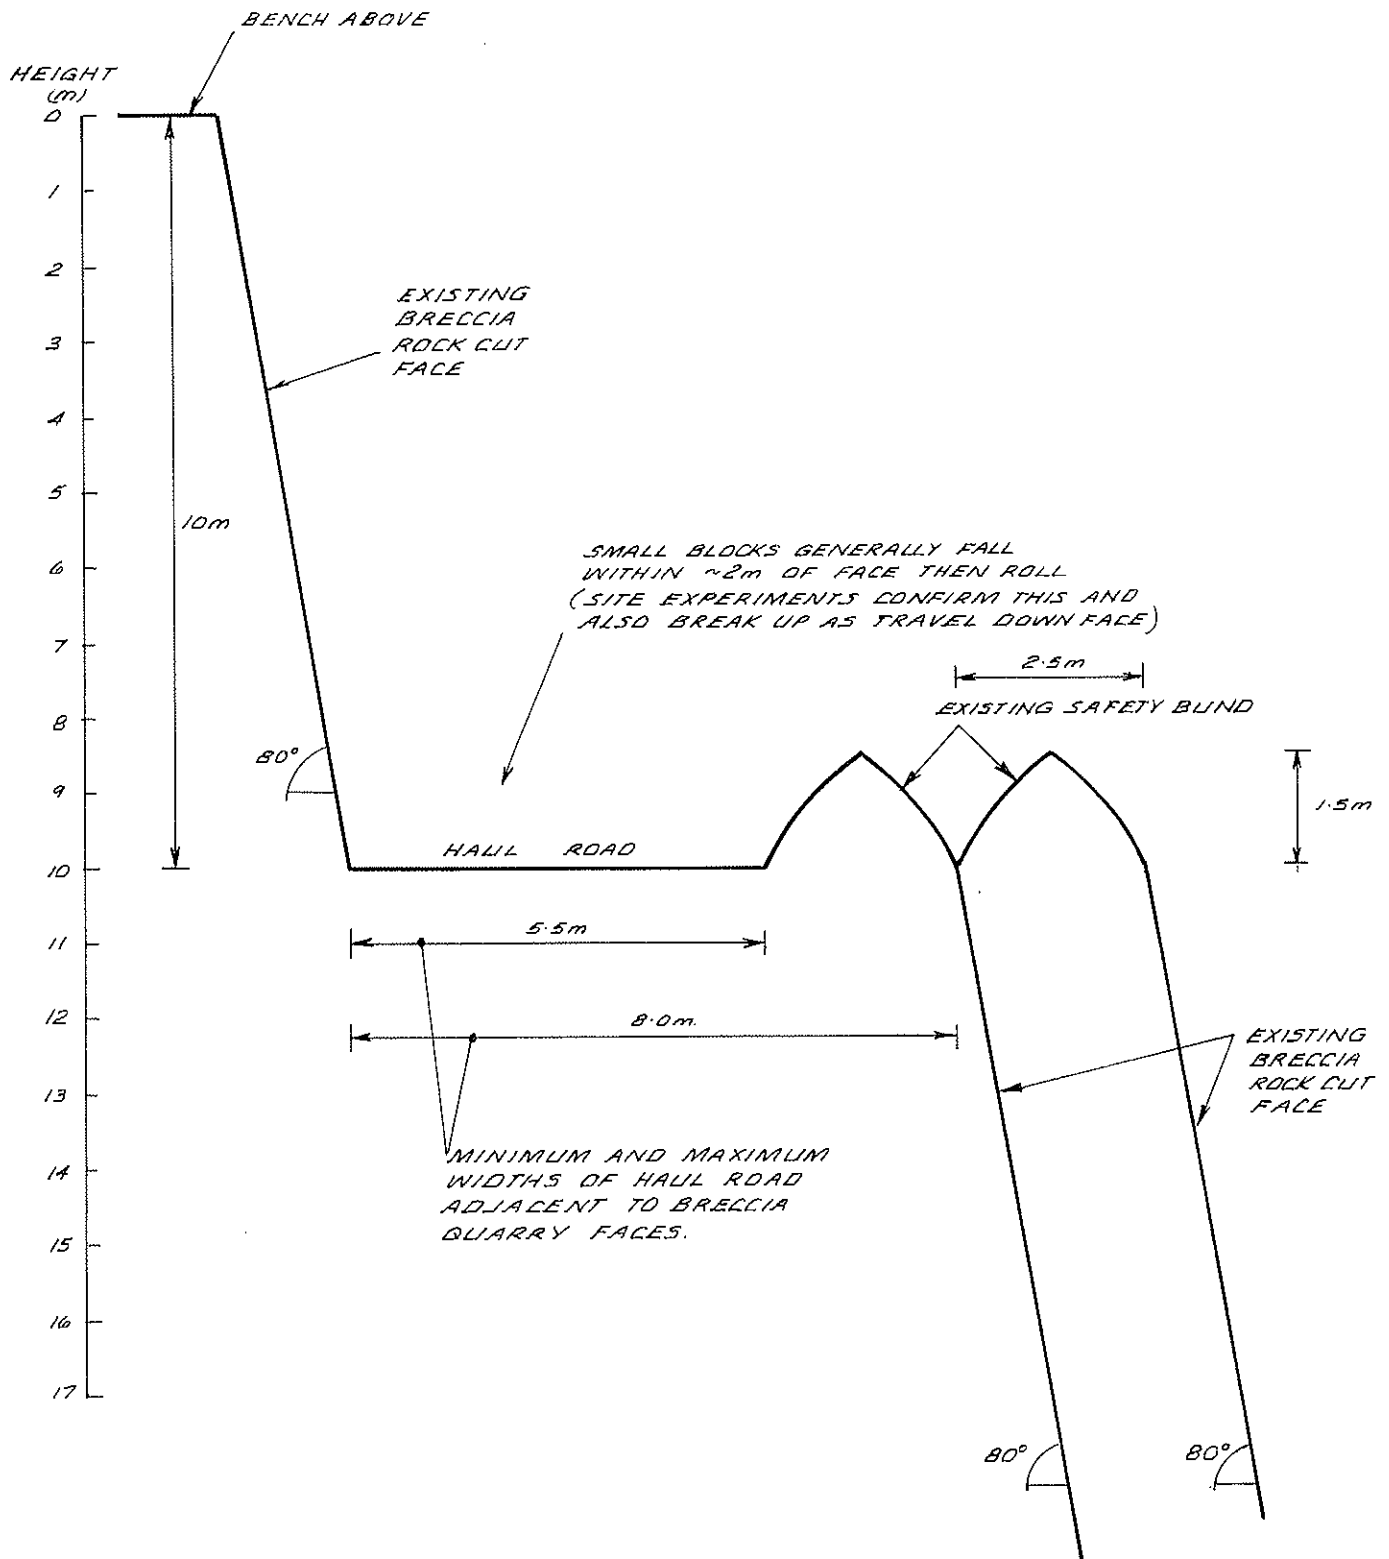
Figure No. 3

TYPICAL CROSS SECTIONAL SKETCH
OF BRECCIA CUT FACES ADJACENT
TO AND BELOW HAUL ROAD

The fractured breccia faces and intact breccia faces adjacent to the haul road should have all potentially loose blocks and fragments scaled off prior to commencement of backfilling operations. Such works would also need to be continued on a regular basis. The frequency may be determined following geotechnical inspection. At this stage we would expect scaling off to be completed on, say, a 6 monthly basis; increased intervals may be appropriate following on-going geotechnical monitoring.

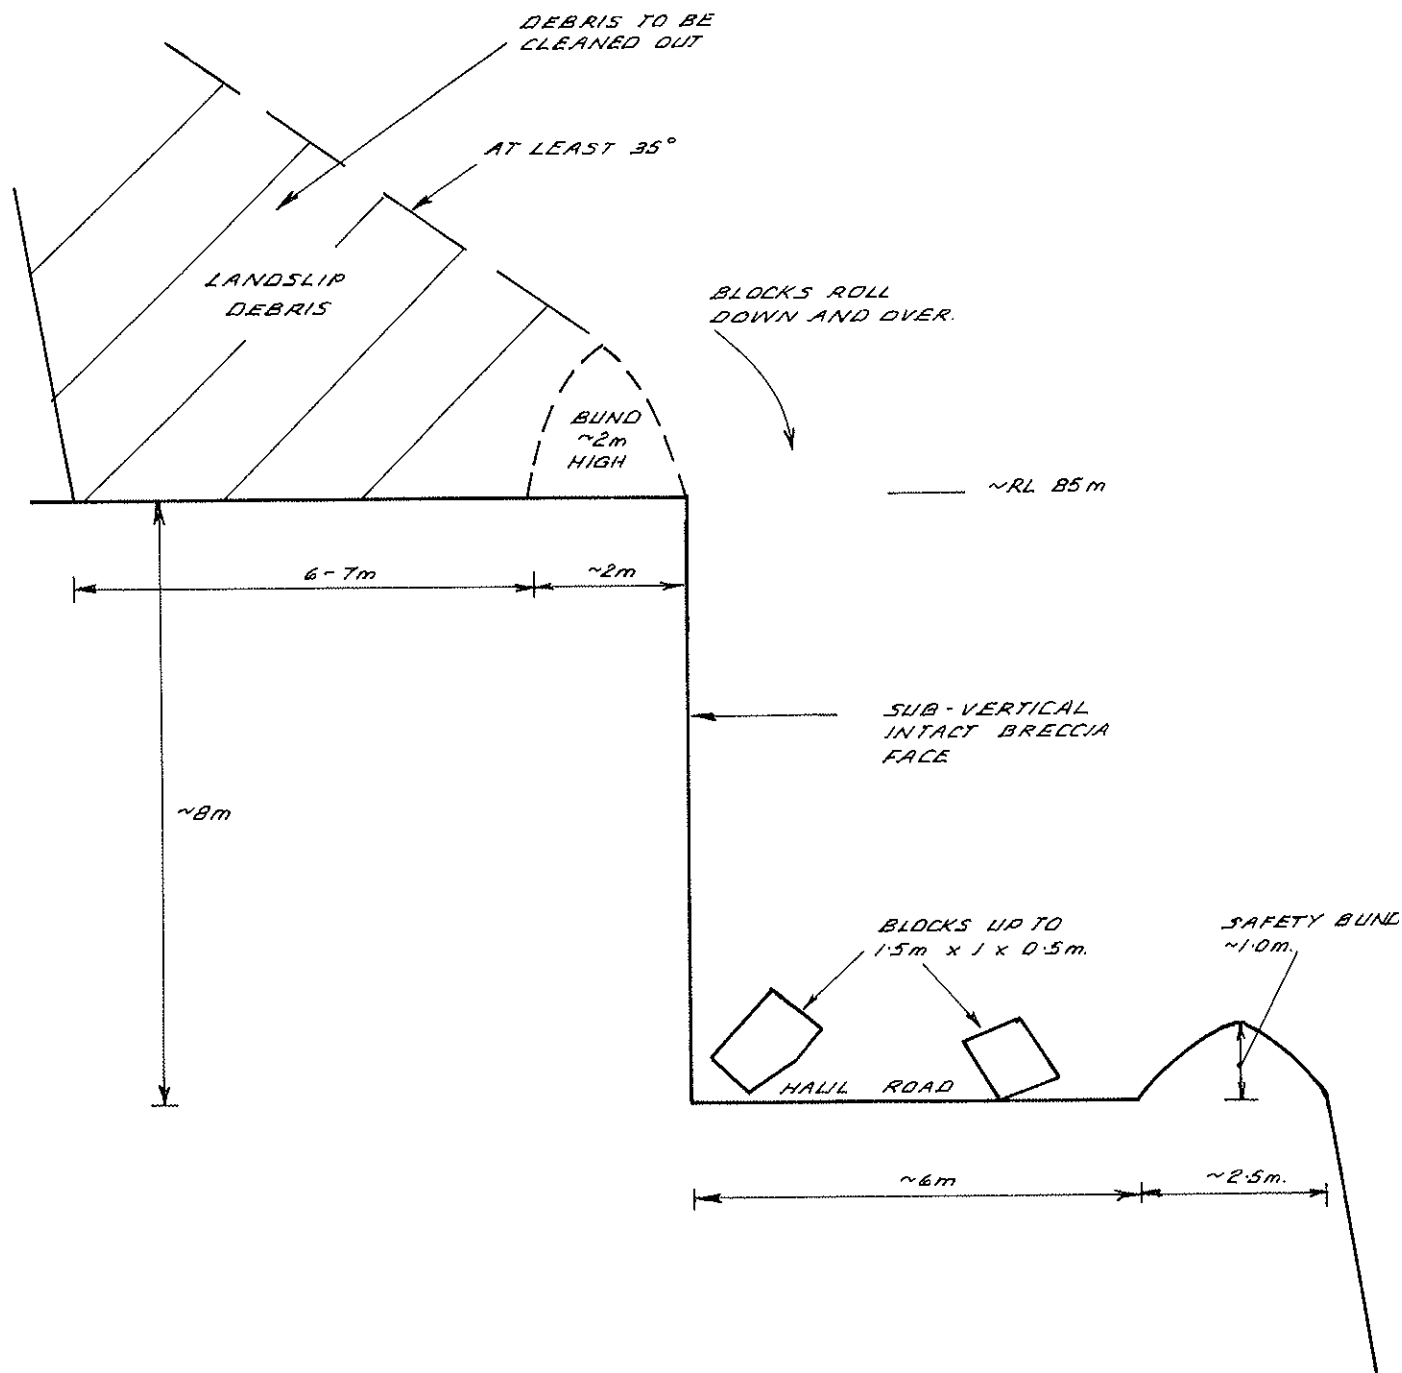
Figure No. 4

The catch bund lining the crest of the berm at the base of the northern face landslip is full of debris and is currently ineffective. We recommend that the catch bund be cleaned out in a similar manner to that outlined by PSM in their report dated 14 December 2007.

CROSS SECTIONAL SKETCH (LOOKING EAST)
BASE OF LANDSLIP WITHIN NORTHERN QUARRY FACE

NORTH FACE LANDSLIP (See Figures 2 and 4)	Re-route haul road to north.	Reduce risk by moving haul road away from potentially unstable area.	Remove material from RL84m bench and reinstate catch bund at crest of bench.
	Excavate out upper portion of slip from haul road (RL136m) down to bench at RL132m.	Remove material that otherwise surcharges remainder of slip mass below and also currently provides source for material moving downslope onto (and over) the bench below.	
	Install at least 2 inclinometers behind believed slip backscar and take readings on regular basis. Possibly supplemented with regular survey monitoring.	On-going monitoring of slip allows early warning of potential movement and better understanding of slip mechanisms so that risk assessment can be refined.	
			Improves effectiveness of bench below the slip so that large blocks likely to be caught on bench rather than roll over top surface of current debris filled bench and impact haul road below.

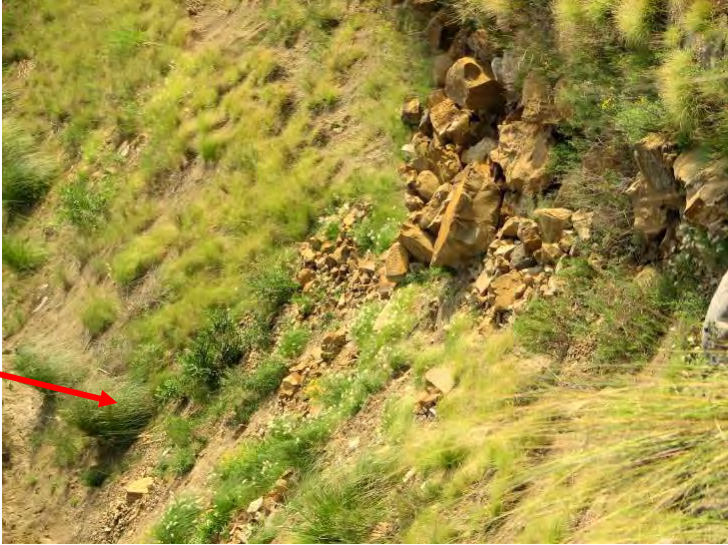
Sandstone blocks from sandstone cap above

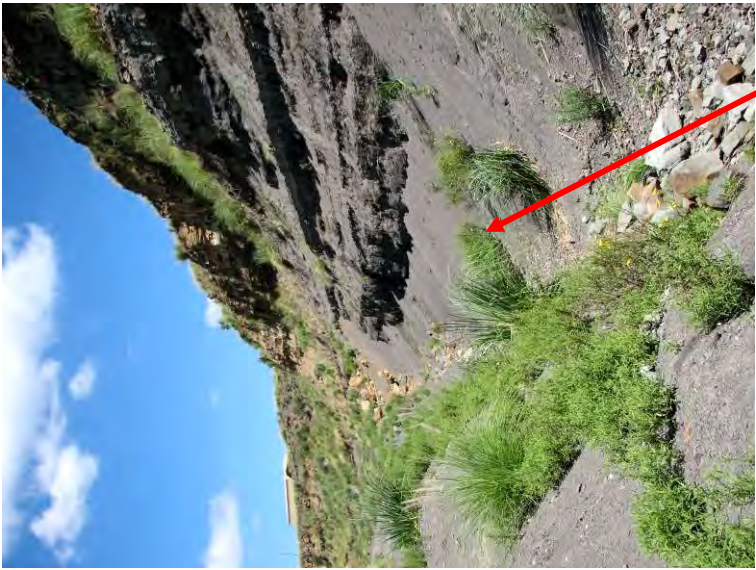
Debris collecting
in berm

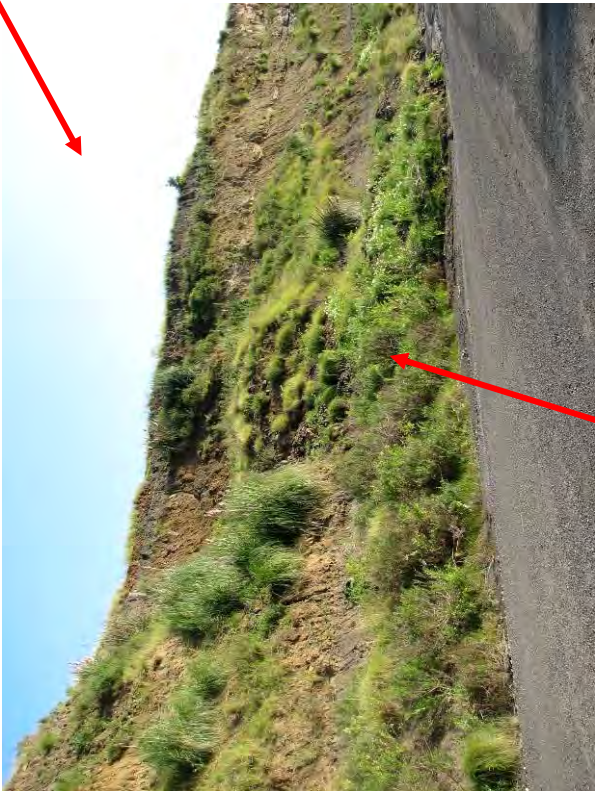
Landslip within shale/soil slope

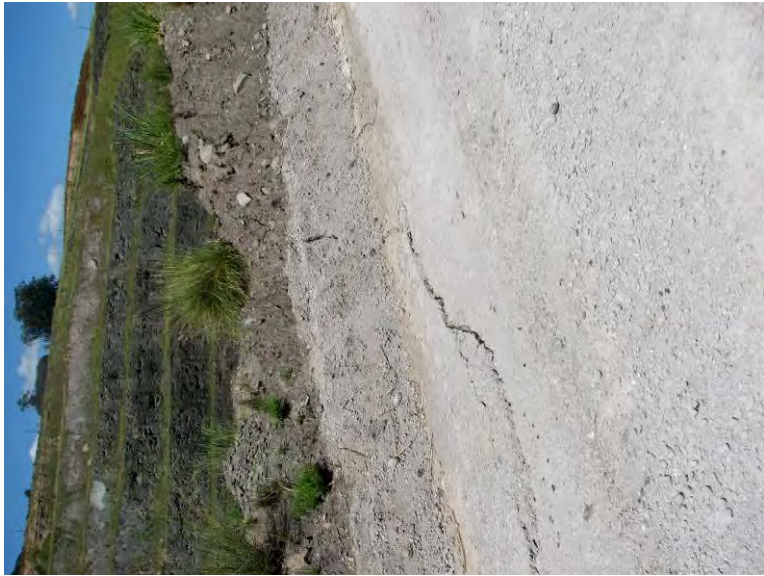
We note that a tension crack has developed in the haul road since December 2007. As outlined to a Hanson representative during our initial site visit (20 February 2008),

Tension crack in
Haul Road above
landslip

the tension crack should be backfilled without delay to prevent ingress of water into the landslide. Such water ingress may lead to further landslide movements. We understand that PSM advised Hanson during December 2007 to re-grade the haul road and provide a seal of cement stabilised road base. We understand that these works were completed. A similar temporary treatment is considered reasonable at this stage.

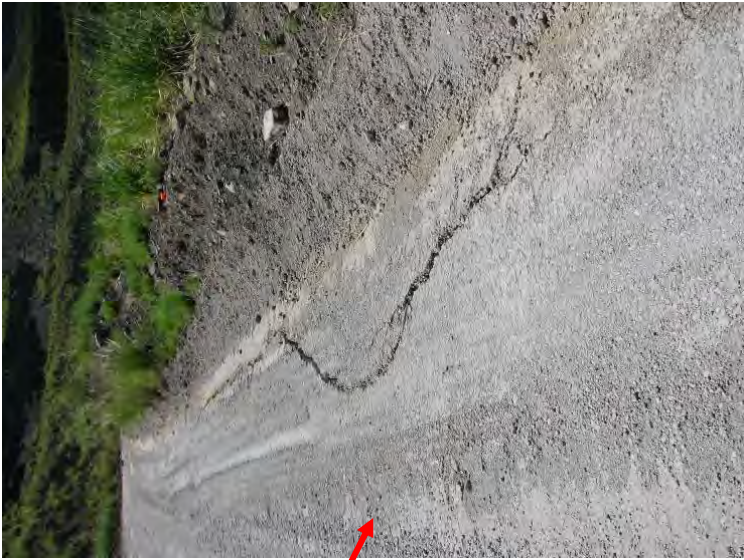
Tension crack in Haul Road above landslip

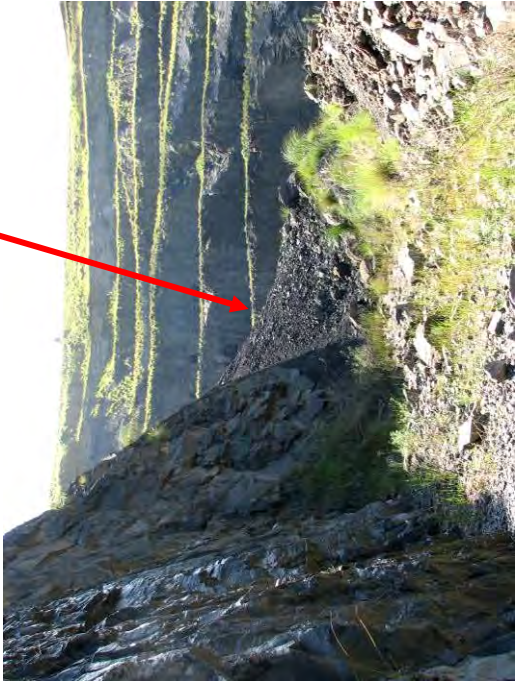
Debris collecting on berm (see Figure 4)

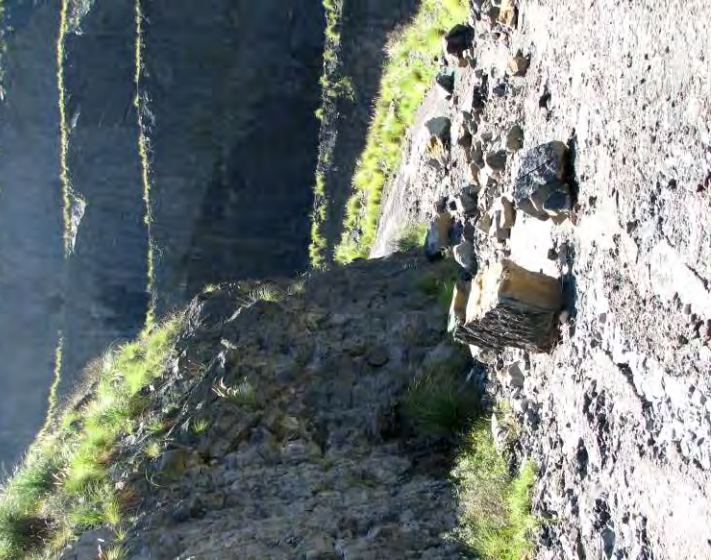
Blocks on Haul Road

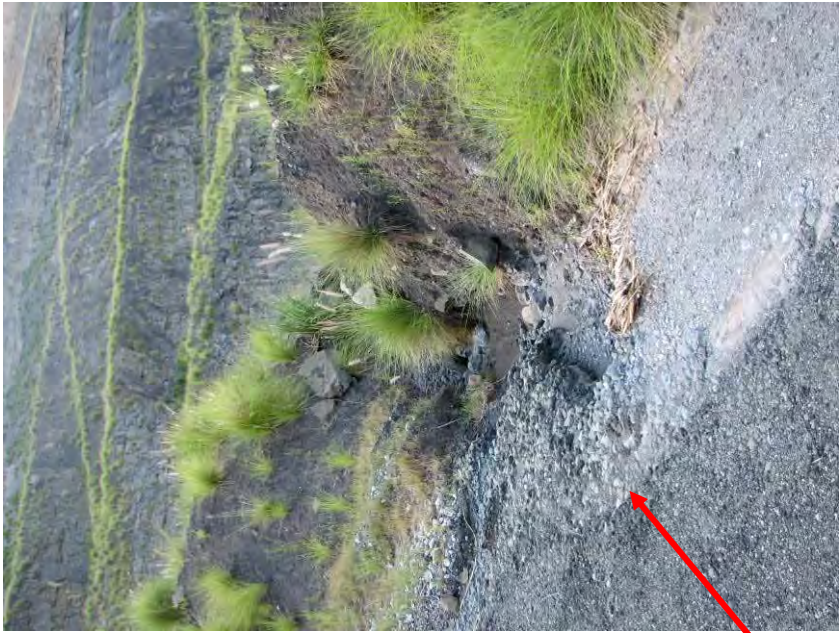
Erosion of crest safety bund

Any safety bunds that have been eroded by concentrated haul road surface run-off should be repaired. The haul road should also be re-graded to direct surface run-off to the bases of the adjacent high side of the haul road face.

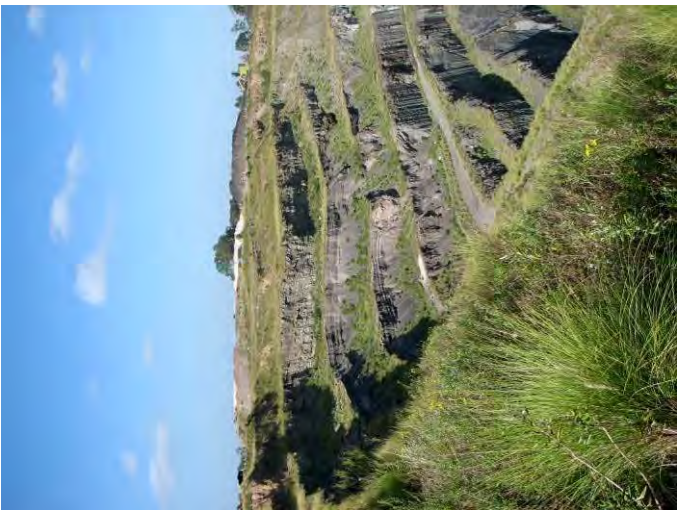
Debris at toe of XW Breccia slope
