RE: SHORT TERM RISKS IN QUARRY

This letter presents the results arising from an inspection of the Wallgrove Quarry on 18th October 2006.

RE: LONG TERM RISKS IN QUARRY

This letter presents the results arising from an inspection of the Wallgrove Quarry on 18th October 2006. The quarry was inspected in the company of Mr Bassos of Hanson.

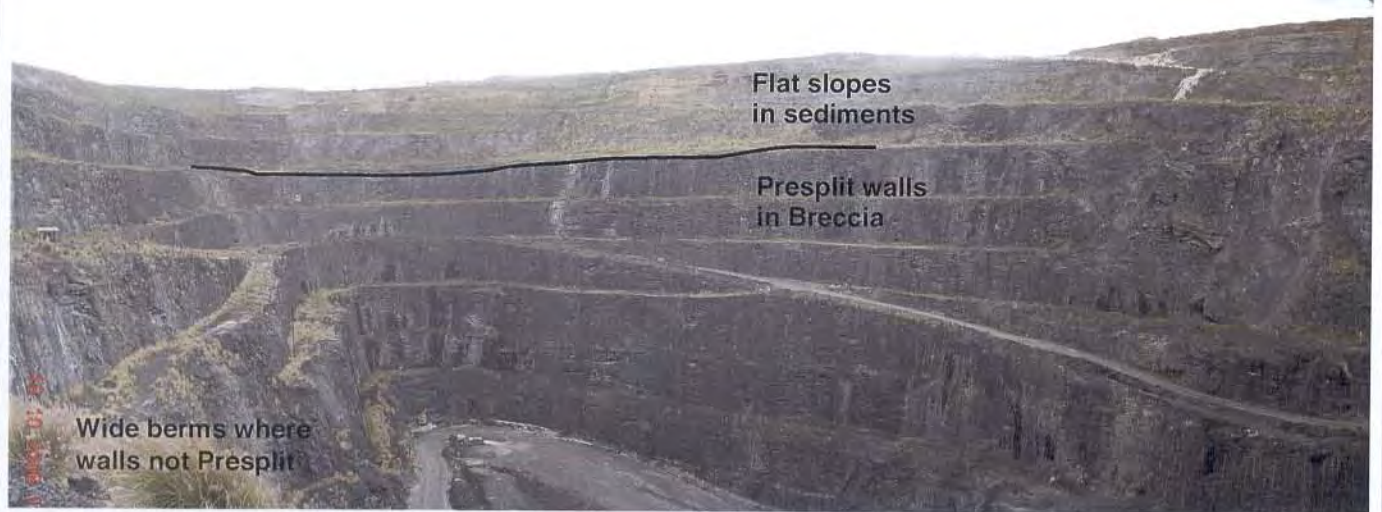
The majority of the western end of the quarry is seen as presenting a low to very low risks to personnel entering the quarry, Plate 1. The majority of pit walls within the sediments have relatively low overall slope angles, with most benches at or near the angle of repose of the sediments. Whilst the pit walls in the breccia materials are steep, these walls have either been pre-split with very little evidence of blocks “hung up” on pit walls or have wide berms beneath each bench (upper south wall).

Plate 1 : Overview of west wall, highlighting generally pre-split walls in breccia and generally flat slopes in the overlying sediments.

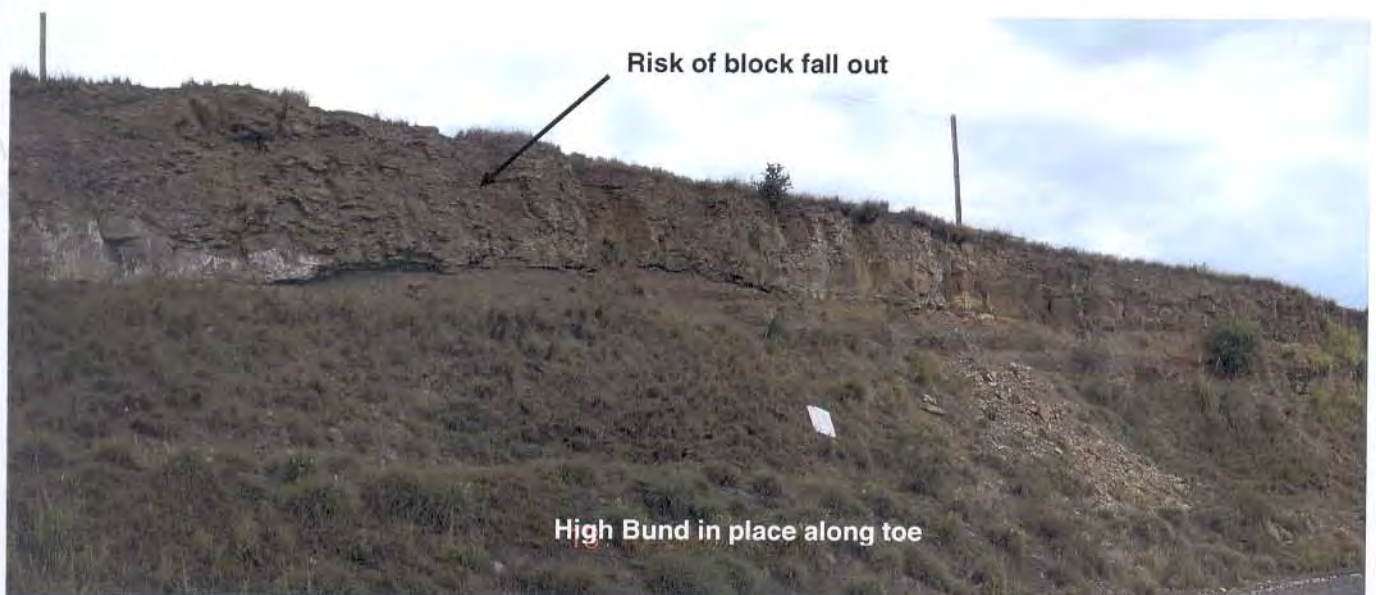
- The upper west wall near surface, where a sandstone layer is being progressively undercut, Plate 2. The risk to the haulroad below from block fall out is considered very low owing to the catch bund immediately below. However, there is a risk of a block fall affecting the road placed near the pit crest, Figure 1. In the short term the risk is considered low with ongoing visual monitoring of the sandstone layer required.
- There remains a risk of block fall out from the instability in the north wall, Plate 3. In the short term the risk is considered low with ongoing monitoring of the instability required.

Plate 2 : Upper west wall, highlighting undercutting of sandstone bed with potential for block fall out. Road below is at low risk owing to bund in place. However there is a risk to road immediately above.

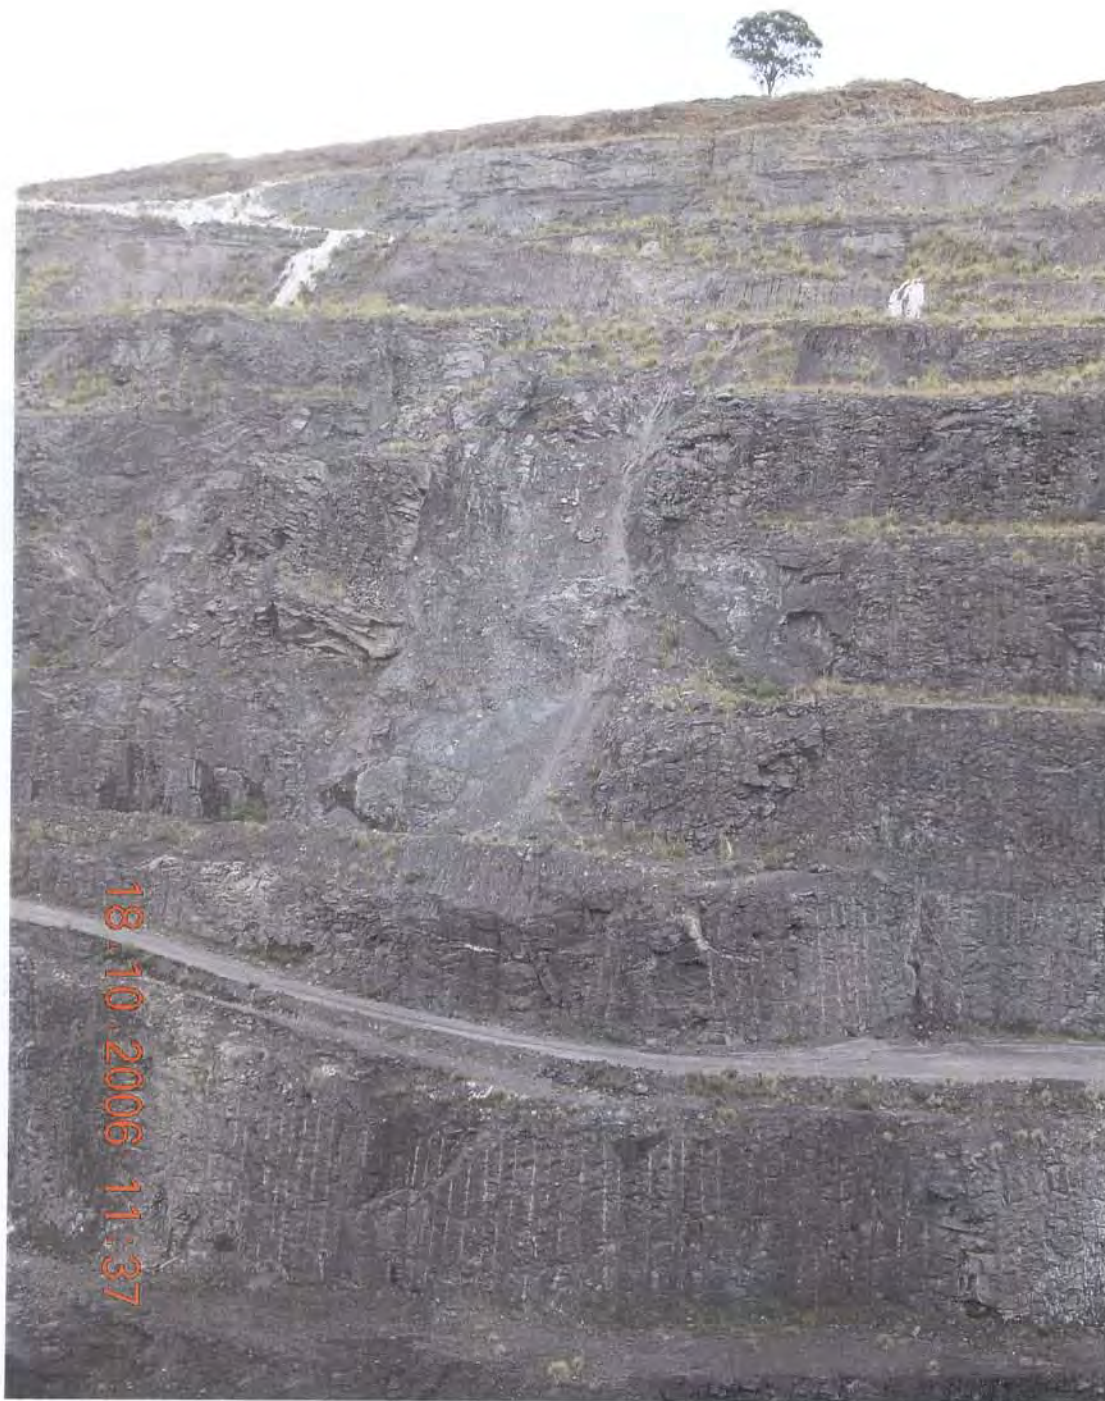
Plate 3 : North wall, highlighting area of instability which initially failed in 2001. Potential for blocks to fall onto road exists. Ongoing monitoring of area required.

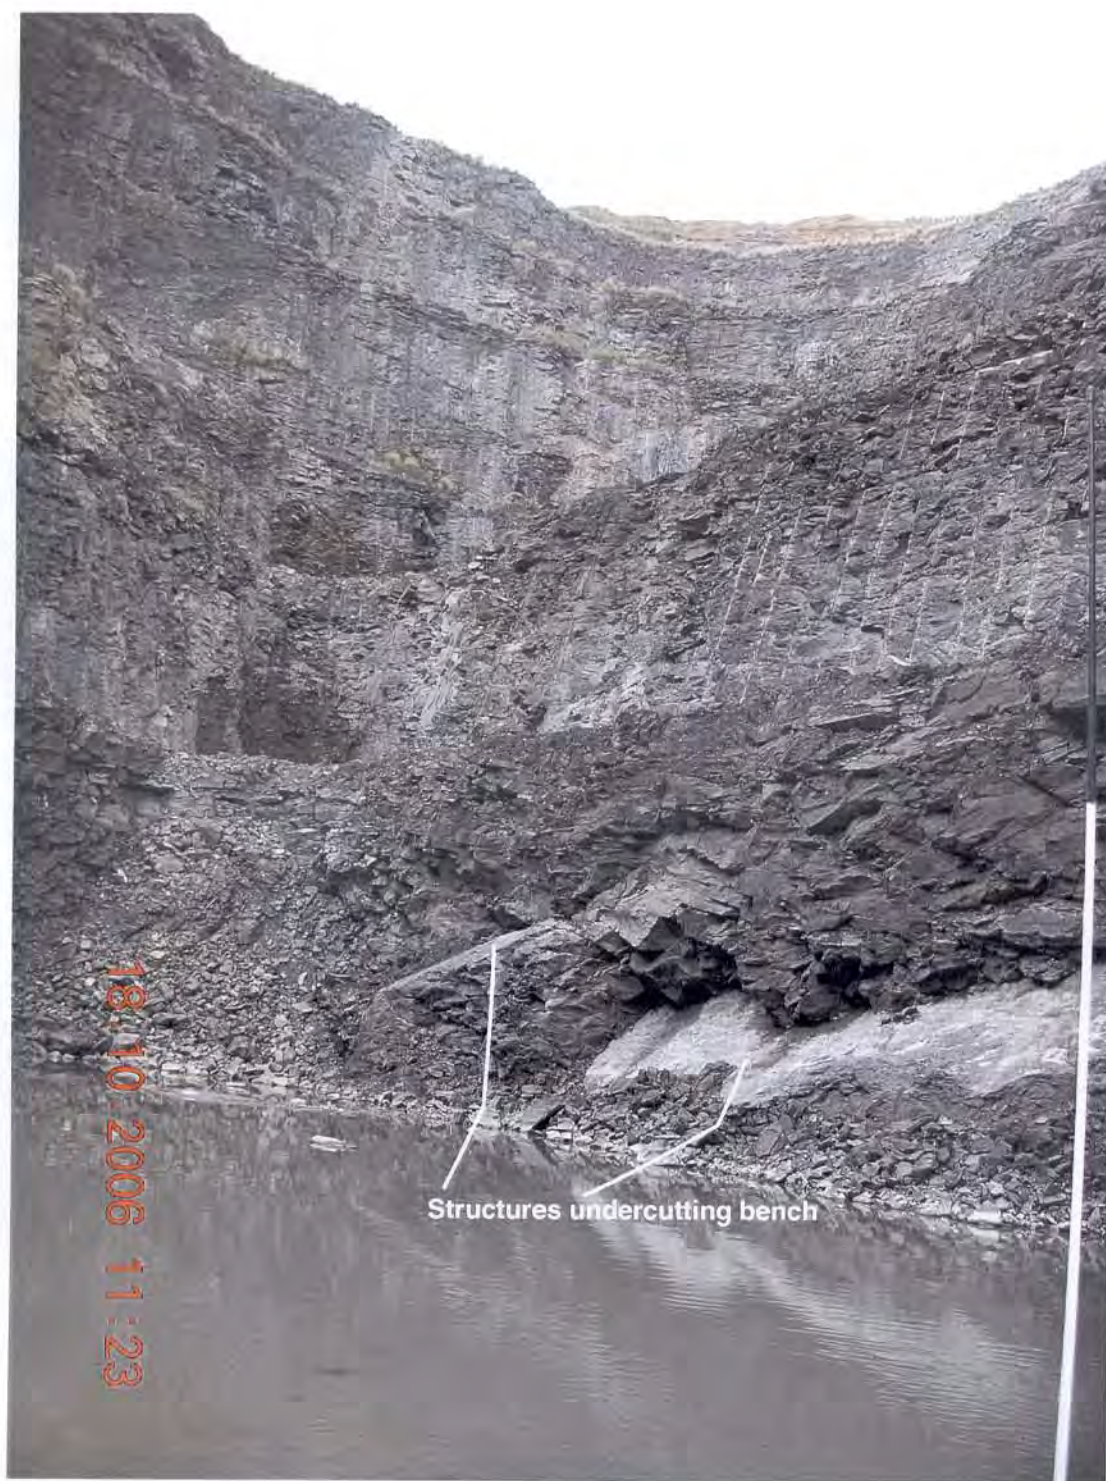
The east wall at the bottom of the quarry, Plate 4, has several structures which undercut the bench above. There is a risk of a failure in this area and it is recommended the area be cordoned off with a stand off distance of at least 30m from the toe.

Plate 4 : Lower east wall, highlighting structures undercutting lowest most bench. Area needs to be cordoned off to limit access.

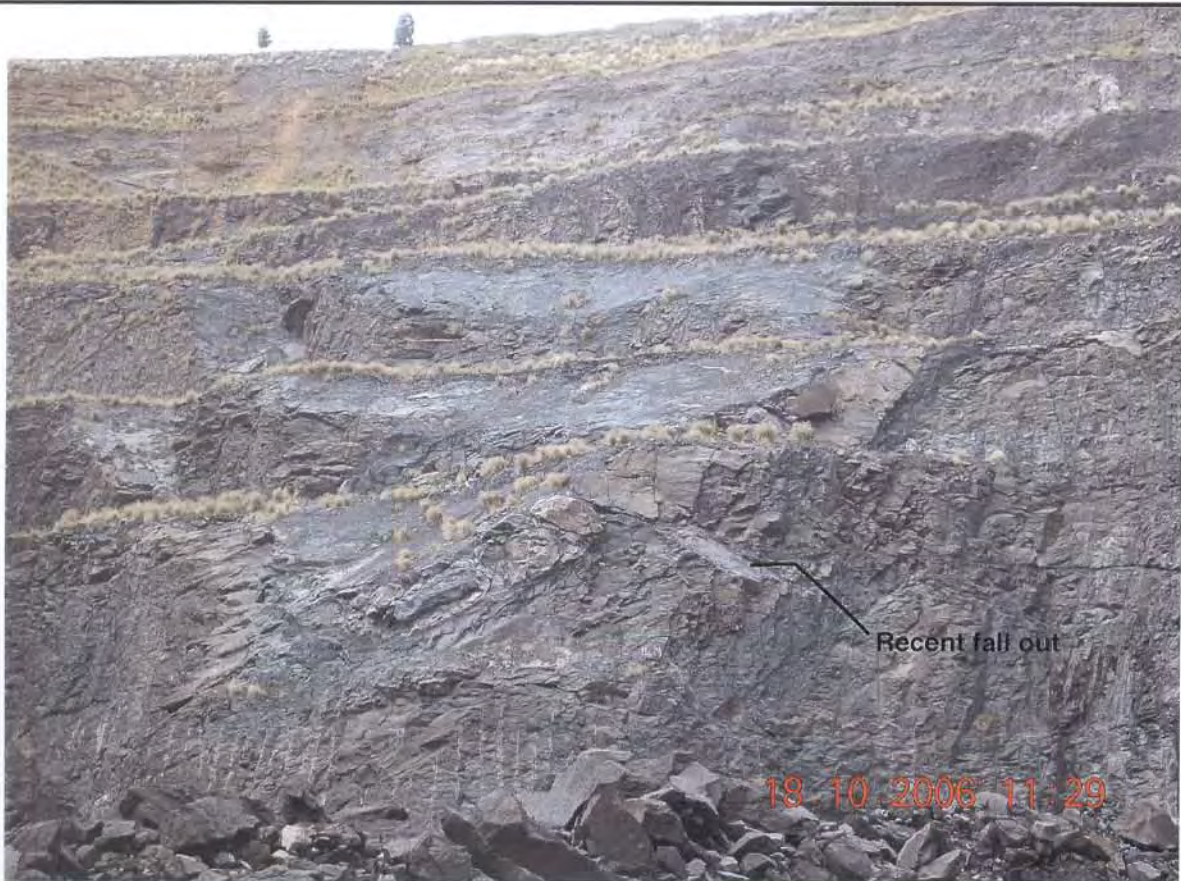
There is an area immediately above the haulroad in the east wall where there is recent evidence of block fall out, Plate 5 and Figure 1. In view of the potential for further rock falls in the immediate area all operations personnel should be made aware of no standing/parking for all vehicles in this area. In consideration of the low number of vehicles traversing this area and with the above mitigative measures in place the risk is considered low.

Plate 5 : West wall immediately above haulroad, highlighting area of recent block fall out. All operations personnel need to be made aware of no standing/parking of vehicles beneath this area.

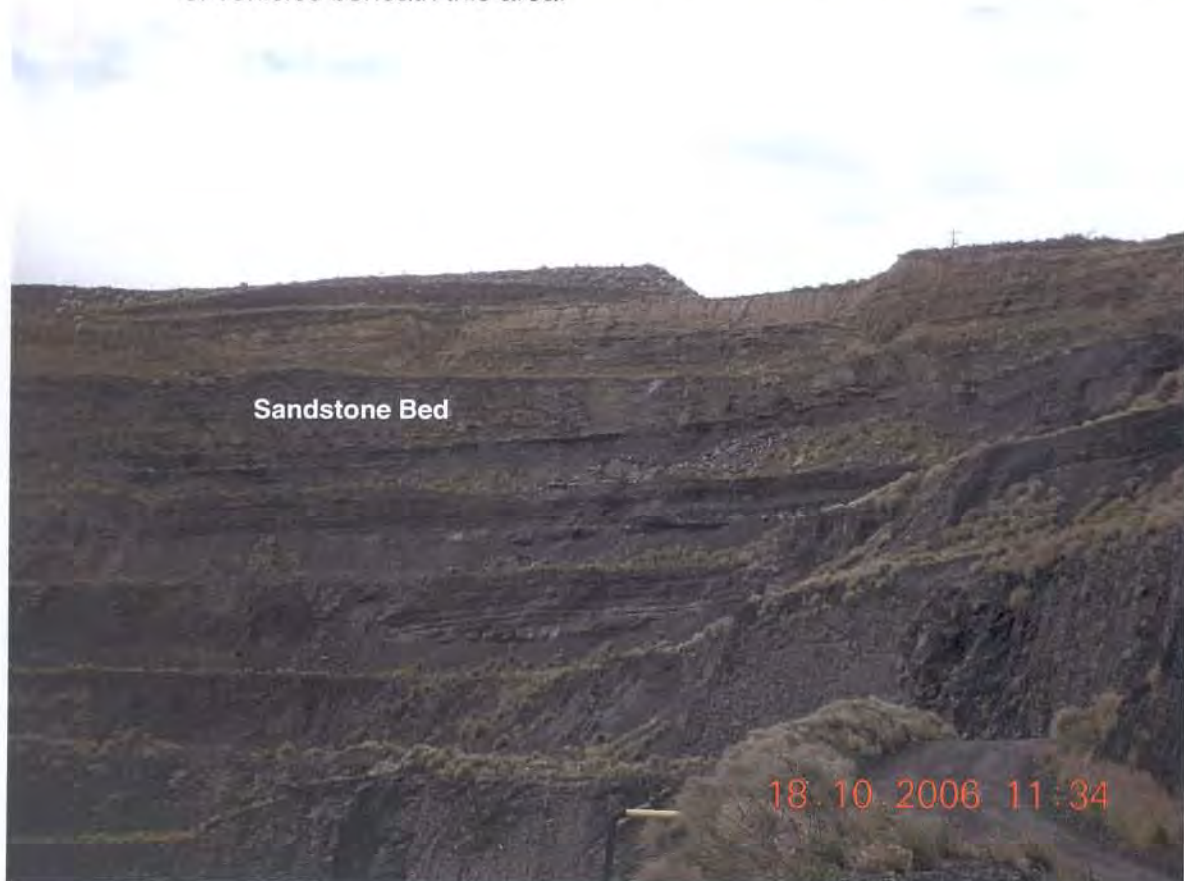
Plate 6 : Overview of upper west wall, highlighting sediments and undercutting of sandstone bed in the area.

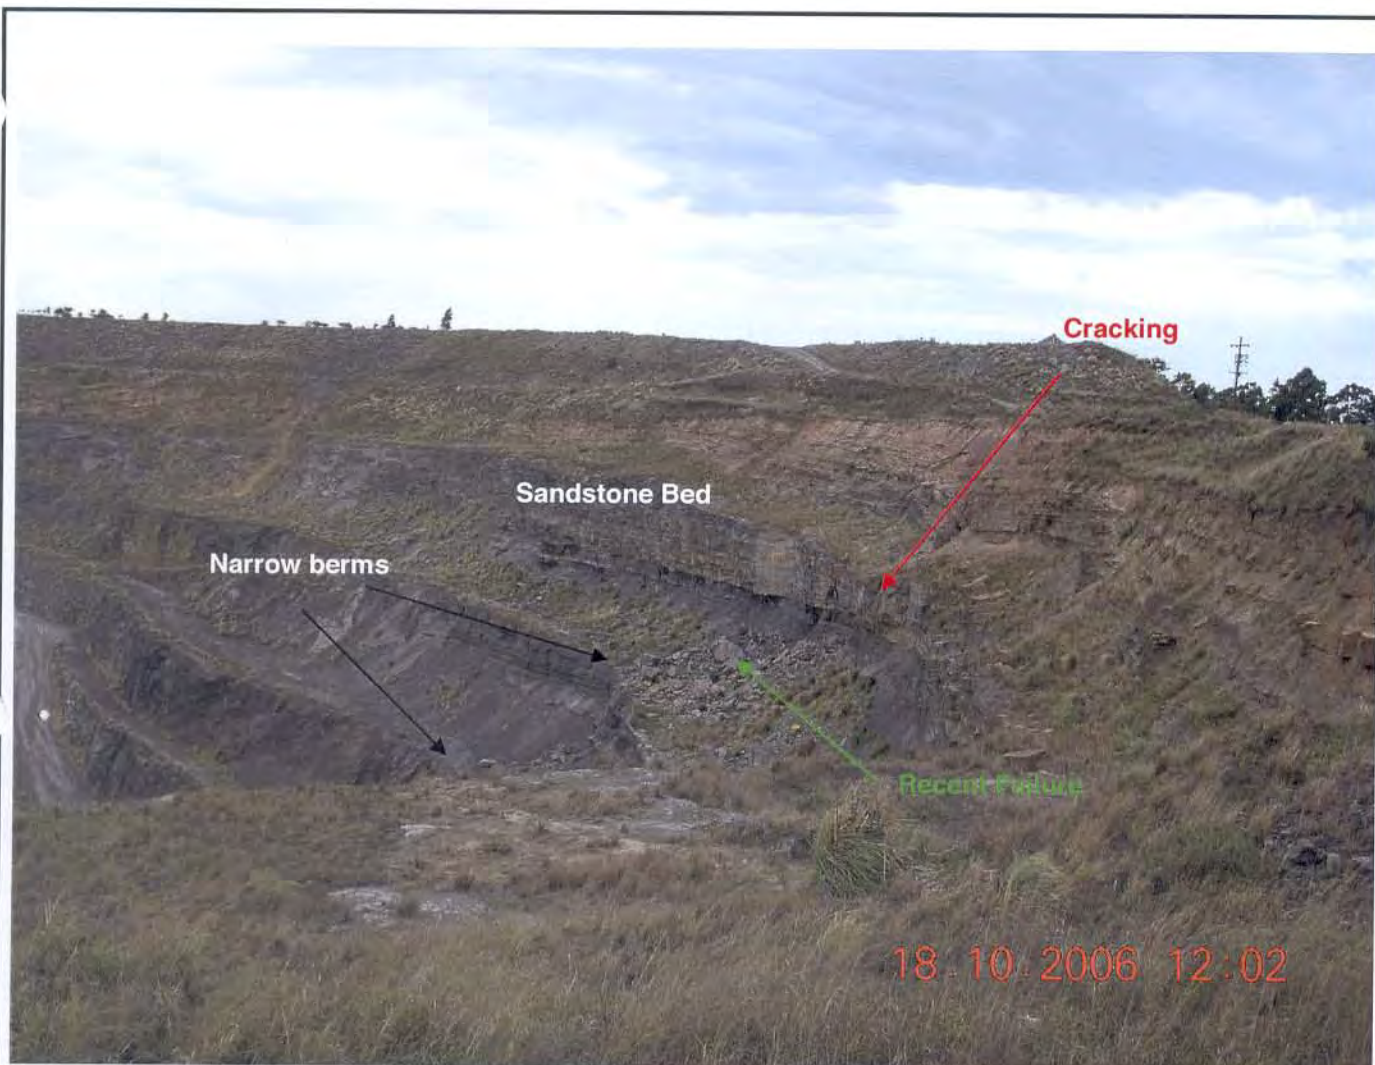
The upper part of the east wall presents the area of highest potential concern at the quarry. The sandstone ledge within the upper most bench is undercut along a substantial length, Plate 6, and with narrow berm widths in key areas, Plate 7. Furthermore, there have been recent large block fall outs, Plate 7, and evidence of cracks within the sandstone unit to suggest that further block fall out could readily occur. Ongoing visual monitoring of this area is recommended. However, the risk to personnel utilising the haulroad remains as low to moderate.

Plate 7 : West wall looking to the north, highlighting undercutting of sandstone bed, narrow berms below, recent failure and cracks within sandstone bed.

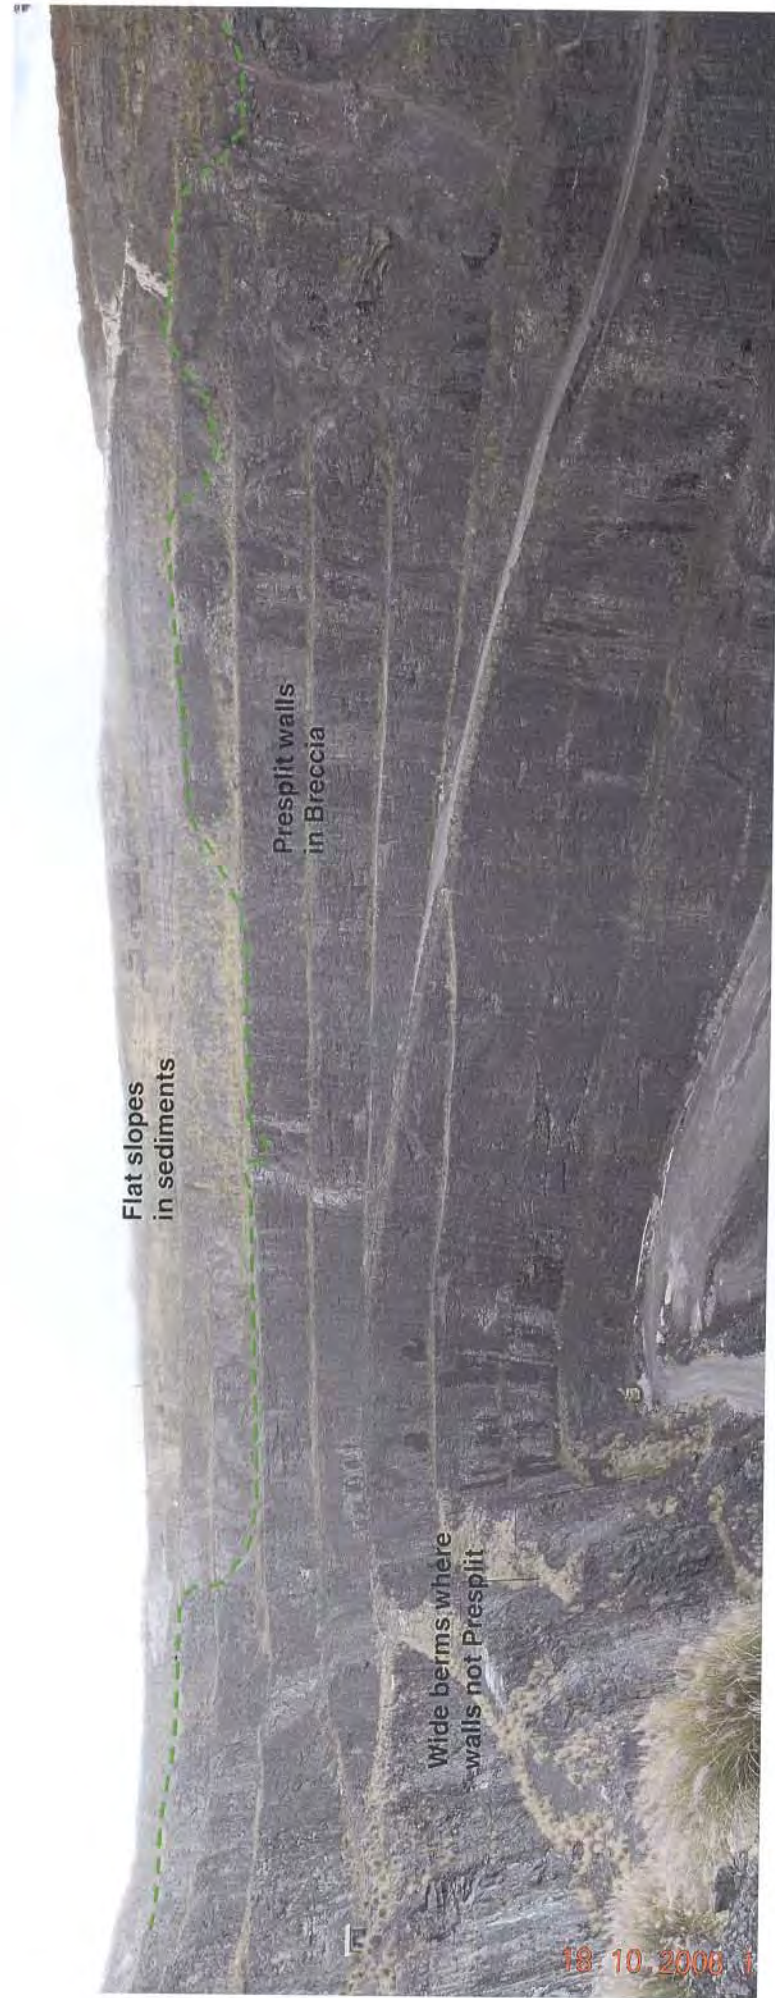
Plate 1 : Overview of west wall, highlighting predominantly pre-split walls within breccia. Generally flat slopes have been developed in the overlying sediments. In the long term rock falls can be anticipated owing to ongoing degradation of breccia. Highest risk is in upper most bench in the breccia near the contact with sediments.

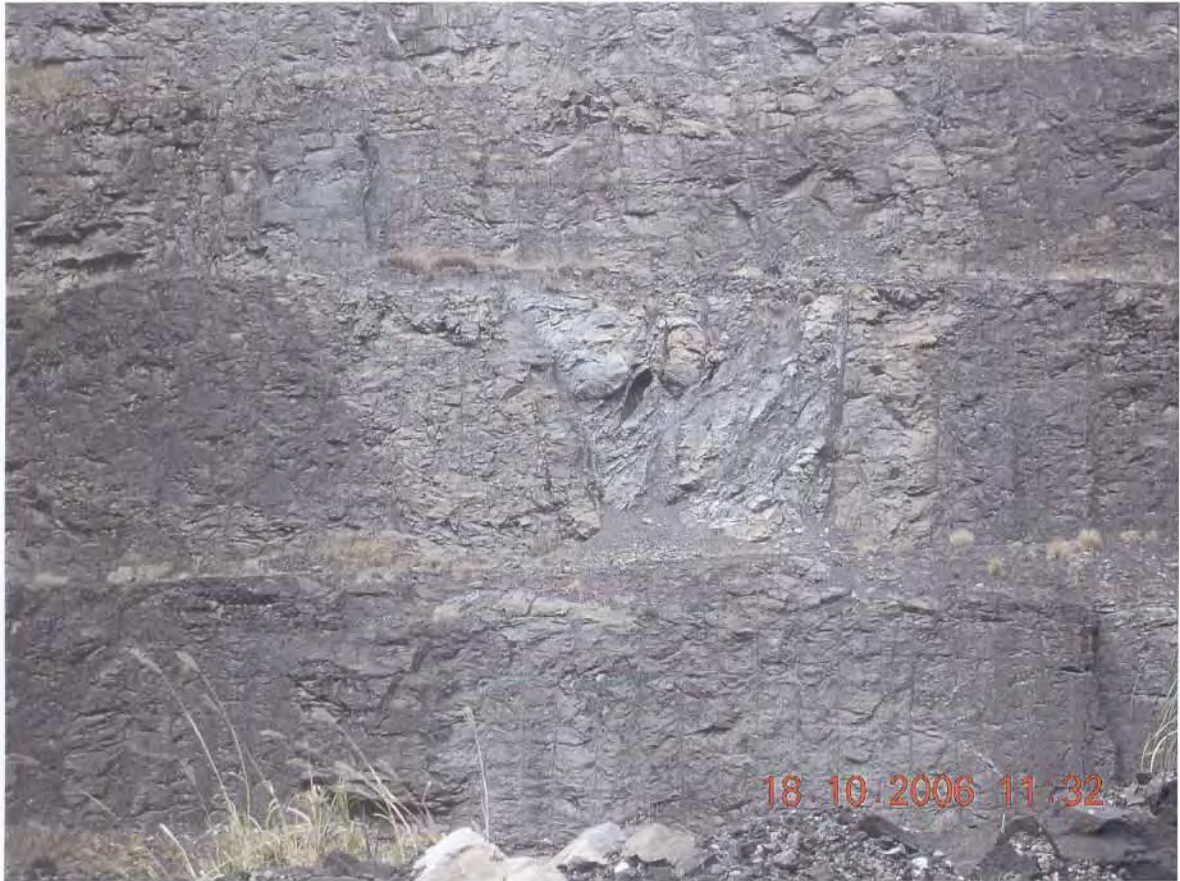
evidence of ongoing block fall out, Plates 2, 8 and 9, and with higher potential than elsewhere within the breccia slopes for block fall out. These areas require ongoing visual observation.

Plate 2: Small areas of walls within breccia, particularly in upper most benches, have entrapped sediments or are very close to sediment contact. These areas are more prone to block fall out.

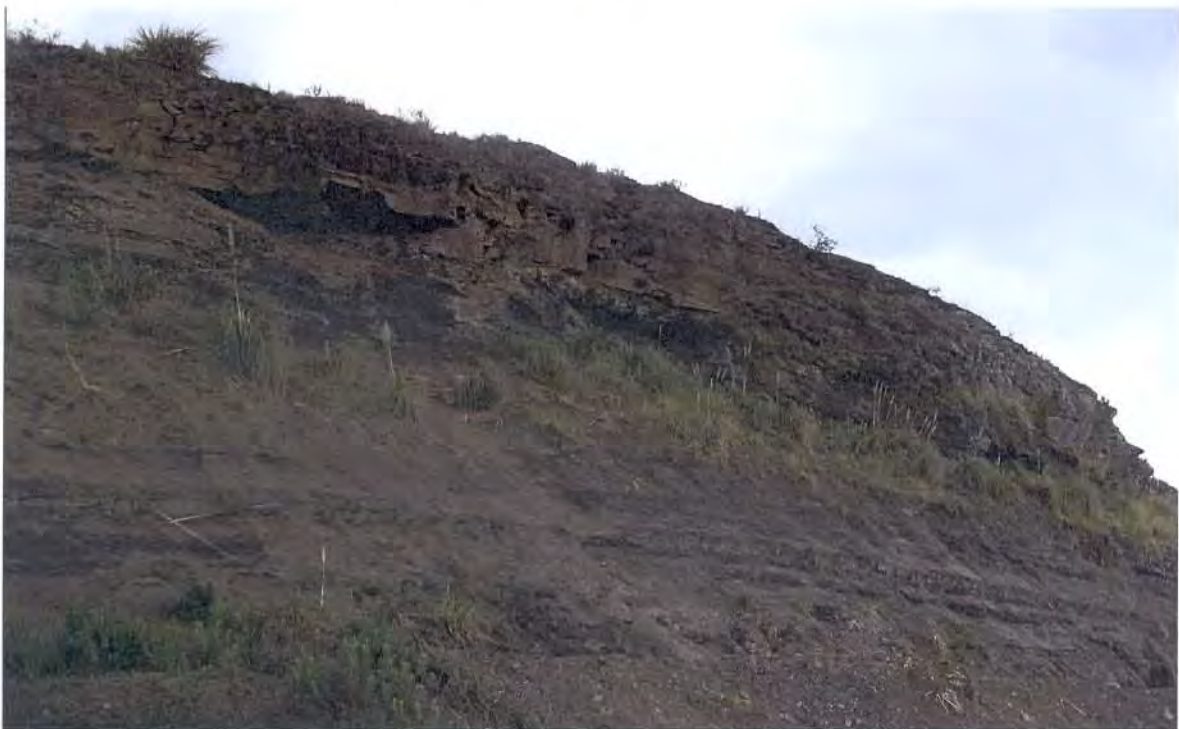
Plate 3: Upper west wall highlighting sandstone bed near surface with underlying shale. Sandstone bed is being progressively undercut with time and loss of quarry crest can be expected.

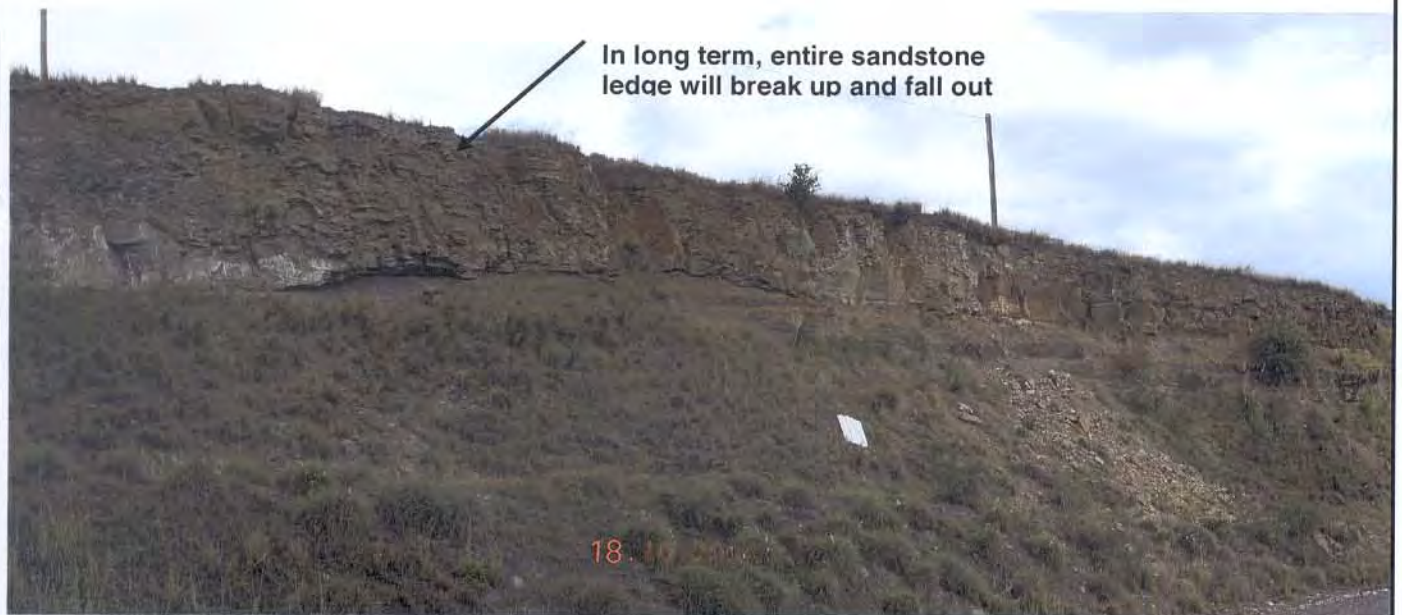
- In the upper part of the west wall, Plate 4, the road between the recently constructed weighbridge and the quarry crest on the western edge will need to be relocated, with also the potential for relocation of the power poles required.
- In the upper part of the east wall, particularly the southern part, Plate 11, the potential for sudden rock falls will pose a risk to any operations utilising the haul road within the quarry. This will require ongoing review with either requirement for increased bunds at the toe of the haulroad or potentially minor cutbacks of the upper benches to remove the sandstone bed.
- For both areas, Figure 1 presents the distance behind the crest where cracking and or failure may extend to.

Plate 4: Upper west wall further south of Plate 3. In long term sandstone ledge will break up and fall out. Road above and power poles may need to be relocated.

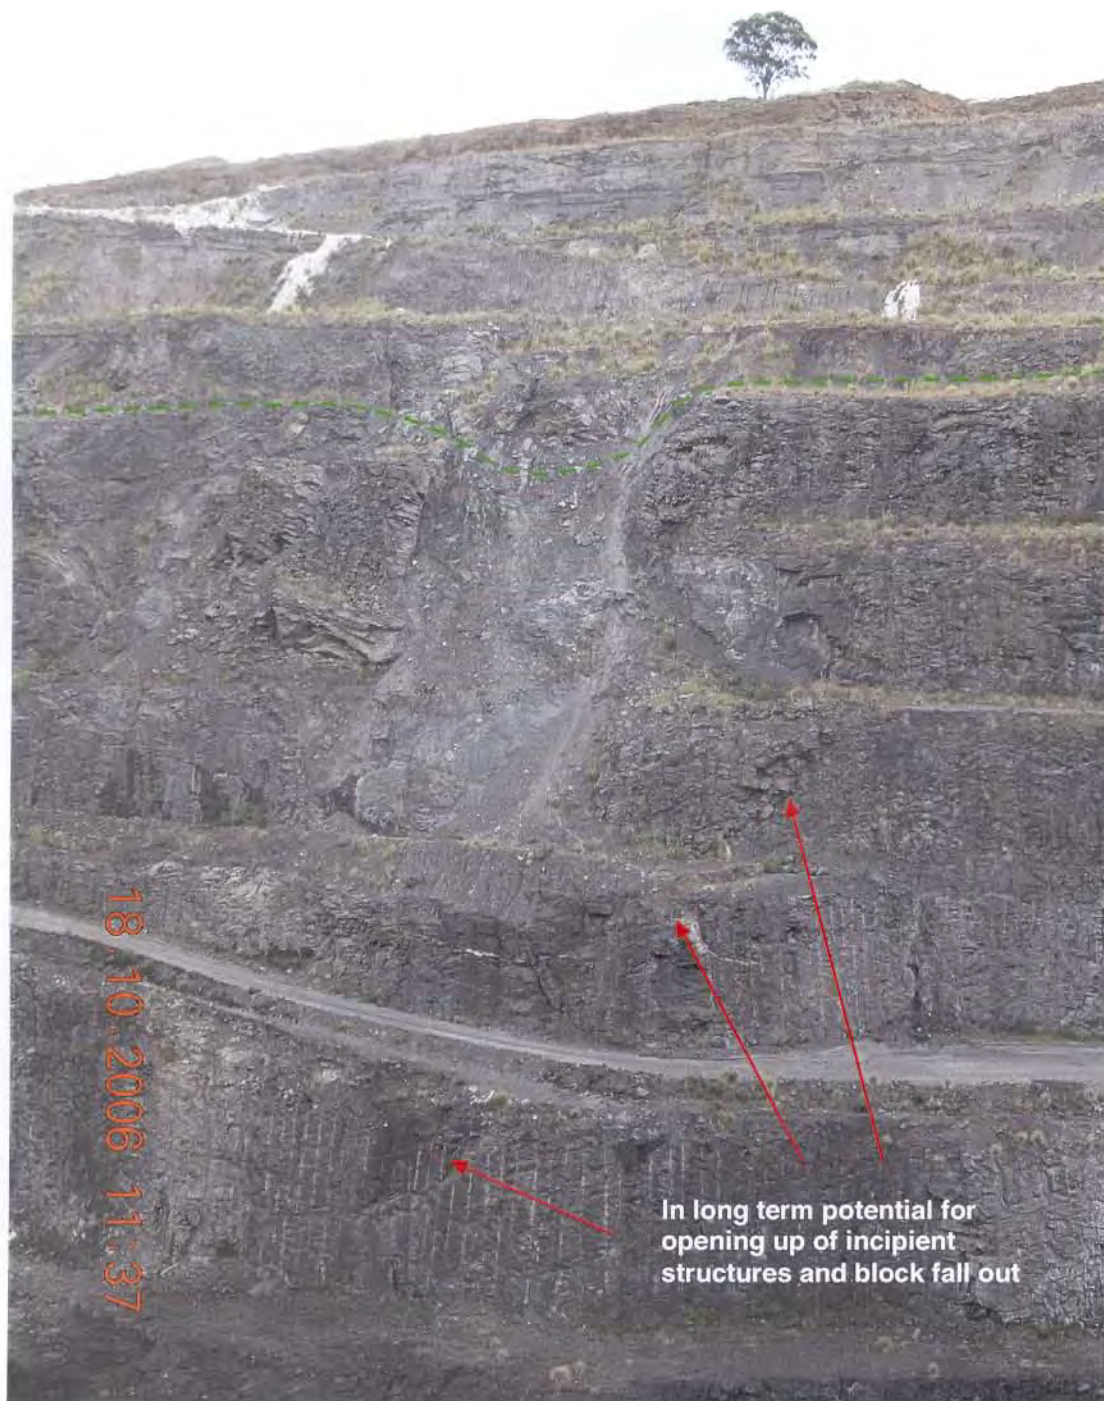
In 2001 there was a moderate scale instability in the north wall. The instability was linked to the contact between sediments and breccia, Plate 5, and with surface water being the primary trigger for the instability. Since the instability the local surface has been reshaped to direct water away from the back of the failure.

In the longer term there is the potential for incipient structures near by to “open up” and with the extent of the instability increasing, Plates 5 and 6. The time frame for this later aspect is unknown and ongoing visual observation is required to monitor this aspect.

Plate 5: North wall, highlighting area of instability which initially failed in 2001. In the long term, opening up of incipient structures can be anticipated. Furthermore, existing rill will continue to gravitate downwards.

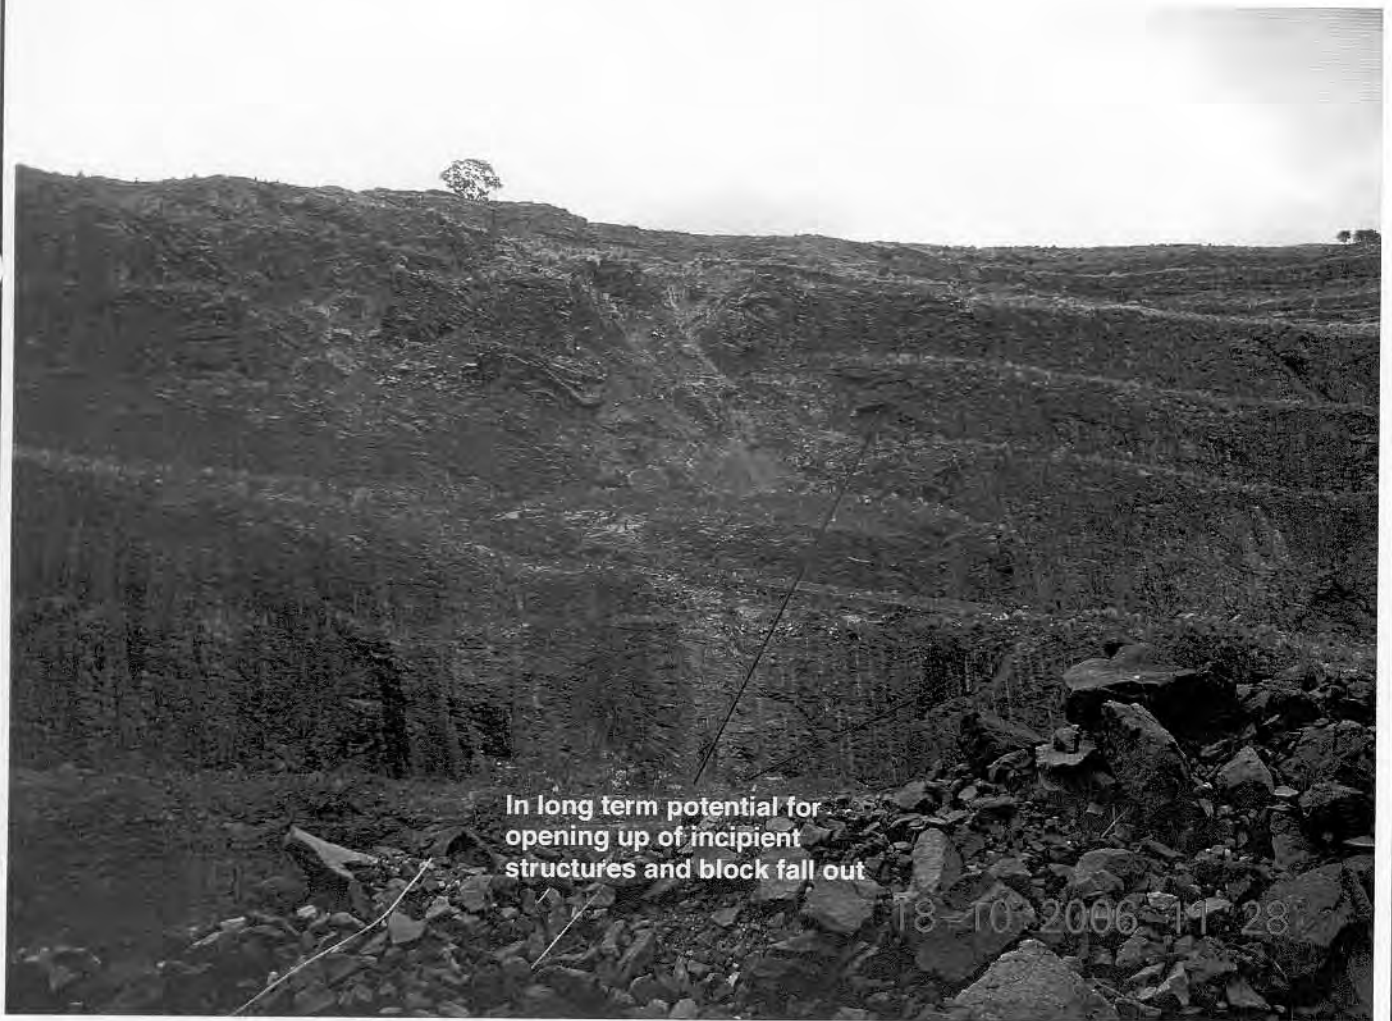
Plate 6: North wall with comments as per Plate 5 applicable.

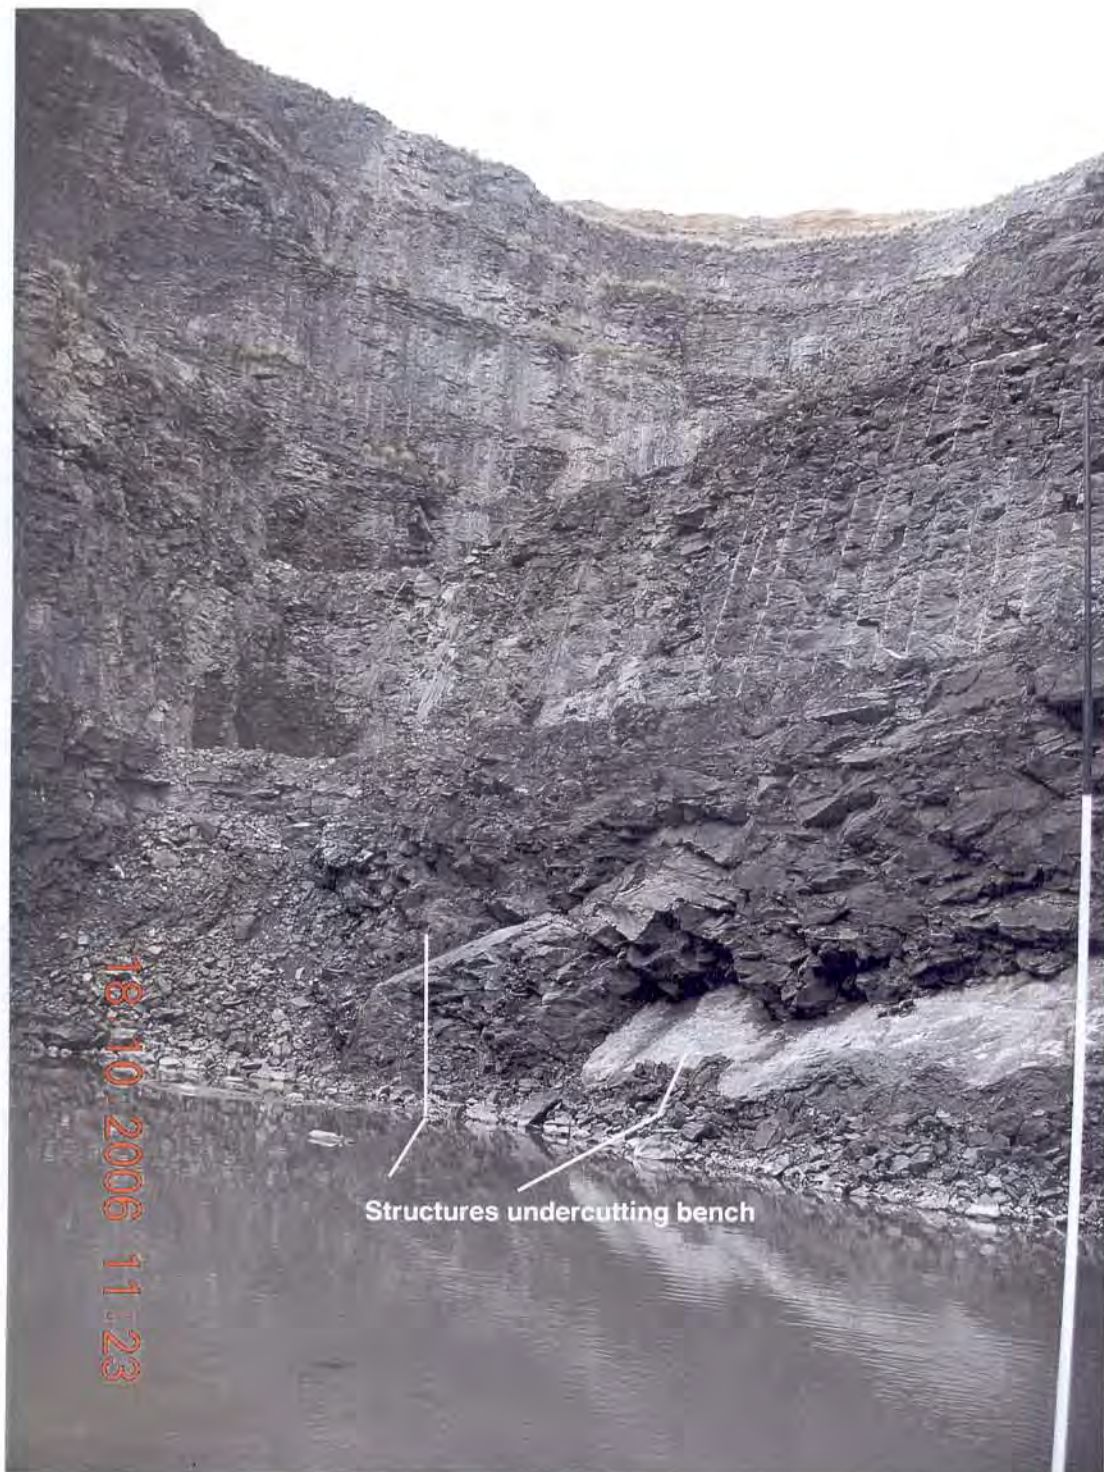
Moderately dipping structures undercutting the toe of the east wall were evident during the site inspection, Plate 7. In the long term loosening of the structures will result in failure of the bench. The area should be cordoned off to within 30m of the toe.

Plate 7 : Lower east wall, highlighting structures undercutting lowest most bench. Loosening of structures will lead to failure of bench.

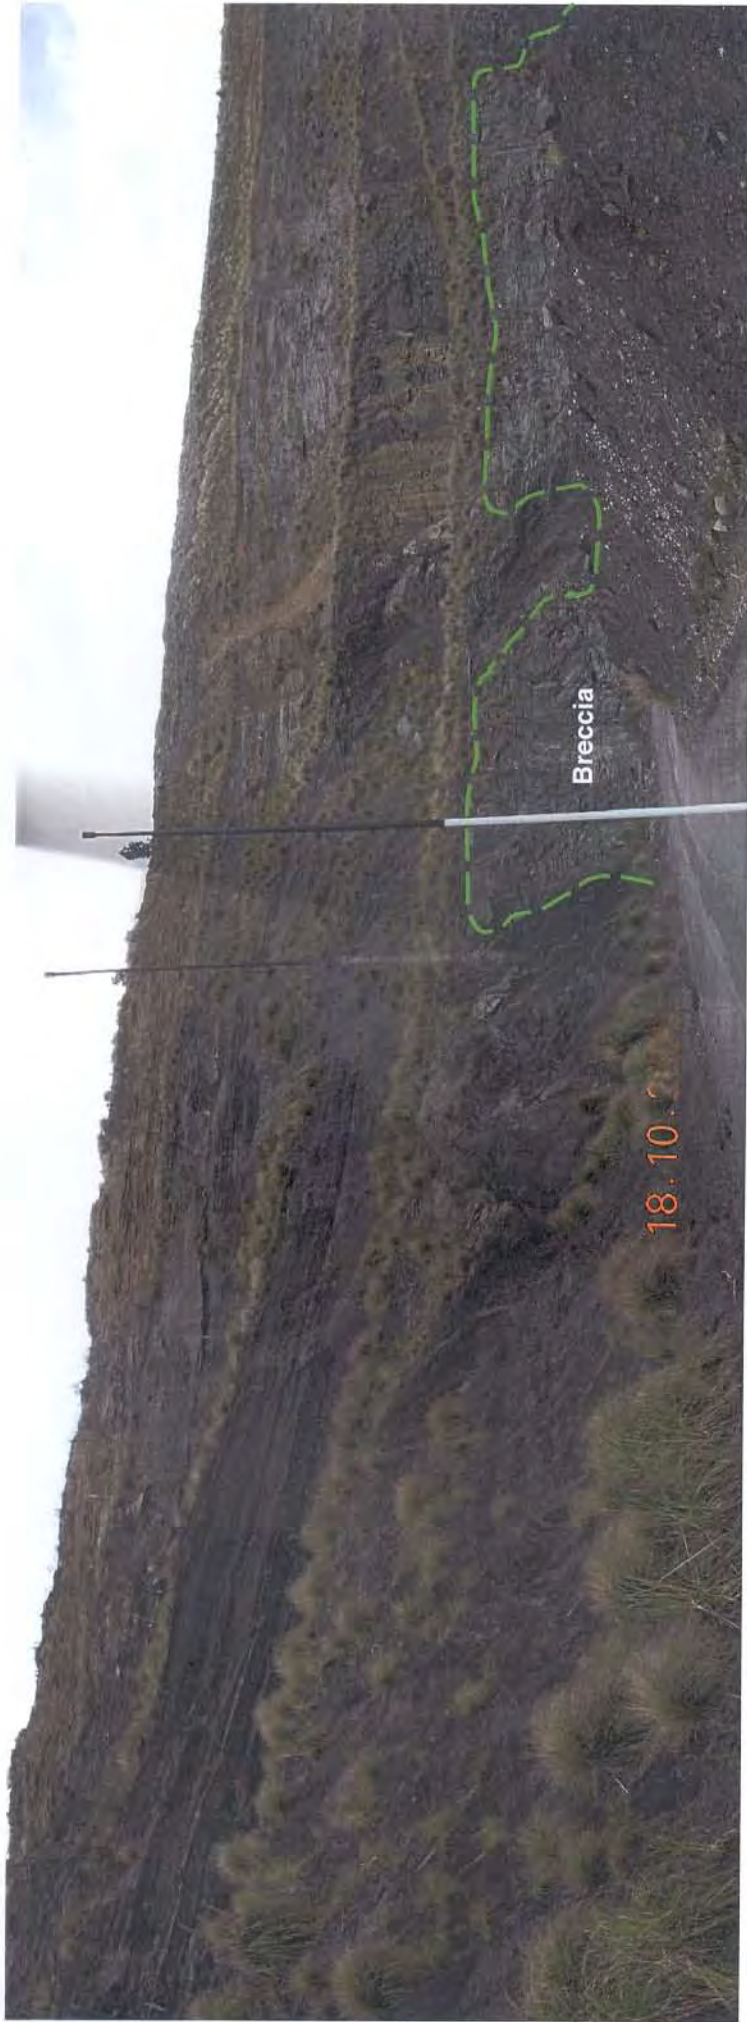
Plate 8: North east quadrant of quarry. Note large rill slopes developed, above breccia. In long term an overall rill slope will be developed.

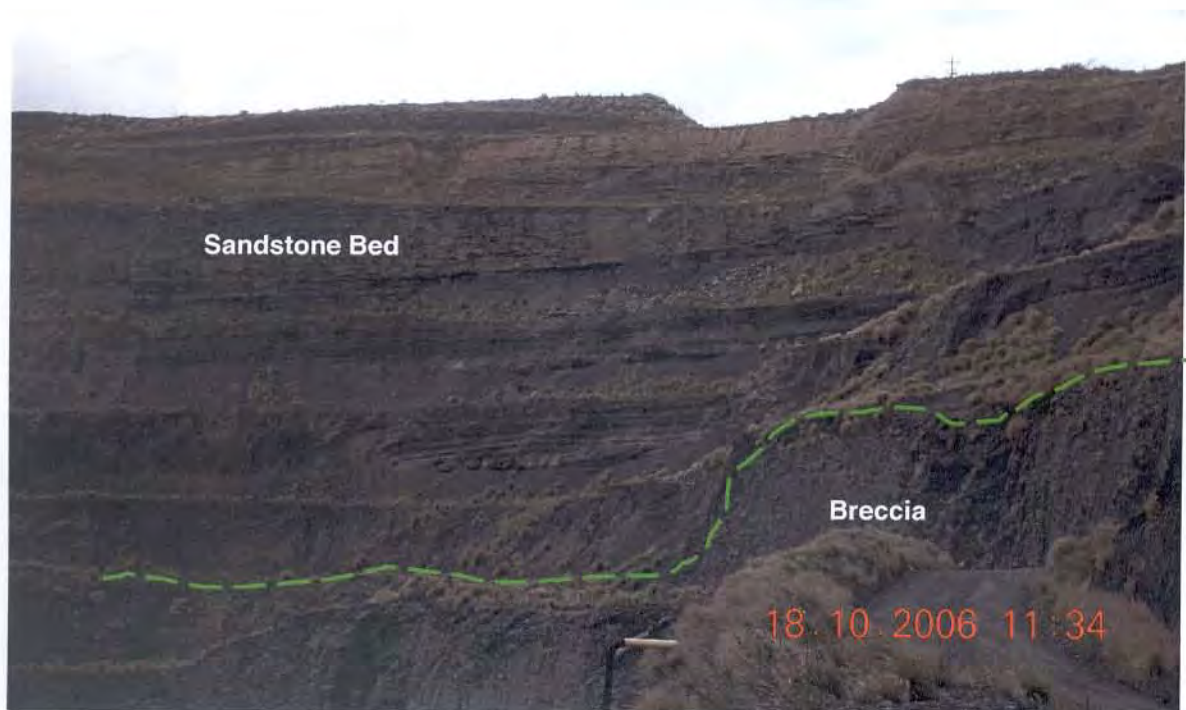
Plate 9 : Overview of upper west wall, highlighting sediments and undercutting of sandstone bed in the area.

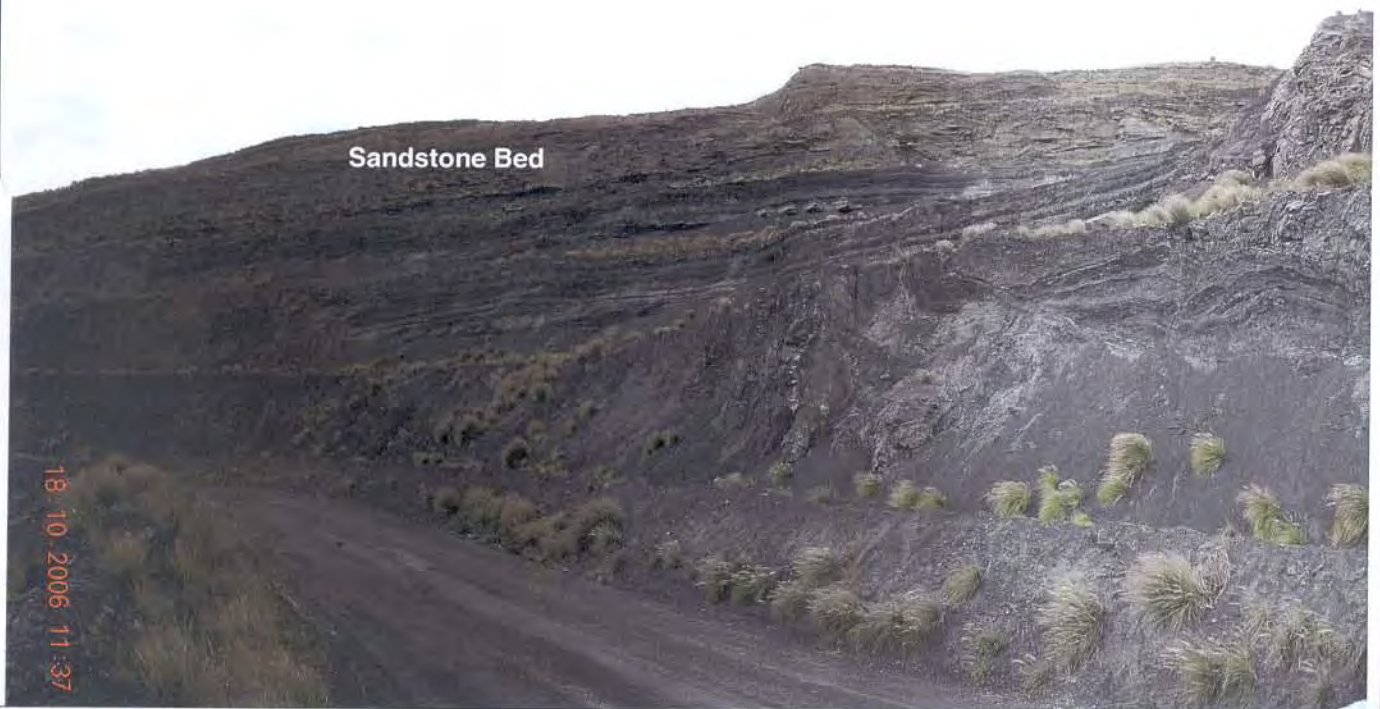
Plate 10: Overview of upper south west wall, highlighting sediments and undercutting of sandstone bed in the area.
