RE: SHORT TERM RISKS IN QUARRY

This letter presents the results arising from an inspection of the Wallgrove Quarry on 18th October 2006.

RE: LONG TERM RISKS IN QUARRY

This letter presents the results arising from an inspection of the Wallgrove Quarry on 18th October 2006. The quarry was inspected in the company of Mr Bassos of Hanson.

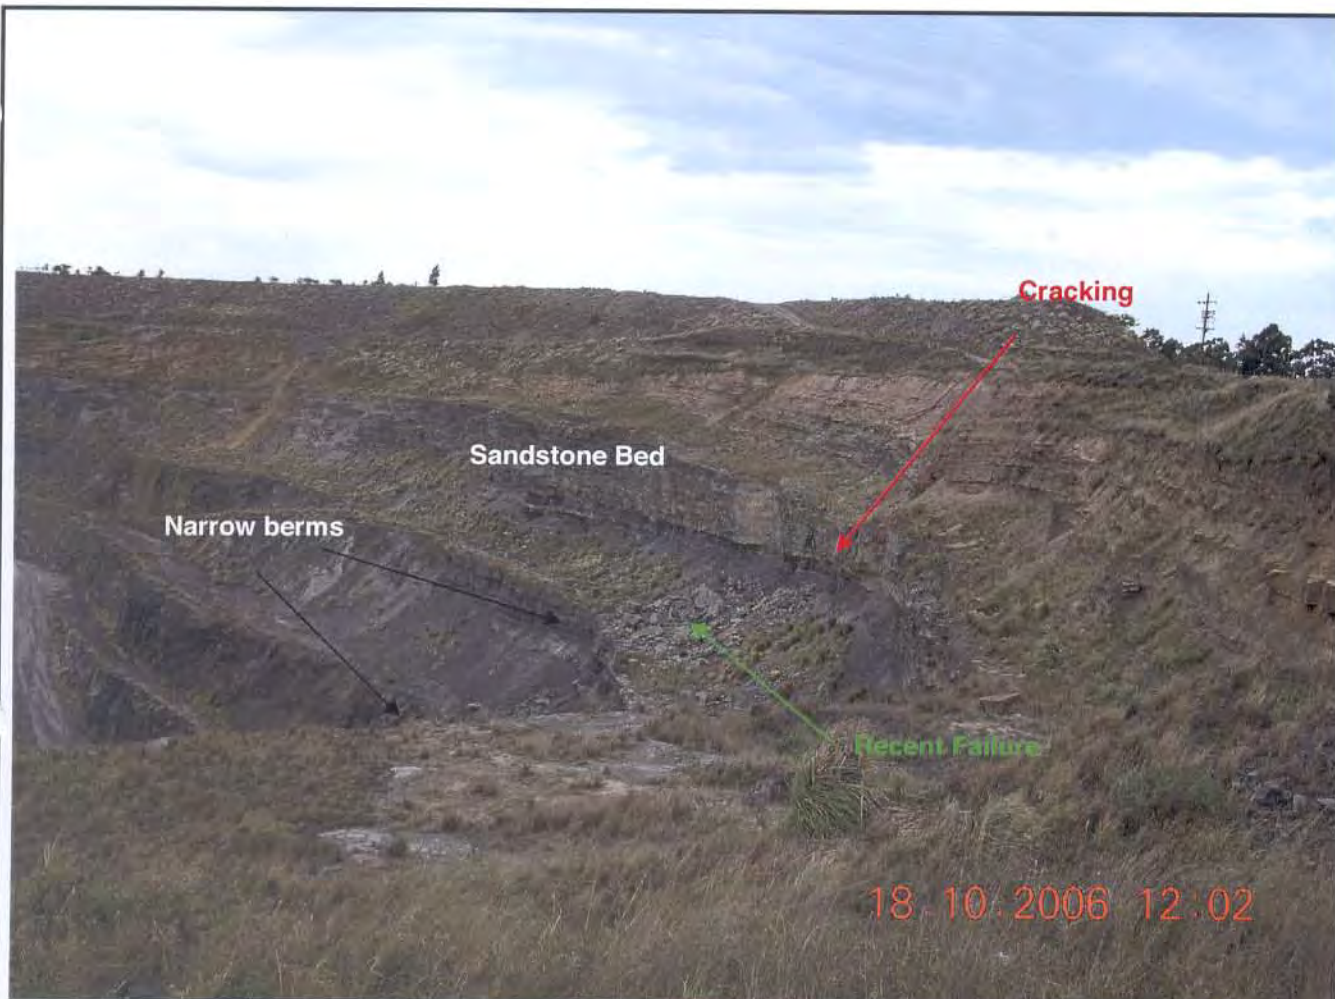
Plate 11: West wall looking to the north, highlighting undercutting of sandstone bed. In long term sandstone ledge will continue to be undercut and with further block fall out anticipated. Process will arrest once a continuous rill slope is formed. Potential for cracking and encroachment behind existing crest.

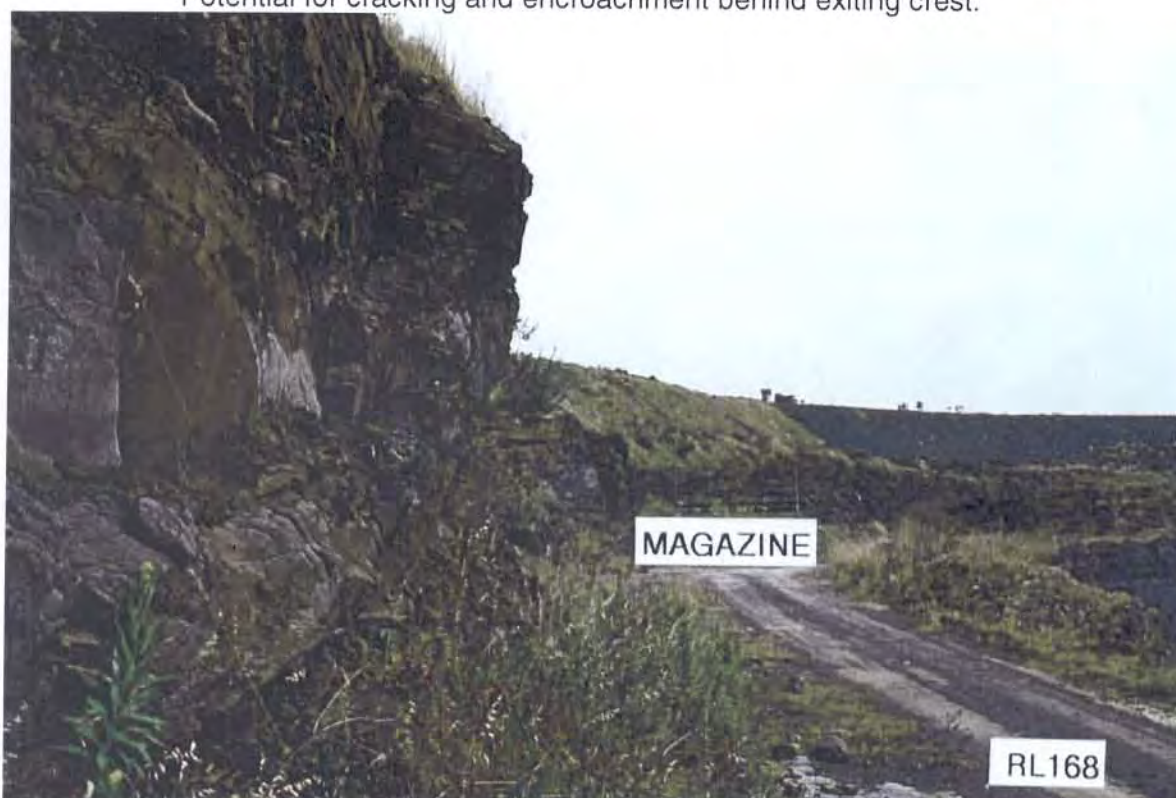
A small area was indicated to Hanson by PSM, PSM497.R1, in the upper north wall where a large block on the point of fall out was observed, Plate 12. In the long term there is a risk to road users from this block. Options comprise either pulling down the block or closing off the road.

Plate 12: Upper most north wall. Toppling block pointed out as issue in PSM497.R1. Block can either be pulled down or the road closed off.

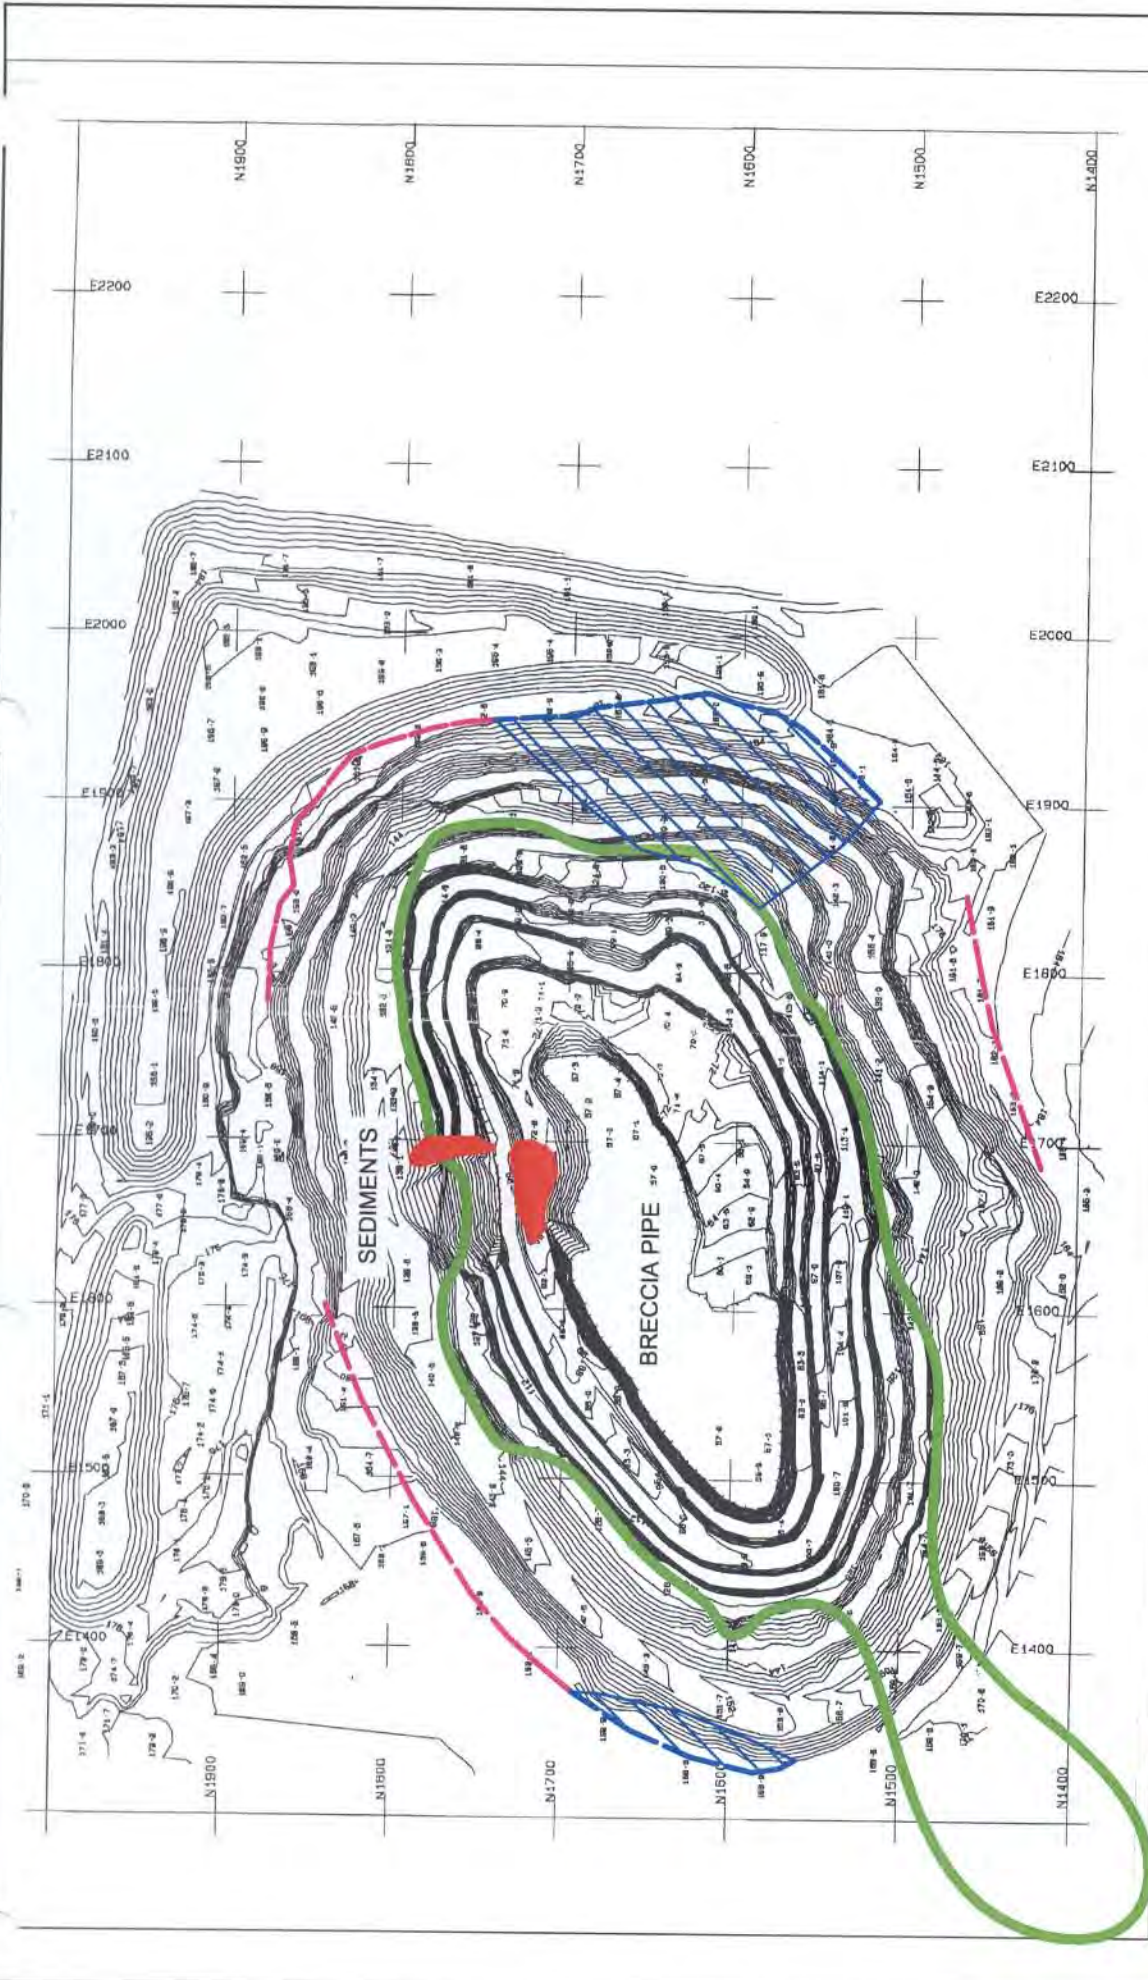
Figure 1

Observations of the behaviour of these upper slopes over the last 5 years has shown that the shale slopes slowly degrade. This degradation is manifested as a loss of bench crest and berm width directly above coupled with filling of the bench toe below with shale rill. Where the entire slope consists of shale, the overall slope will eventually result in an large rill slope. This is evident in the northwest corner, Plate 8, where a rill slope over 3 benches is already evident. The process will be gradual and will eventually result in an impingement of the final crest location of the quarry, Figure 1.
