**Re: Environmental Compliance Audit – Dial-a-Dump (EC) Pty Ltd – Environment Protection Licence Number 13426**

## **ATTACHMENT A: EPA response to Genesis Pty Ltd email dated 25 March 2018**

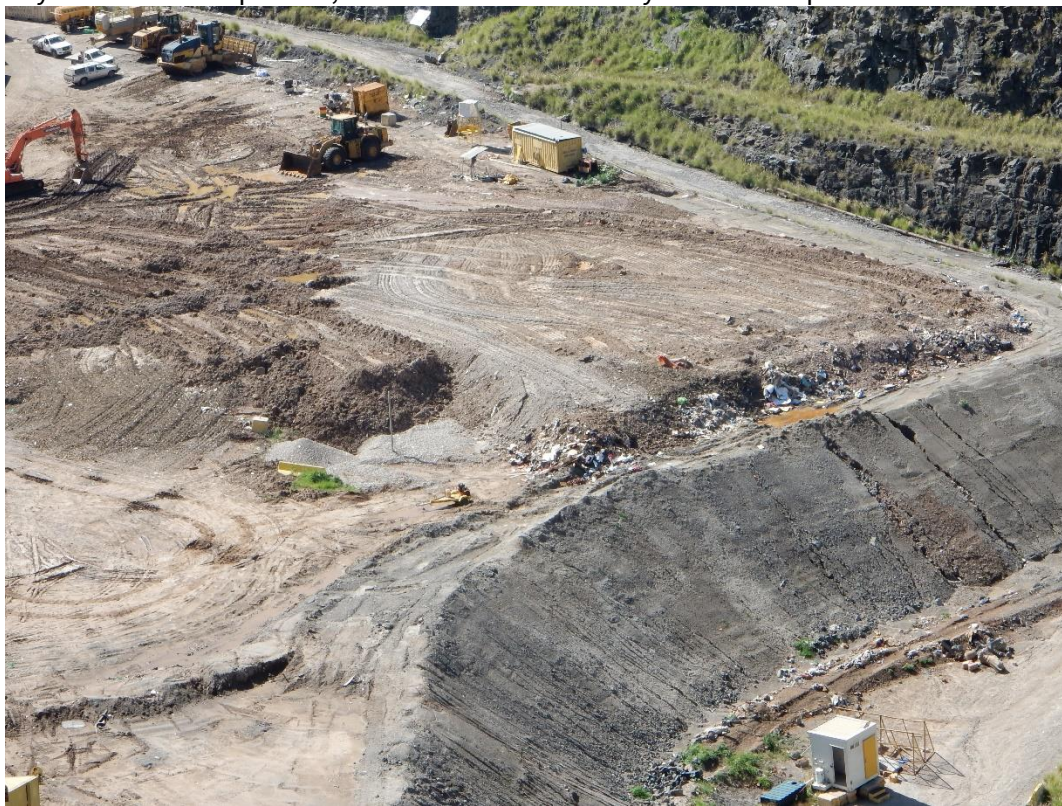
On the day of the audit inspection the area with the uncovered waste was first observed from the viewing platform at **9.37am** by the auditors. It was clear *that no waste was being disposed of* in the area referenced at that time or on the day of the audit inspection, which can be seen clearly in attached photo.

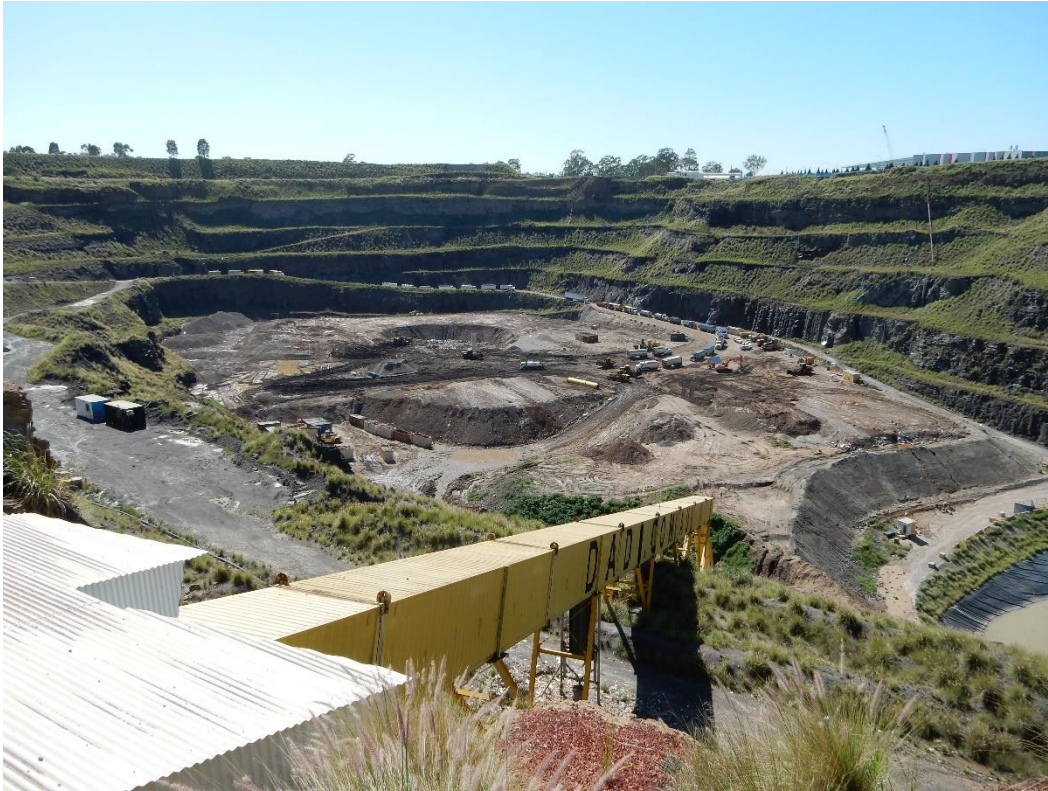
On the day of the audit inspection, filling operations were concentrated at the north-east portion of the landfill. It is also noted that very little waste had been disposed even in that area, due to a truck transporting waste to the tipping face getting stuck in the mud formed from the heavy rain experienced during the weekend. There was a long queue of truck that had formed, awaiting their turn to dispose of waste (attached photos).

Waste filling operation at 9:37am on the day of the audit inspection indicating where filling operations were taking place in the north-east areas of the landfill

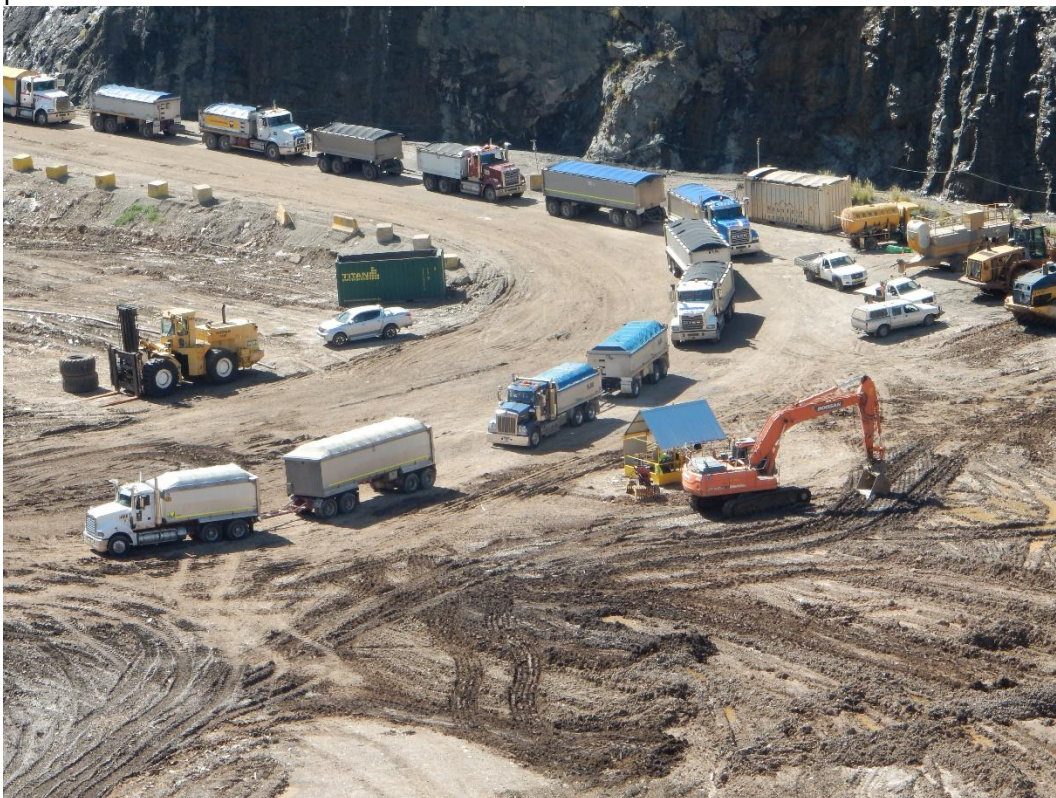
Close-up of vehicles queuing up.

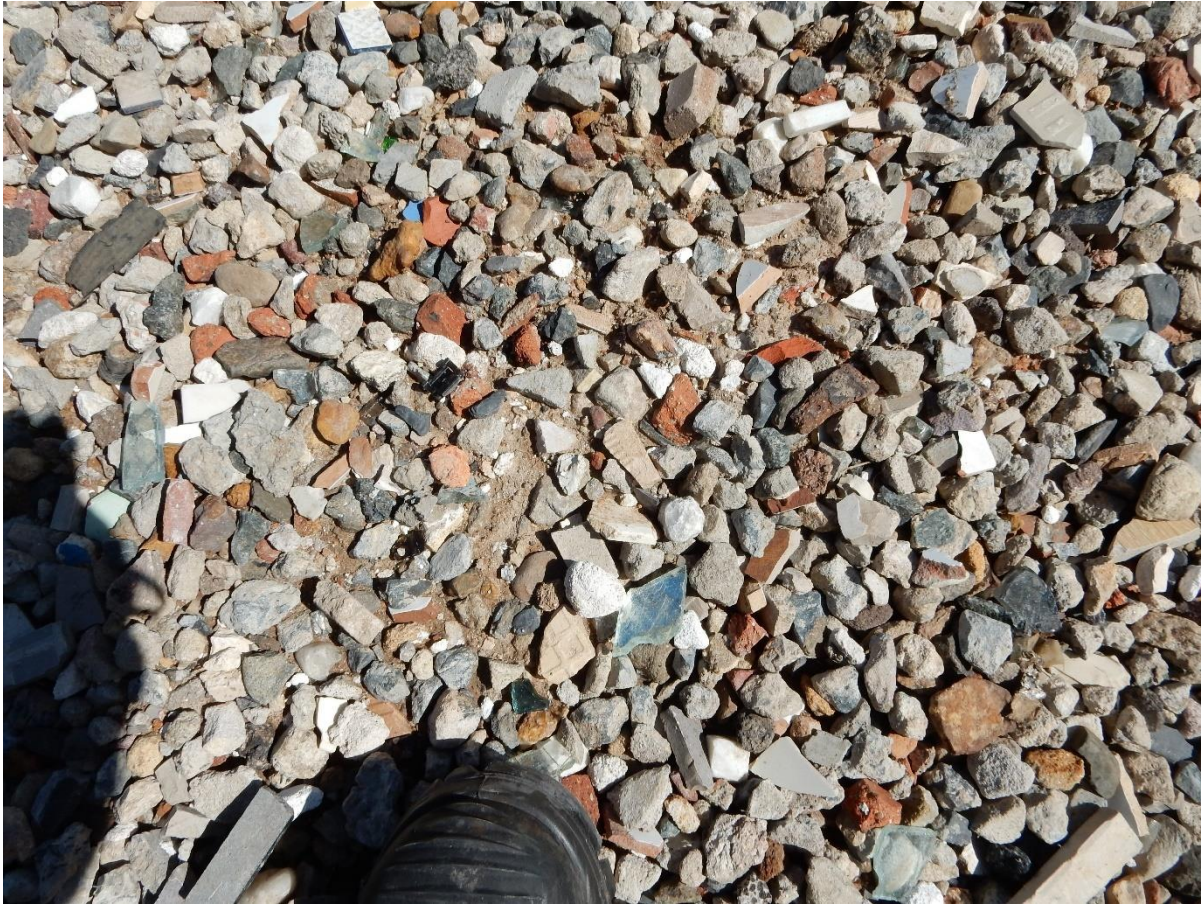
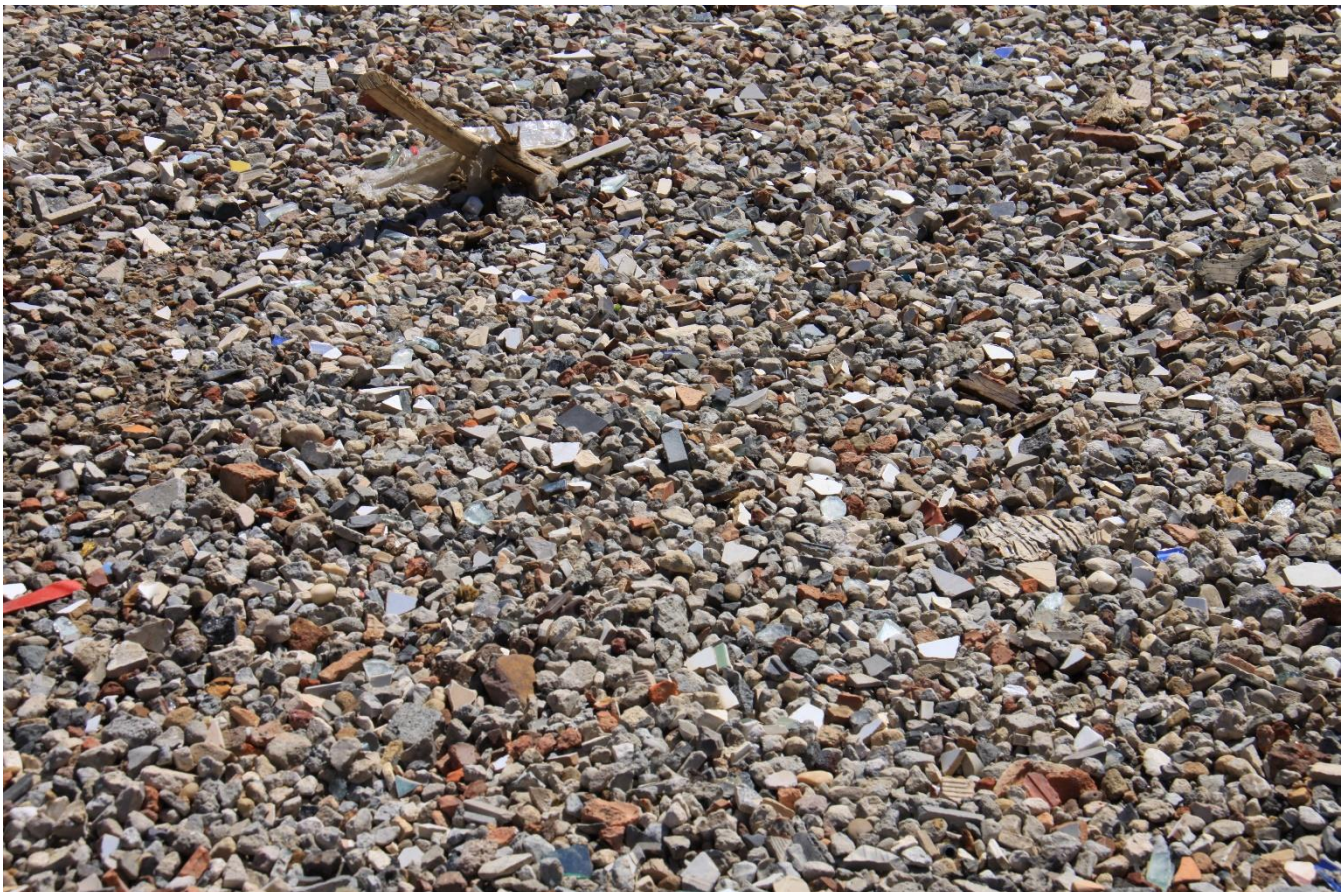
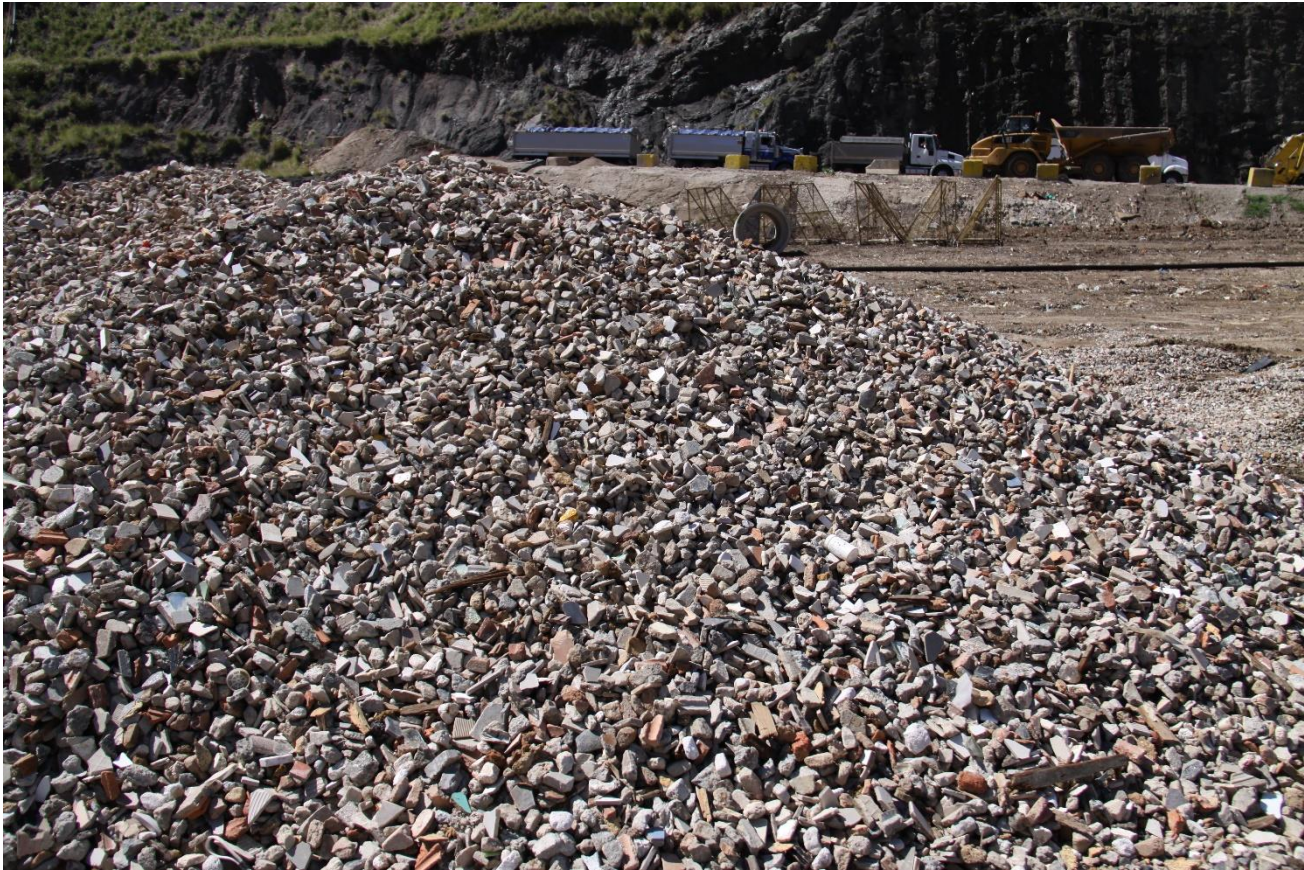
The licensee's representative was present and as stated in the draft report, measured the alternative cover material and at no time did he disagree with the auditors at that time. The attached photos clearly indicate that this material is alternative cover material consisting of crushed concrete, crushed bricks, crushed clay tiles and crushed glass.

The EPA would also like to point out that the specification for the drainage material as referenced in condition O5.23 requires that the material be a minimum of 20mm and a maximum of 40mm and must not be angular. If this was drainage material, then the licensee is in breach of the specification of the drainage material.
