Genesis Facility (Landfill)

Final Compliance Audit Report – Waste Disposal by Application to Land Audit Program

EPL 13426

March 2019

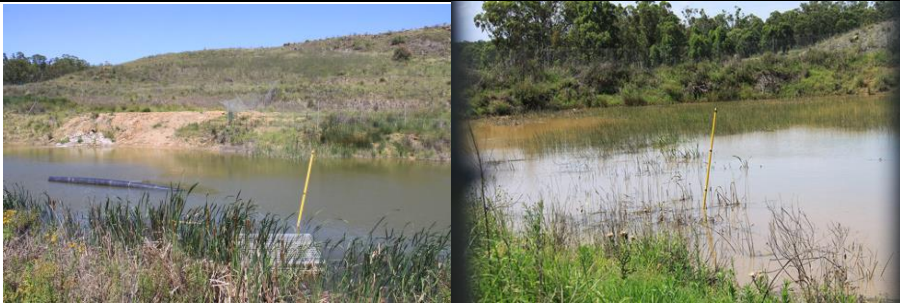
Condition Number	Compliance / Risk assessment	Comment	Action required by licensee
		<p>no need for the sediment basins to be desilted. They referred to results of water quality monitoring for recent years showing low levels of sediments and effective sediment control devices to prevent sediment from reaching the dams.</p> <p>It is noted that the licensee only undertakes water quality monitoring each quarter, therefore it is not a good indicator of sediment build-up. The daily site visual inspection report (28 November 2018) indicates that both the sediment traps and the detention basins having build-up of sediments. Unless action is taken immediately to remove sediments trapped in the control devices, sediment is invariably washed into the sediment dams.</p> <p>This is also contrary to licensee own procedures detailed in the Environmental Management Strategy (EMS) Soil, Water and Leachate Management Plan dated March 2017 which specifies: "Remove silt build-up regularly..." and "Keep sedimentation basins in a drawn-down state by preferential use of the water carts by tankers for dust suppression",</p> <p>Maintenance of Depth Indicators</p> <p>The licensee was also not maintaining the freeboard depth indicators installed in the sediment detention basins.</p> <p>On the day of the audit inspection it was observed that the depth indicators in the north western and south western detention basins were not being maintained. The depth indicators in both ponds were leaning sideways and were not indicating the correct freeboard (Photo 2).</p>	<p>The licensee must ensure that the depth indicators are maintained to accurately show the remaining freeboard.</p>

<p>Photo 1: Slouching depth indicator poles in north west and south west detention basins respectively showing inclination</p>	
L1.4	Not Applicable	<p>On the day of the audit inspection no surface water was being generated that required to be diverted away from the areas where waste was being landfilled.</p> <p>However, it is noted that the licensee has measures in place to divert surface water away from areas where waste is being landfilled. The water is diverted to the in-pit dam.</p>	
L2	Concentration limits (Water and/or Land)		
L2.1/L2.2	No Code Yellow	<p>Concentration limits - EPA ID Point 5 & 6 - Water and/or Land Concentration Limits</p> <p>Based on the licensee's published monitoring results, the licensee exceeded the limit for any pollutant in the table in accordance with the requirements of the licence as follows:</p> <ul style="list-style-type: none"> EPA ID Point 6: TSS and pH were respectively 220 mg/l and 8.59 on 29/11/18 from the south west detention dam. <p>However, condition L2.4 permits limits to be exceeded, if the overflow event occurred solely because of a rainfall event at the premises exceeding 45 millimetres over any consecutive five-day period and the licensee has taken all practical measures to avoid or minimise water pollution, the licensee is not deemed to have exceeded the limit.</p>	The licensee must not exceed the limits specified for the overflow points.

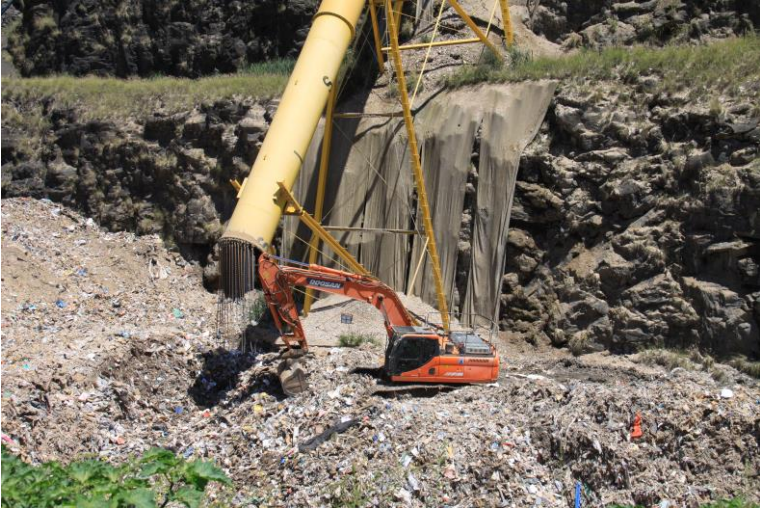
<p>Photo 2: Large mountain of crushed waste at bottom of chute.</p>	<p>of acceptance from the destination</p> <ul style="list-style-type: none"> • The total amount of waste that has been transported for the period 2 March 2017 to 1 March 2018. • Evidence that the waste transported is being landfilled.

Condition Number	Compliance / Risk assessment	Comment	Action required by licensee
		<p>The deposited material contained large quantities of, plastics, shredded paper, pieces of wood and is considered a fire hazard.</p> <p>An analysis of weighbridge dockets provided to the EPA, indicate that waste is transported from the landfill to Queensland (see assessment of condition L5.1).</p> <p>Based on the advice provided to the auditors by the licensee's representative, the waste material that is transported is landfilled. This condition does not allow the licensee to dispose of any waste produced from the output of the waste processing facility, other than for purposes prescribed in the condition.</p> <p>The EPA is concerned that the licensee is not complying with the condition as no waste is permitted to be disposed offsite, other than for purposes specified in the licence. The EPA is also concerned that the licensee is storing large quantities of waste increasing the likelihood of fire.</p>

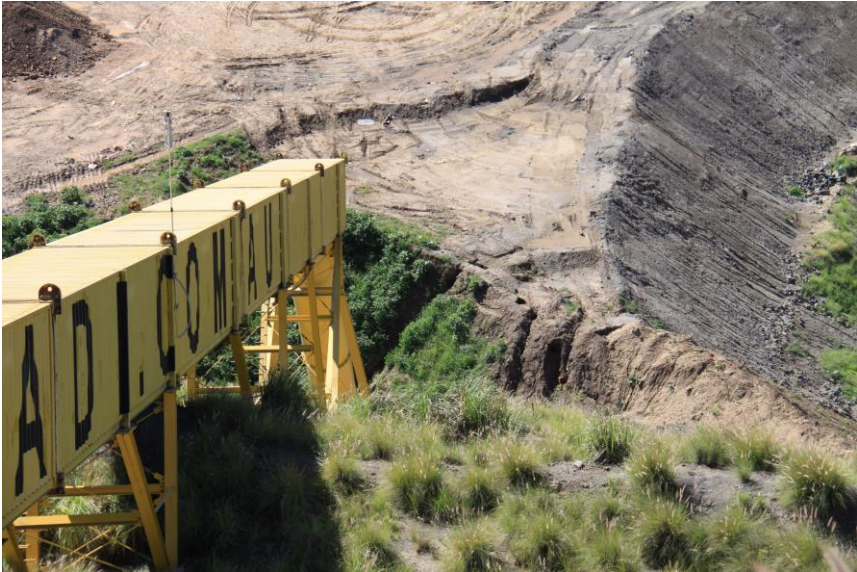
Condition Number	Compliance / Risk assessment	Comment	Action required by licensee
		<p>declared noxious weeds such as <i>Pampas grass</i> and <i>Spear and Star thistle weed</i> near the chute system within the landfill (See Photo 3 & 4) and other areas such as near sediment detention basins (Photos 5 & 6)) and overlooking the in-pit-sediment dam. It is noted that the licensee's representative noted this for discussion with personnel responsible for keeping weeds under control. It is also noted that at one point, after viewing substantive growth of weeds, the licensee's representative telephoned a person responsible for organising weed control and asked him why the weed control had not been undertaken.</p> <p>Although, the license has in place regular monitoring of pests, vermin and weeds, it appears that the monitoring process is not effective in ensuring that noxious weeds are not present in sufficient numbers to pose an environmental hazard.</p> <p>During the audit inspection the auditors also observed two wild goats and a kangaroo in an area above the sedimentation dams.</p> <p>The EPA is concerned that not effectively monitoring the growth of weed could cause:</p> <ul style="list-style-type: none"> • The substantive growth of weed, as reported above, requiring the use of larger quantities of weed eradicating spray, increasing the likelihood of pollution of waters, especially in areas near sediment detention basins which have the potential to overflow. • Increased infestation of noxious weeds to other areas of the site through wind-blown transport of noxious weed germinating seed (the auditors observed noxious weed in many areas of the landfill) including the transport of seed through the use of the in-pit-dam water for dust suppression. • Increased likelihood of contamination of waste material at the bottom of the chute system from wind-blown noxious weed germinating seed, some of which is being transported by the licensee inter-state for landfilling. It is noted

Condition Number	Compliance / Risk assessment	Comment	Action required by licensee
		<p>that seed from noxious weeds can remain viable (alive) for at least two years, and for some species for much longer. It is also noted that the transport of material from NSW to another State that is potentially contaminated with noxious weed seedlings is prohibited.</p> <ul style="list-style-type: none"> • Overflow of detention basins with weed germinating/seed being transported offsite and contaminating surrounding areas.

<p>Photo 4: Weeds growing hear Chute.</p> <p>The EPA is also concerned that the licensee is not monitoring the effectiveness of the pest management program, which has also been reported in several Independent audit reports previously.</p>

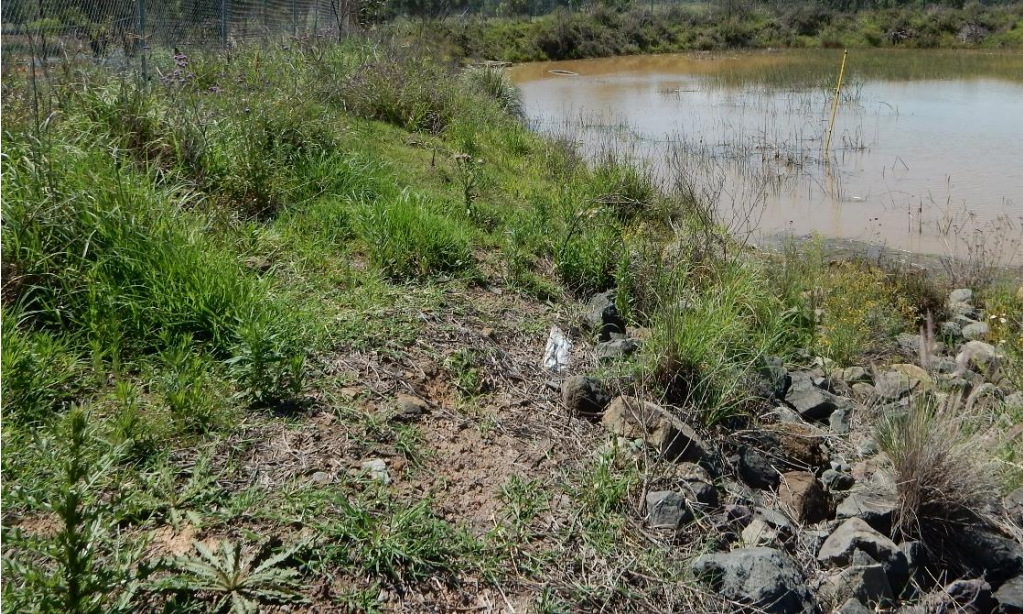
<p>Photo 6: Weeds including noxious <i>spear thistle</i> growing near south-west sediment dam</p>	see
O4.2 (c)	Yes	Ongoing monitoring of pests, vermin and noxious weeds However, see O4.2 (c) above.	
O4.3	Yes	Managing risks of fire However, see assessment of condition L3.4	
O4.4	Yes	Tracking of waste (scope on the day of the audit inspection)	
O5	Waste Management

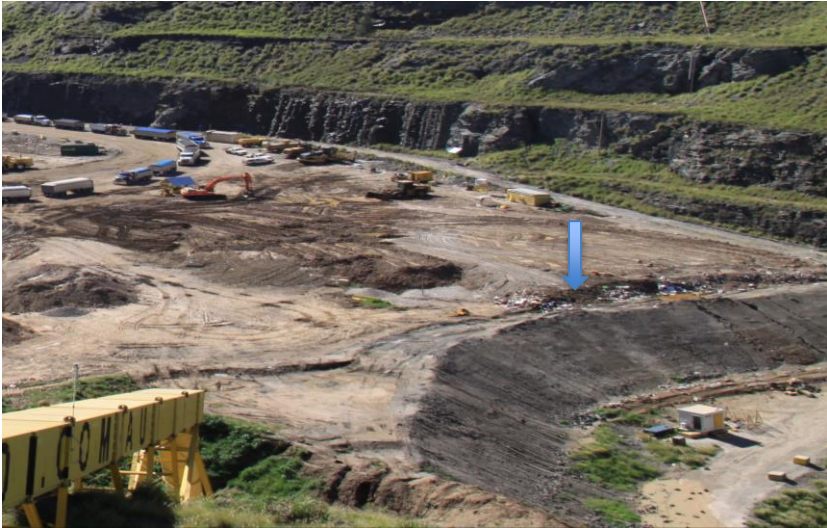
Condition Number	Compliance / Risk assessment	Comment	Action required by licensee
		<p>The EPA is concerned that the licensee is not covering waste adequately, including asbestos waste as required by the licence and the POEO Regulation.</p>

<p>Photo 7: Exposed waste near in-pit dam</p>

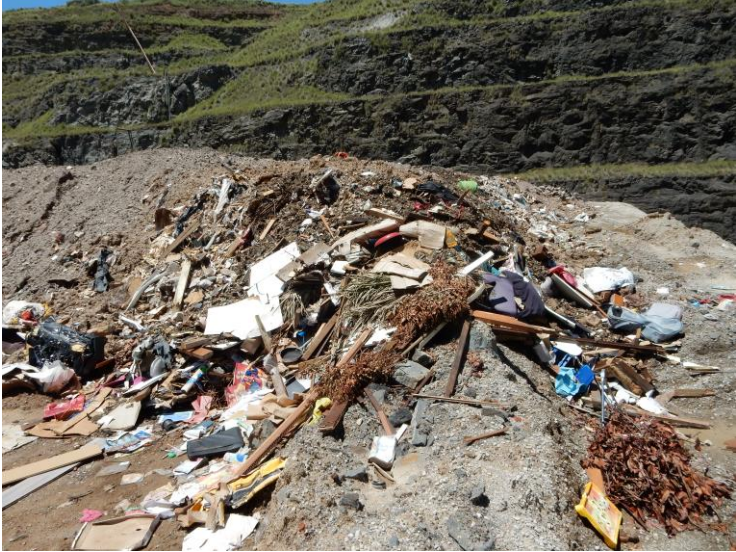
<p data-bbox="600 903 1160 943">Photo 8: Close-up of the uncovered waste.</p>

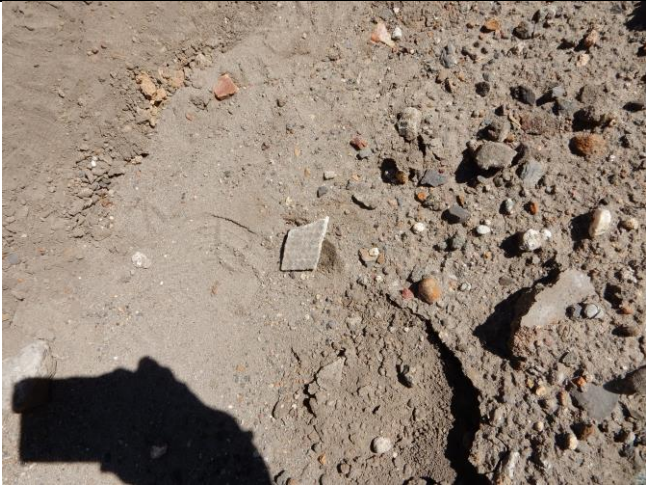
<p data-bbox="602 879 1245 914">Photo 9: One of the asbestos sheeting fragments</p>

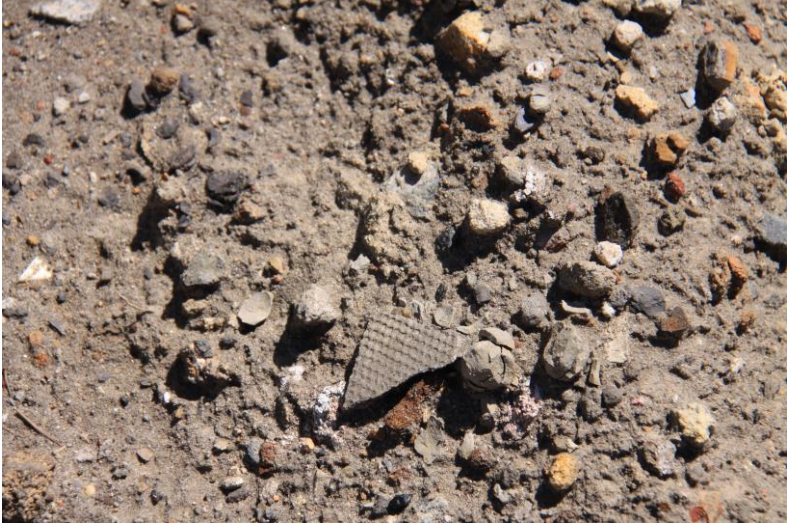
<p>Photo 10: Second fragment of asbestos sheeting</p>	
O5.4 (a) ii)	No Code Blue	<p>Using unapproved alternative cover (scope on the day of the audit inspection) The licensee was using an alternative cover material that was not approved by the EPA.</p> <p>It is noted that the licensee was permitted to undertake a 12-month trial of the alternative material 'Concover' in December 2012 and was required to provide a report to the EPA, one month after the end of the trial in December 2013.</p> <p>The licensee indicated that due to management changes the licensee forgot to send the report to the EPA. However, in 2014, an independent audit report undertaken as part of the planning development consent, identified this non-compliance. The licensee contracted a consultant to undertake a review of the trial and prepare a report as required by the EPA. However, the report was only sent to the Department</p>	The licensee must ensure that only EPA approved alternative material is used on the site.

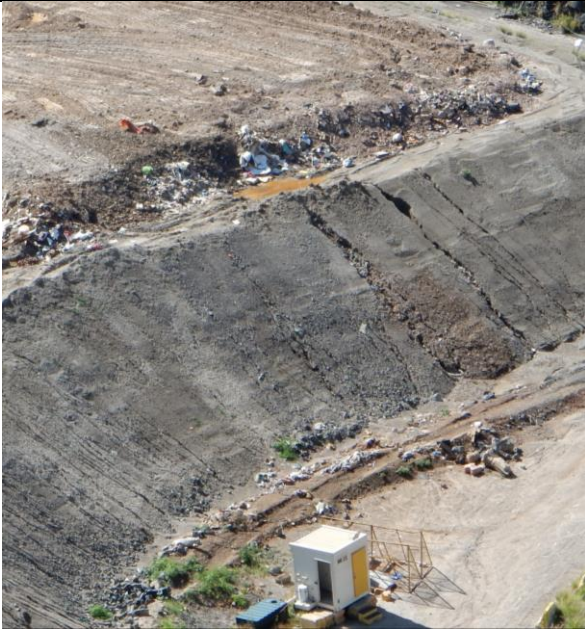
<p>Photo 11: Exposed waste with pooling of leachate right above the deep erosion gully</p>	
O5.9	No Code Blue	<p>Disposal of waste in landfill void The licensee was not disposing of all waste within the landfill void.</p> <p>The licensee transports waste dumped into the landfill through the chute system to Queensland for landfilling.</p> <p>See also condition L2.4</p>	The licensee must dispose of waste only in the landfill void unless otherwise specified in the licence.
O5.10	No	Filling Plan	The licensee must submit and maintain a

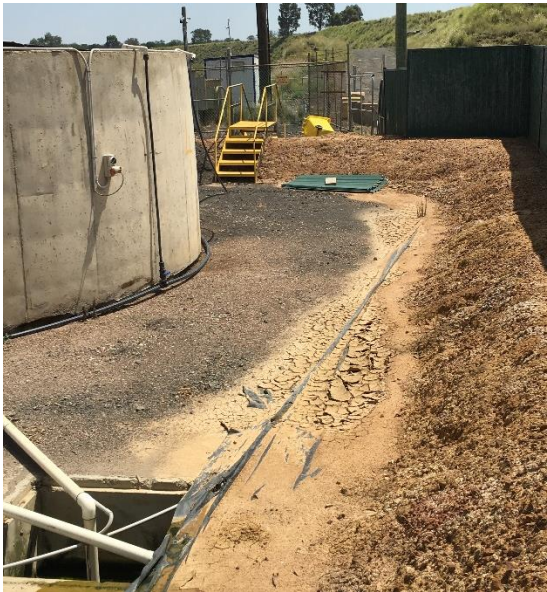
Condition Number	Compliance / Risk assessment	Comment	Action required by licensee
		<p>nature of the bund wall. However, the licensee was unable to provide any such evidence.</p> <p>It was also observed that pipes were located within the bund in a concrete sump that were clearly going underneath the bund wall, potentially providing a pathway for escape of liquids and which may compromise the integrity of the bund wall unless the joints between the pipes and the bund are sealed adequately to prevent leakage (Photo 14).</p> <p>It is noted that the bund wall has the capacity to hold 110% of the largest tank and the tanks are a distance away from the bund wall, enabling it to contain pressurised leaks or spills.</p> <p>The EPA is concerned that the leachate bund wall and floor may not provide sufficient permeability to prevent any spill or leak from escaping and potentially causing pollution of water and/or groundwater.</p>

<p>Photo14: Sump with pipes going under the bund wall</p>	
O6.6	<p>No</p> <p>Code Yellow</p>	<p>Storage of chemicals</p> <p>The licensee was not storing chemicals on site in appropriately designed impervious bunded area.</p> <p>The licensee was storing a small number of drums and one 205l drum with unknown substances outside an appropriately designed impervious bund.</p>	<p>The licensee must ensure that all chemicals are stored in appropriately designed impervious bunded area.</p>

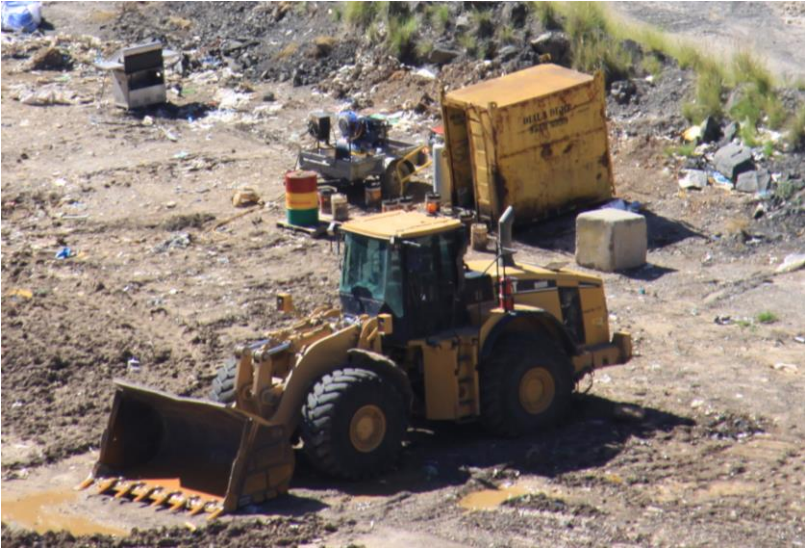
Condition Number	Compliance / Risk assessment	Comment	Action required by nsee
		<p>On the day of the audit inspection the auditors observed a number of 20l drums presumably drums containing the two components of Concover and a 205 l drum on a wooden pallet with an unknown substance being stored on soil outside the designated bunded yellow mini shipping container (Photo 15). An unchained compressed air cylinder was also observed next to the drums with Concover and the Easy Lawn Unit that is used to spray Concover</p> <p>The EPA is concerned that storing Concover without appropriate containment increases the likelihood of potential stormwater contamination.</p> <p>See also further observation.</p>

Condition Number	Compliance / Risk assessment	Comment	Action required by licensee
		Photo 15: Chemicals and fuels being stored without bunding	
M1.1		This condition requires monitoring results to be recorded and retained as set out in M1.2 and M1.3. See assessments for M1.2 and M1.3.	
M1.2 a)	Yes	EPA ID Point 2,3,5,6, 7 and 9 to 27 <i>Keep records in legible form</i>	
M1.2 b)		<i>Keep records for at least 4 years</i> It is beyond the scope of the audit to determine whether the licensee will keep the current monitoring records for a period of at least four years.	
M1.2 c)	Yes	<i>Produce records to authorised officer</i>	
M1.3 a)	Yes	<i>Keeping of records with respect to any samples required to be collected as part of this licence</i> <i>Date of sampling</i>	
M1.3 b)	Yes	<i>Time of sampling</i>	
M1.3 c)	Yes	<i>Point at which sample was taken</i>	
M1.3 d)	Yes	<i>Name of person who took the sample</i>

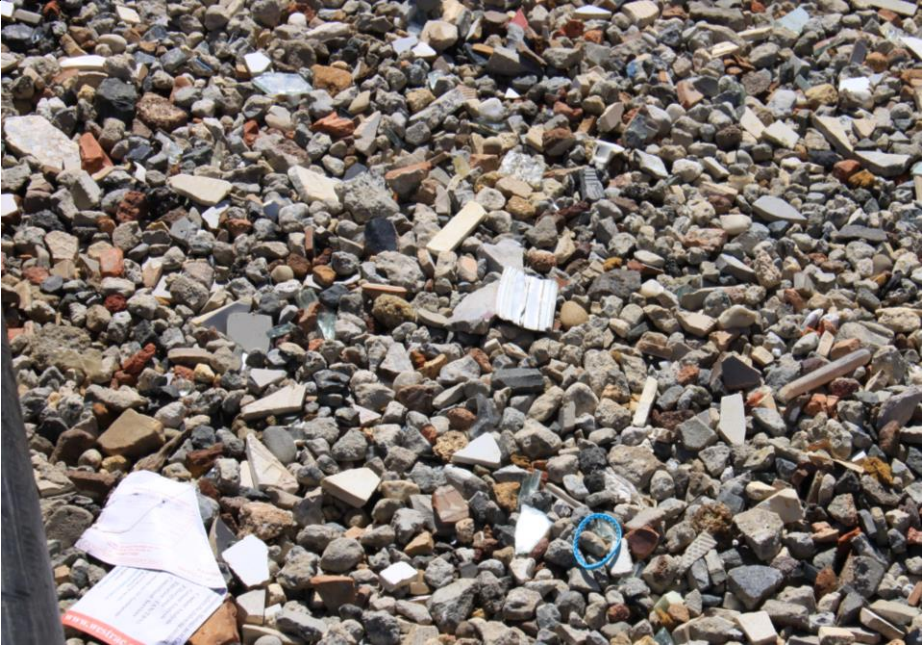
<p data-bbox="620 1018 1666 1082">Photo 16 - 18: Alternative cover material showing paper, wood, plastics and material with sizes exceeding 50mm, and <50% material not less than 1mm.</p>

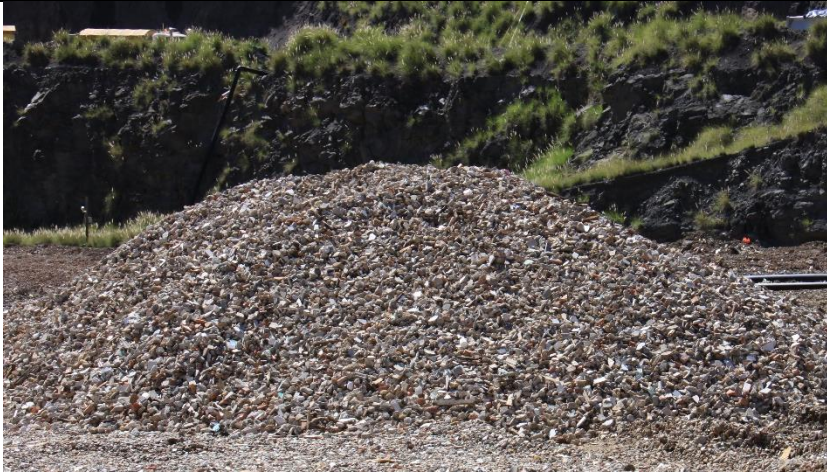
<p>Photo 18: Alternative cover material stockpile</p>	
E4.1 b.	Not applicable	On the day of the audit inspection the licensee did not use alternative cover material to cover the waste at the end of the day's operation.	
E4.1 c,	Not determined	The auditors did not sample and analyse the contaminant concentration in the cover material. It is noted that the licensee provided the EPA results of analysis that satisfied the requirements of this condition, during the process of obtaining approval.	
E4.1 f. & g.	Yes	From what was observed on the day of the audit inspection the alternative cover material appeared to have the ability to suppress odours and did not generate any odour. Alternative waste material coming into contact with alternative material was classified by the licensee as leachate and managed likewise.

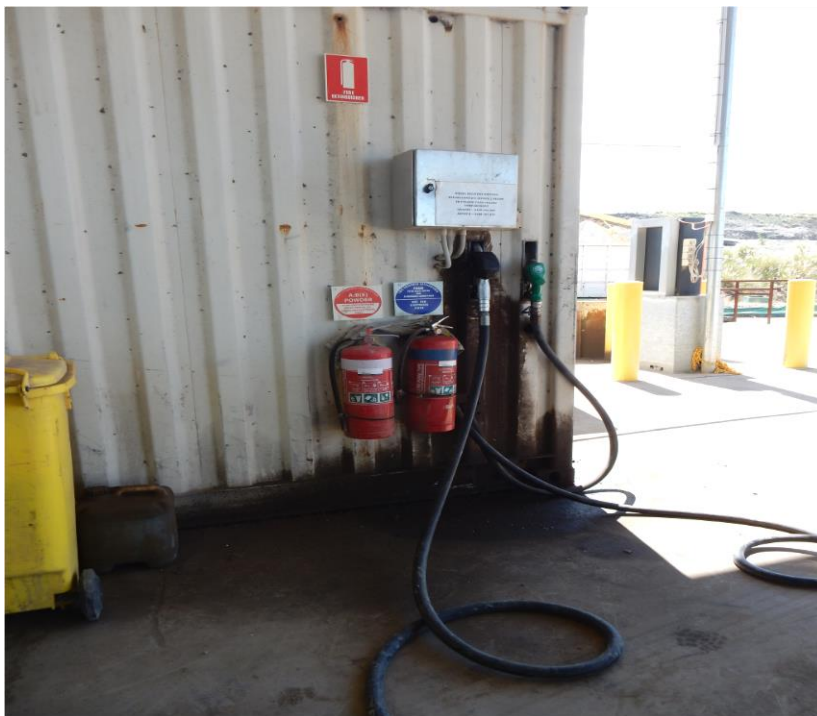
Photo 19: Fuel hoses being strewn across driveway. Decolourisation of concrete floor.

The licensee should ensure that fuel hoses are kept within a bunded area having at least a capacity to hold 15 litres of liquid.

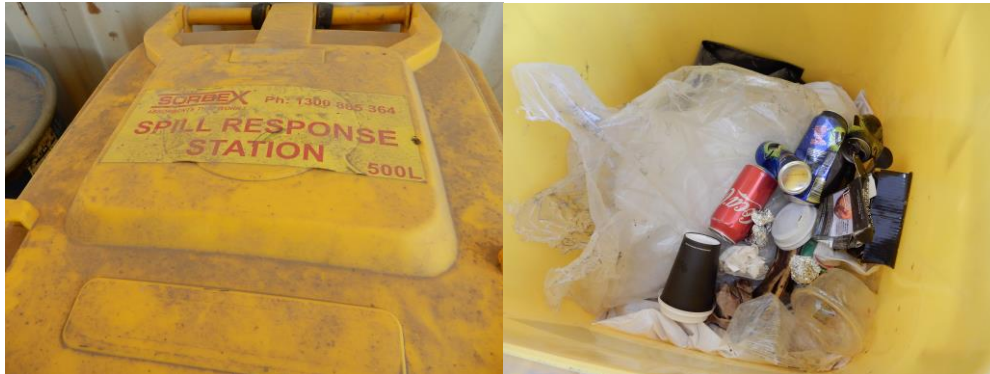
The auditors inspected two spill kits near the diesel fuel storage shed and observed that one of the spill kits was not being maintained in a proper and efficient condition. The spill kit was half full and contained rubbish and used cans.

Photo 20: Spill station with and without cover being opened. Rubbish and used cans being stored in spill stations.

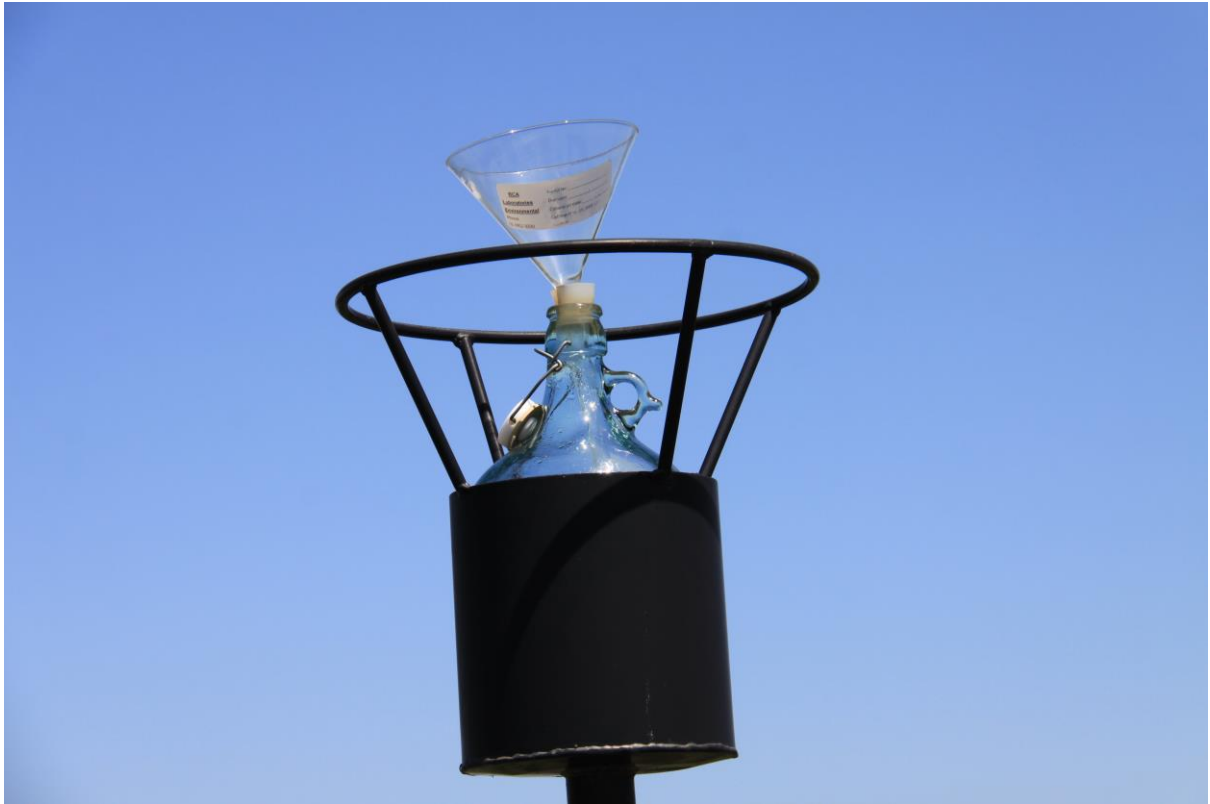
Photo 21: Dust gauge with funnel not horizontal and dust gauge not vertical.

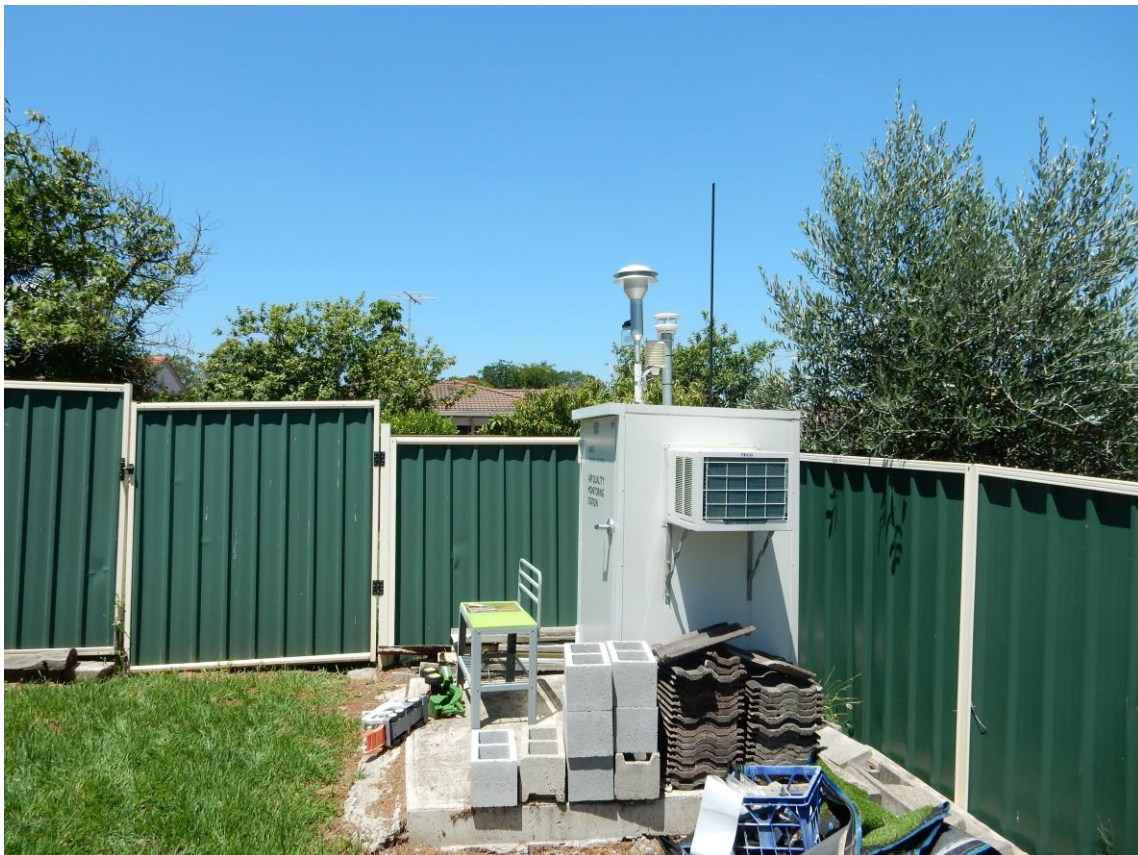
The Tapered Element Oscillating Microbalance (TEOM) was currently not located in the correct location. Due to the construction of many new residences between the current location and the landfill, this site is no longer representative of a neighbourhood site. The location also did not satisfy the requirements for siting as specified in the standard AS/NZS 3580.1.1:2007. The sampler did not have an unrestricted airflow around the sampling inlet due to a tree growing nearby (photo 22) and was within 50 metres of a road.

Photo 22: TEOM with tree covering the unrestricted airflow of the sampler inlet

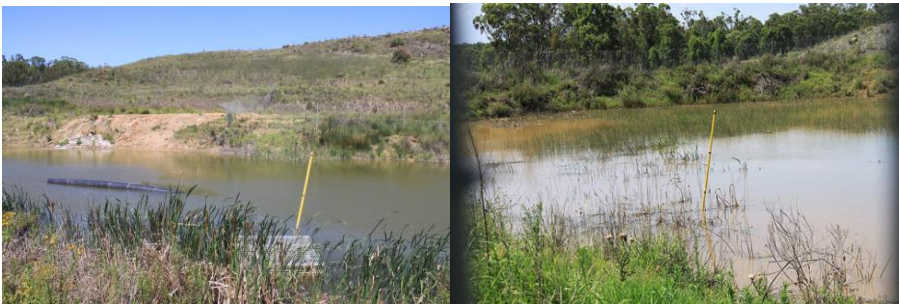
Condition Number	Compliance / Risk assessment	Comment	Action required by licensee	Licensee Comments
		<p>maintained. The depth indicators in both ponds were leaning sideways and were not indicating the correct freeboard (Photo 2).</p>

<p>Photo 1: Slouching depth indicator poles in north west and south west detention basins respectively showing inclination</p>		
L2.1/L2.2	No Code Yellow	<p>Concentration limits - EPA ID Point 5 & 6 - Water and/or Land Concentration Limits</p> <p>Based on the licensee's published monitoring results, the licensee exceeded the limit for any pollutant in the table in accordance with the requirements of the licence as follows:</p> <ul style="list-style-type: none"> EPA ID Point 6: TSS and pH were respectively 220 mg/l and 8.59 on 29/11/18 from the south west detention dam. <p>However, condition L2.4 permits limits to be exceeded, if the overflow event occurred solely because of a rainfall event at the premises exceeding 45 millimetres over any consecutive five-day period and the licensee has taken all practical measures to avoid or minimise water pollution, the licensee is not deemed to have exceeded the limit.</p> <p>The discharge event from EPA ID Point 6 for 29/11/18, which recorded levels of TSS of 220 mg/l and pH of 8,59 was deemed to have satisfied one of the exception rules in condition L2.4 as the rainfall within the previous</p>	The licensee must not exceed the limits specified for the overflow points.	<p>The licensee carries out procedural inspections of all pits and drains on site (Fortnightly photographic OSD Pit Inspections). Pits and Dams are checked fortnightly and desilted as required.</p> <p>It is the licensee's opinion that dealing with silt at point of generation is more effective than at the end of the process i.e. Dams.</p>

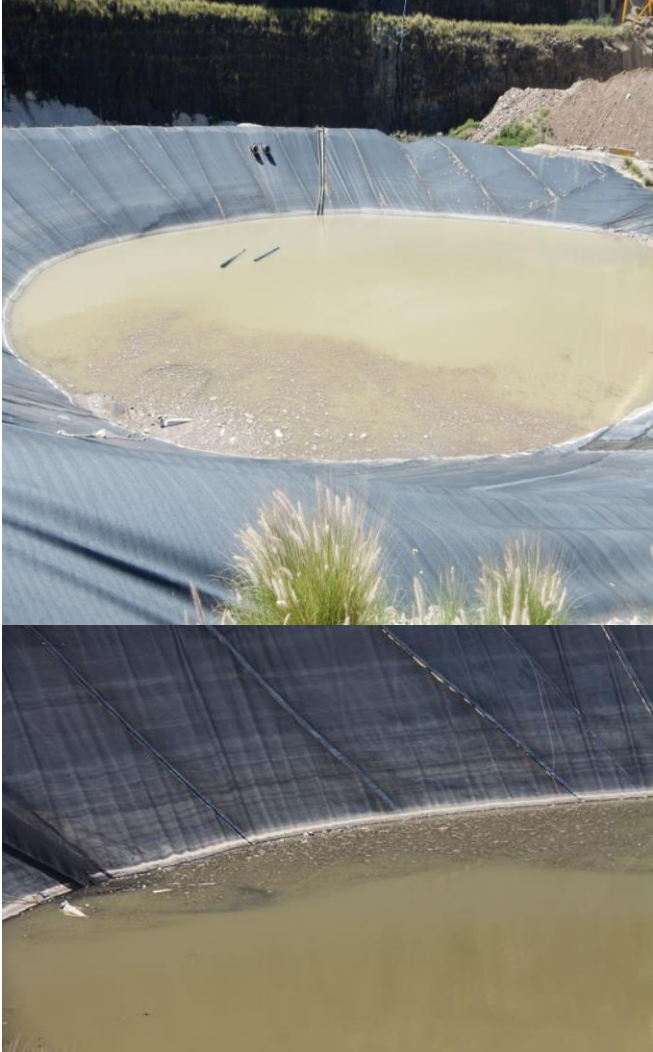
Condition Number	Compliance / Risk assessment	Comment	Action required by licensee	Licensee Comments
		Photo 3: In-pit-dam with rubbish, litter and sunken dinghy.		
O4.2 (b)	No Code Orange	<p>Effectiveness of pests and noxious weed management</p> <p>The licensee was not ensuring that the measures taken to eradicate noxious weeds on site are working effectively to prevent the presence of declared noxious weeds in sufficient numbers to pose an environmental hazard.</p> <p>The licensee inspects the site on a regular basis, however, on the day of the audit inspection the auditors observed substantial growth of noxious weeds including declared noxious weeds such as <i>Pampas grass</i> and <i>Spear and Star thistle weed</i> near the chute system within the landfill (See Photo 3 & 4) and other areas such as near sediment detention basins (Photos 5 & 6)) and overlooking the in-pit-sediment dam. It is noted that the licensee's representative noted this for discussion with personnel responsible for keeping weeds under control. It is also noted that at one point, after viewing substantive growth of weeds, the licensee's representative telephoned a person responsible for organising weed control and asked him why the weed control had not been undertaken.</p> <p>Although, the license has in place regular monitoring of pests, vermin and weeds, it appears that the monitoring process is not effective in ensuring that noxious weeds are not present in sufficient numbers to pose an environmental hazard.</p> <p>During the audit inspection the auditors also observed two wild goats and a kangaroo in an area above the sedimentation dams.</p> <p>The EPA is concerned that not effectively monitoring the growth of weed could cause:</p> <ul style="list-style-type: none"> The substantive growth of weed, as reported above, requiring the use of larger quantities of weed eradicating spray, increasing the 	The licensee must comply with the condition and ensure that noxious pests and weeds are controlled in an effective manner.	The vegetation management plan was submitted and accepted by the Department of Planning as required. The Licensee has been compliant to the standards within the management plan. See attachment O4.2b.

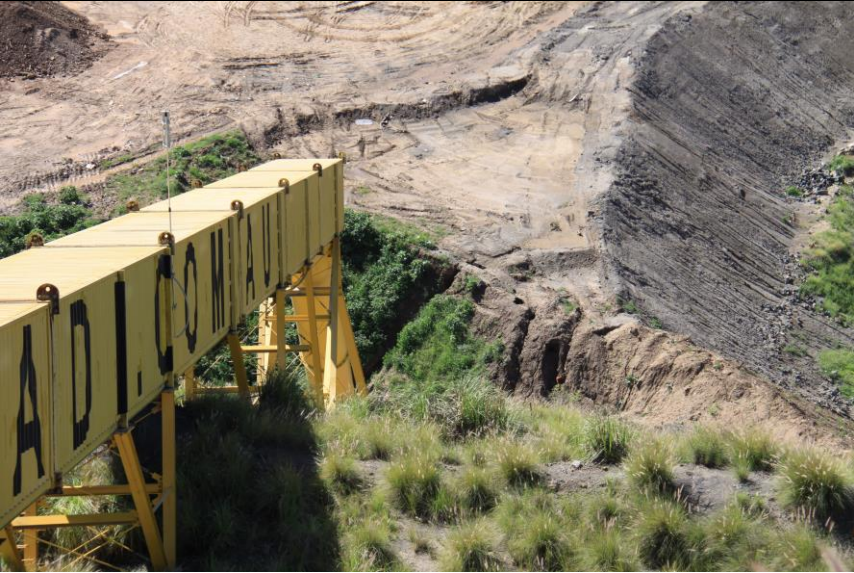
<p data-bbox="678 884 1111 911">Photo 4: Weeds growing hear Chute.</p> <p data-bbox="678 954 1491 1045">The EPA is also concerned that the licensee is not monitoring the effectiveness of the pest management program, which has also been reported in several Independent audit reports previously.</p>

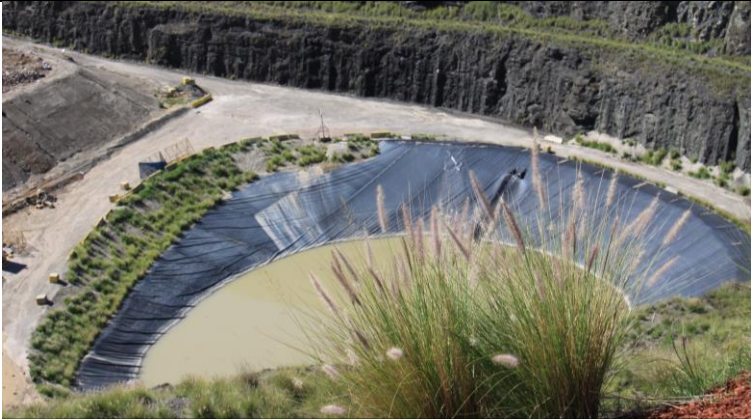
<p>Photo 4a: Noxious <i>pampas</i> grass overlooking in-pit-sediment dam</p>

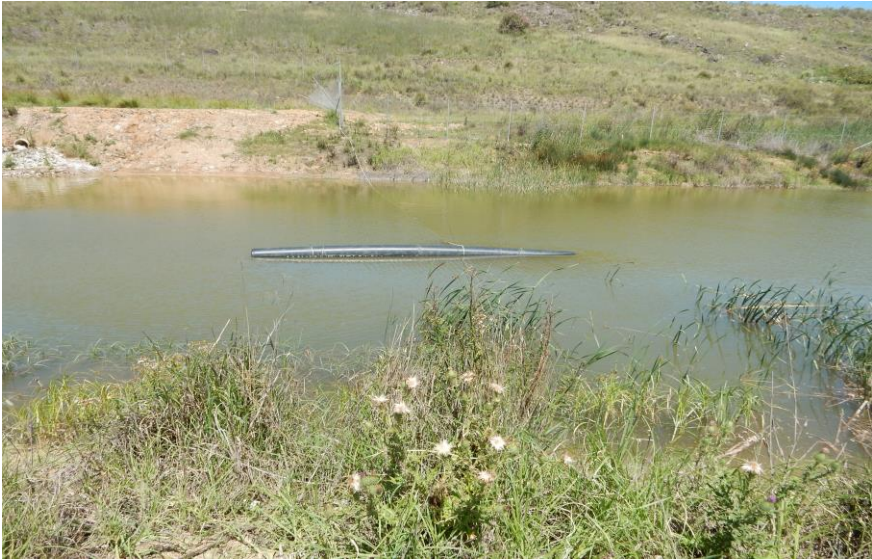
<p>Photo 5: Weeds including noxious <i>star thistle</i> growing near north-west sediment dam</p>

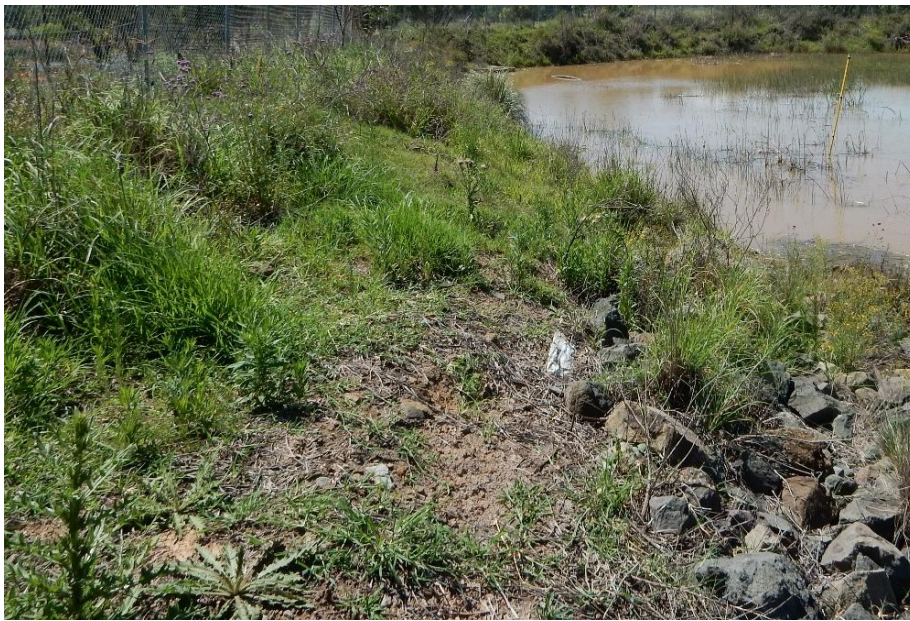
<p>Photo 6: Weeds including noxious <i>spear thistle</i> growing near south-west sediment dam</p>		
O5.4 (a) i)	No Code Yellow	<p>The licensee had not applied daily cover to a minimum of 15 centimetres over all exposed landfill waste prior to ceasing operations at the end of each day.</p> <p>On the day of the audit inspection the auditors observed exposed waste that had not been covered with the daily cover material, in a previously filled area adjacent to the in-pit dam (photos 7 & 8). It is noted that, after being told and shown, where waste has not been covered, the licensee ensured that the waste was covered prior to the auditors leaving the site.</p>	The licensee must ensure that all exposed waste is covered daily. The licensee must also ensure that asbestos waste is covered as required by the POEO Regulation.	The area was inspected after landfill operations had started during the day. There is no evidence to suggest that the material was tipped there on previous days, the licensee is of the opinion that the material was being used to rise the landfill floor to create the

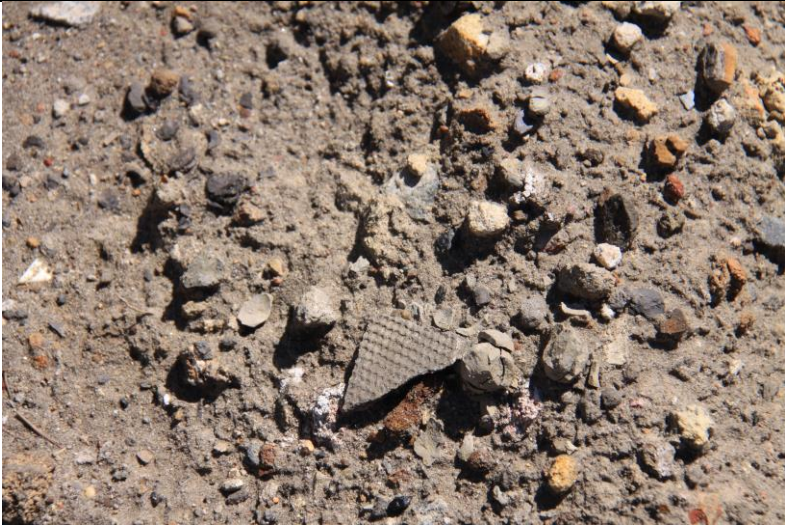
<p>Photo 10: Second fragment of asbestos sheeting</p>		
O5.4 (a) ii)	No Code Blue	<p>Using unapproved alternative cover (scope on the day of the audit inspection) The licensee was using an alternative cover material that was not approved by the EPA.</p> <p>It is noted that the licensee was permitted to undertake a 12-month trial of the alternative material 'Concover' in December 2012 and was required to provide a report to the EPA, one month after the end of the trial in December 2013.</p> <p>The licensee indicated that due to management changes the licensee forgot to send the report to the EPA. However, in 2014, an independent audit report undertaken as part of the planning development consent, identified this non-compliance. The licensee contracted a consultant to undertake a review of the trial and prepare a report as required by the EPA. However, the report was only sent to the Department of Planning and not to the EPA</p>	The Licensee must ensure that only EPA approved alternative material is used on the site.	<p>Noted. The Licensee has submitted an application for a variation to licence condition O5.4 to reinstate the use of Concover.</p> <p>We have responded to all requests of the EPA in support of this licence variation.</p>

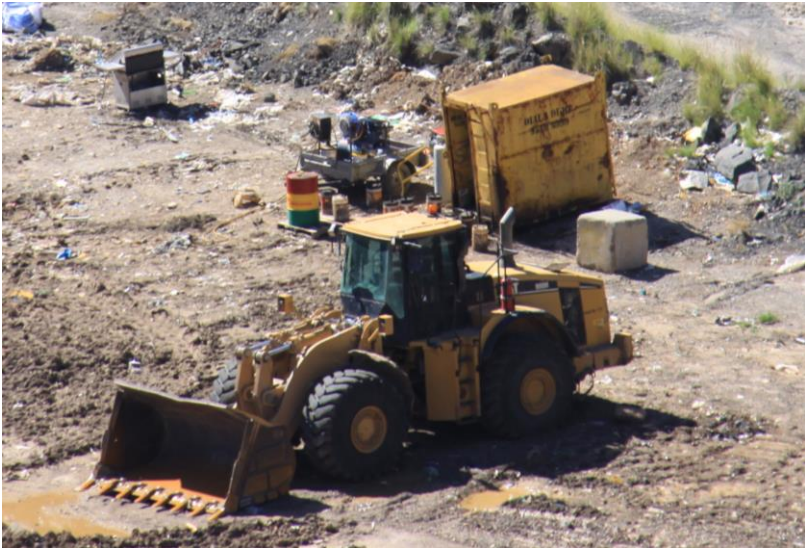
<p>Photo 15: Chemicals and fuels being stored without bunding</p>		
	No Code Blue	<p>Monitor at each monitoring/discharge point</p> <p>Condition M2.1 requires the licensee to sample at monitoring points 2.3.5.6.7 and points 9 – 27 including 21 and 22 at BH 10D and BH 12D. As reported in their annual return the licensee did not monitor from these locations, as these bores were blocked for some time. Instead the licensee sampled at points BH 25d and BH 26d.</p>	The Licensee must ensure that all samples are collected at prescribed locations or renegotiate the monitoring points with the EPA.	Noted.
	No Code Blue	<p>Monitor at each monitoring/discharge point</p> <p>As indicated above the licensee did not monitor from these locations. Instead the licensee sampled at points BH 25d and BH 26d.</p>	The Licensee must ensure that all samples are collected at prescribed locations or renegotiate the	Noted.

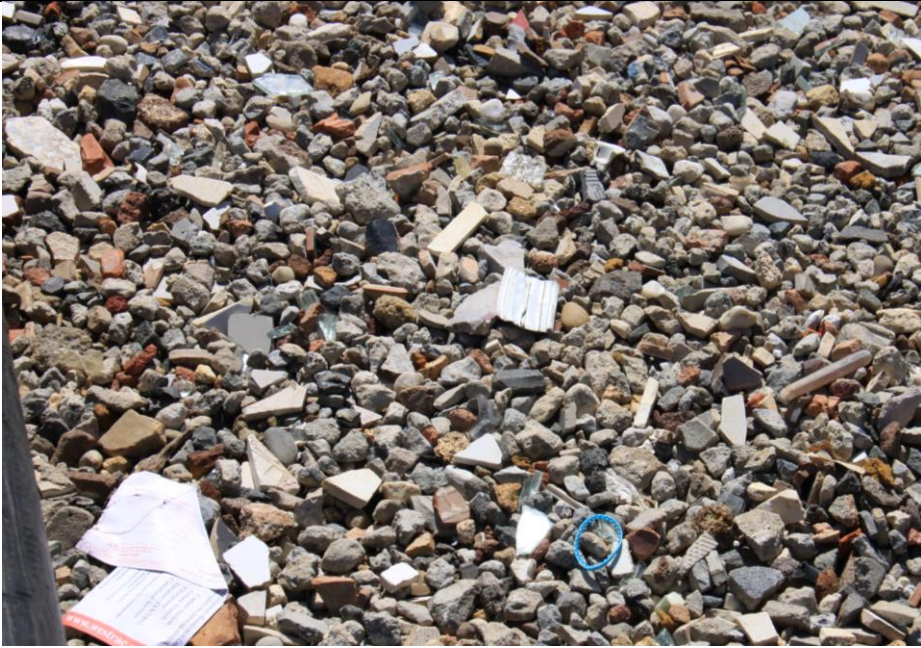
<p data-bbox="667 975 1585 1050">Photo 16 - 18: Alternative cover material showing paper, wood, plastics and material with sizes exceeding 50mm, and <50% material not less than 1mm.</p>

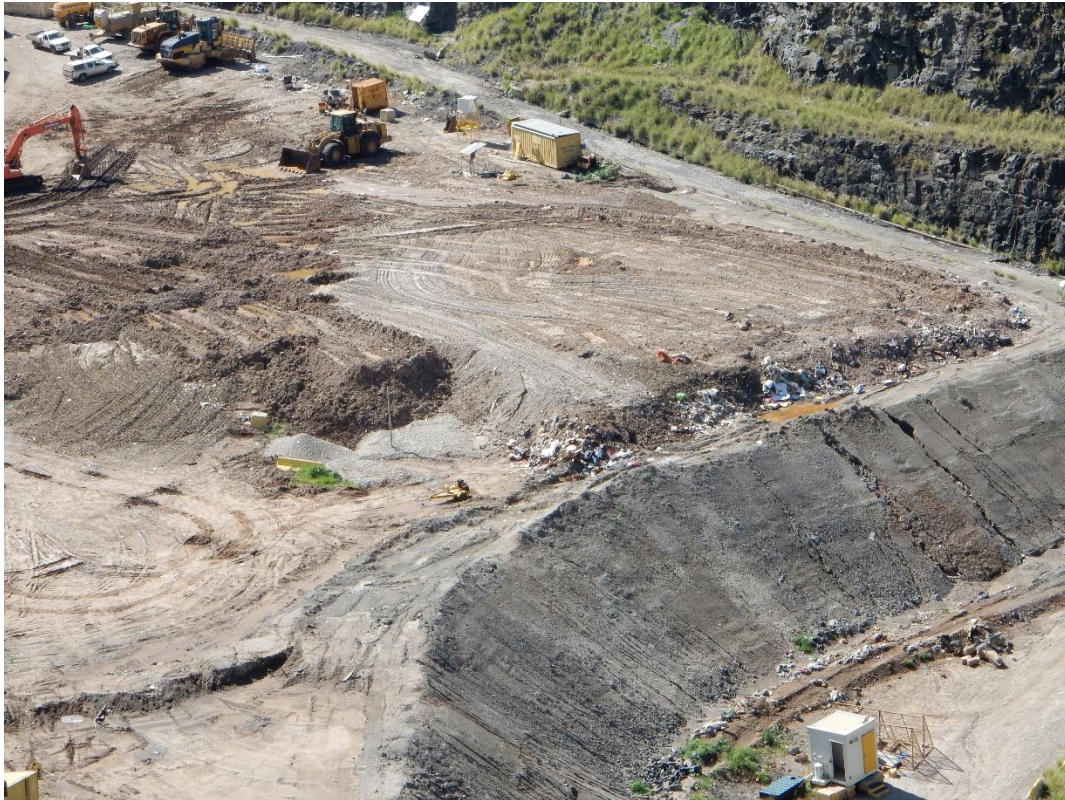
On the day of the audit inspection the area with the uncovered waste was first observed from the viewing platform at **9.37am** by the auditors. It was clear *that no waste was being disposed of* in the area referenced at that time or on the day of the audit inspection, which can be seen clearly in attached photo.

The contrasting colours of the soil indicate that there had been no filling operations on the day of the audit inspection where the auditors observed the uncovered waste.

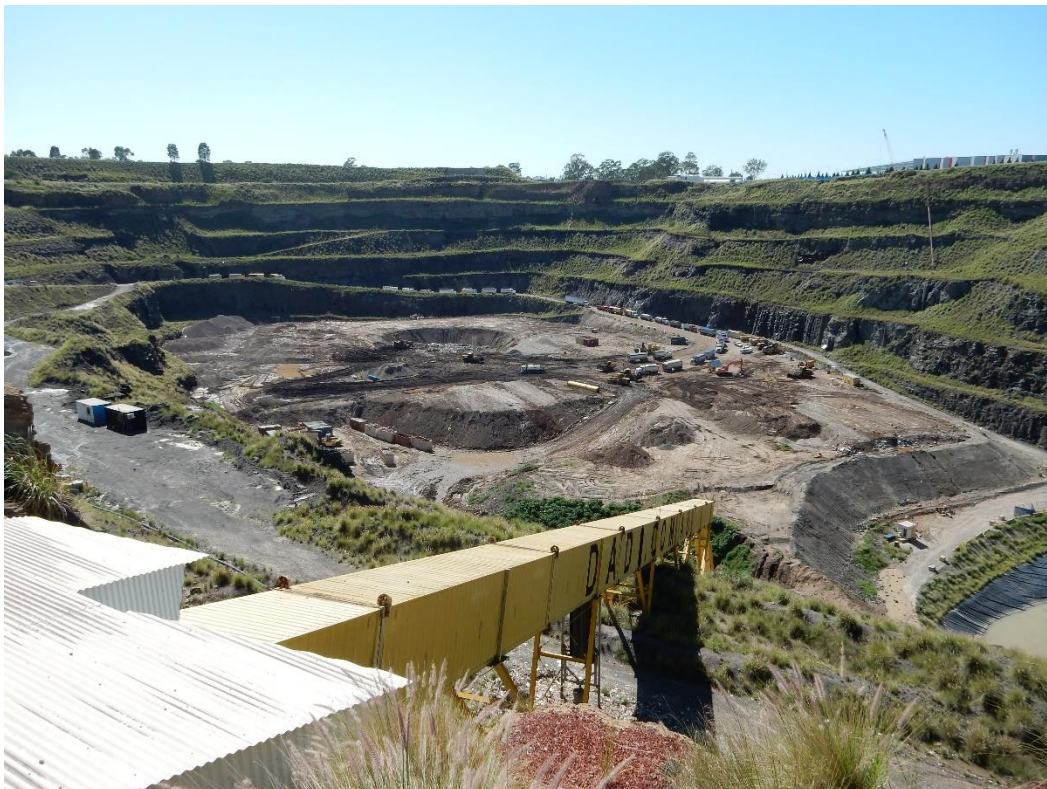
Waste filling operation at 9:37am on the day of the audit inspection indicating where filling operations were taking place in the north-east areas of the landfill

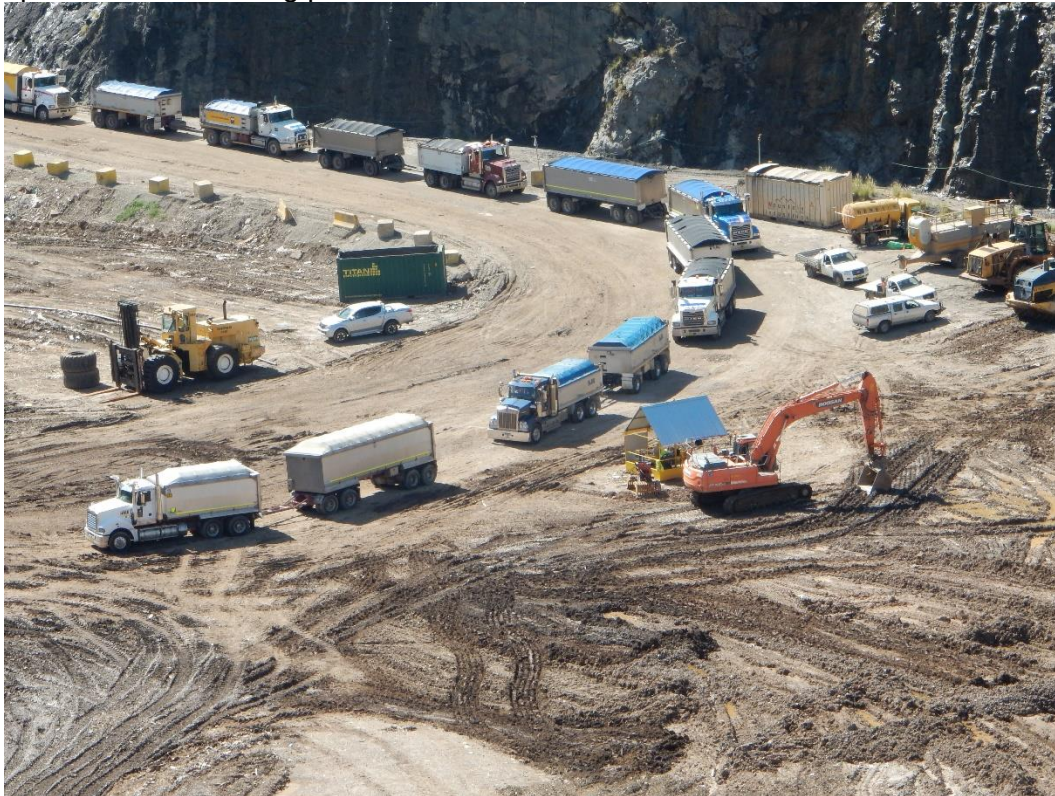
Close- up of vehicles queuing up.
