Independent Environmental Audit

Genesis Landfill and Recycling Centre

Prepared for Dial a Dump Industries Pty Ltd

21 August 2015

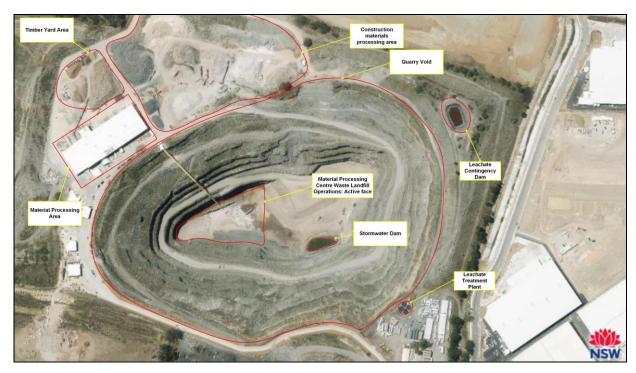
Figure 2.1 - Simplified site layout as found on 10 June 2015

A simplified site layout highlighting the key areas at the Facility (as found on 10 June 2015) is shown in **Figure 2.1**.

The following sections are intended to provide a brief overview of each key process area shown in **Figure 2.1** as found on 10 June 2015.

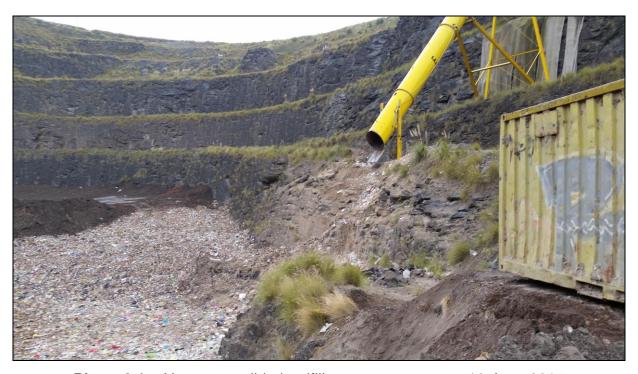
The non-putrescible landfill currently resides inside a large void area which was previously used as a quarry. The non-putrescible landfill currently receives waste product generated from the Material Processing Centre (MPC) which is conveyed to the bottom of the void active tipping face area by a long vertically steep chute system. The waste conveyed through the chute system primarily consists of material that cannot be recycled or recovered in the MPC. **Photo 2.1** shows the non-putrescible landfill area and chute system as present on 10 June 2015.

Photo 2.1 - Non-putrescible landfill area as present on 10 June 2015

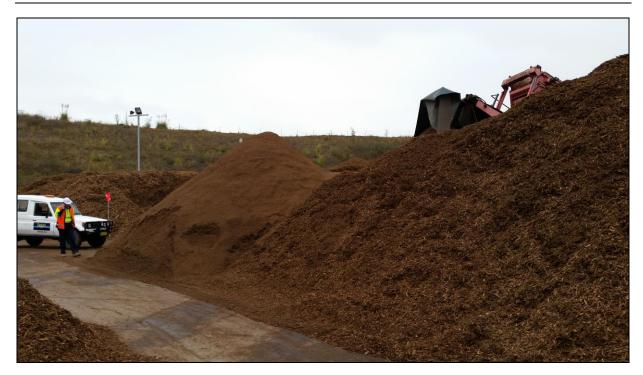
Photo 2.2 - A section of material stockpiled in the TYA as present on 10 June 2015

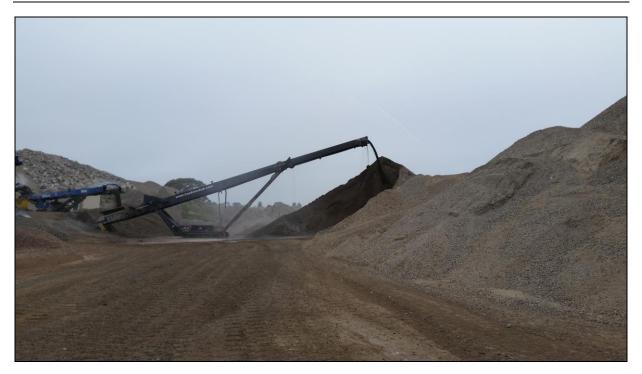
The construction material processing area stores sorted construction waste that is segregated/crushed to different size fractions. The final product is used as recyclable building material. An example of stockpiled material in the TYA as present on 10 June 2015 is shown in **Photo 2.3.**

Photo 2.3 – An area section of the construction material processing area as present on 10 June 2015

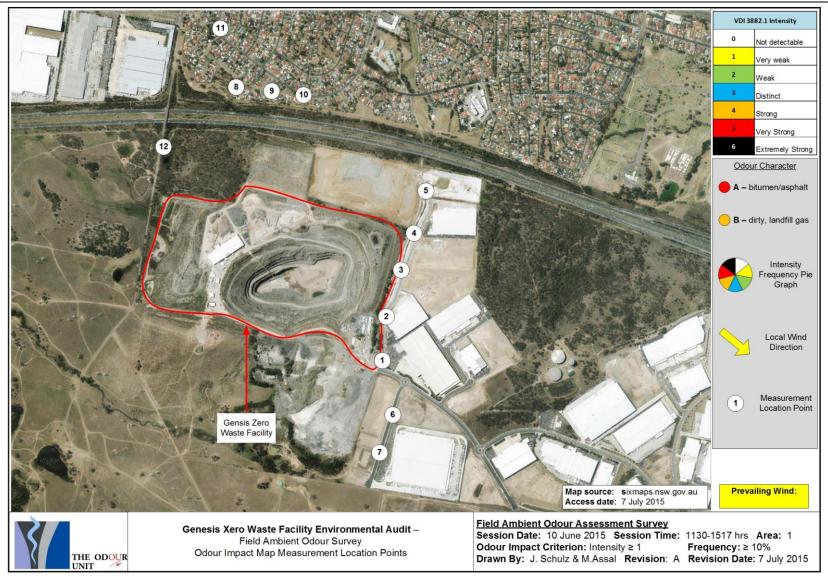
Figure 3.1 presents the map template for the assessment area and highlights the location of the Facility relative to the measurement location points (see **Section 3.1.1** for details).

Figure 3.1 – FAOA Survey Template for the Assessment

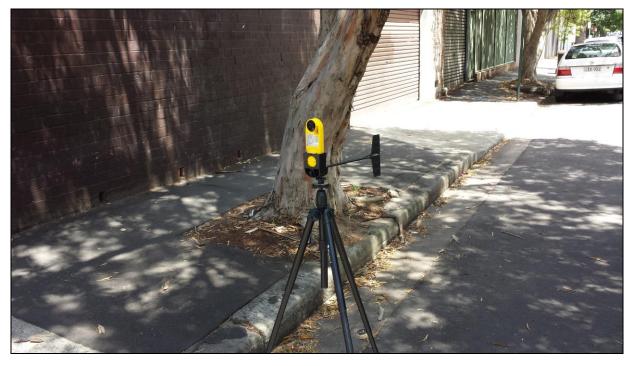
Photo 3.1 – Illustrated setup of the Kestrel Anemometer apparatus in operation (Source: The Odour Unit Pty Ltd)

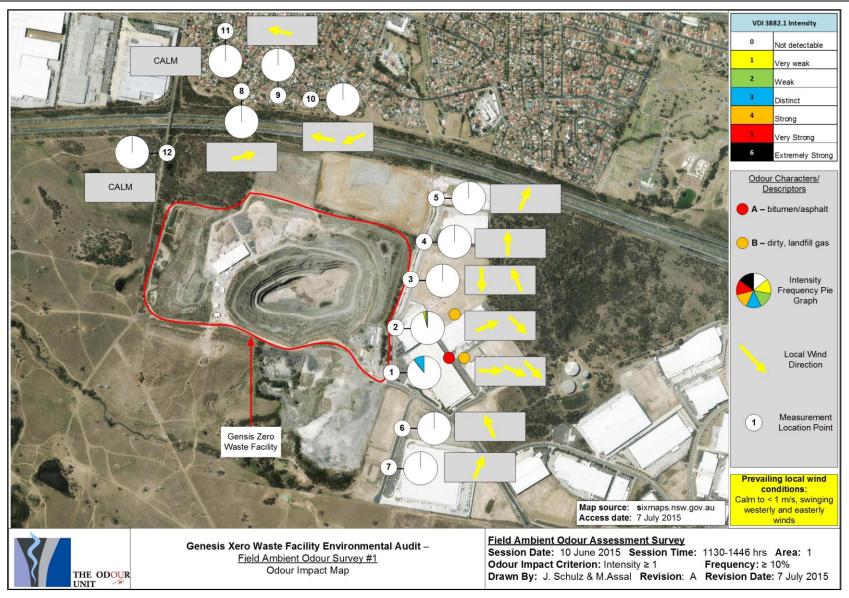
FAOA Survey Map Plot 5.1 - FAOA Survey No. 1: 10 June 2015 between 1130 hrs and 1446 hrs

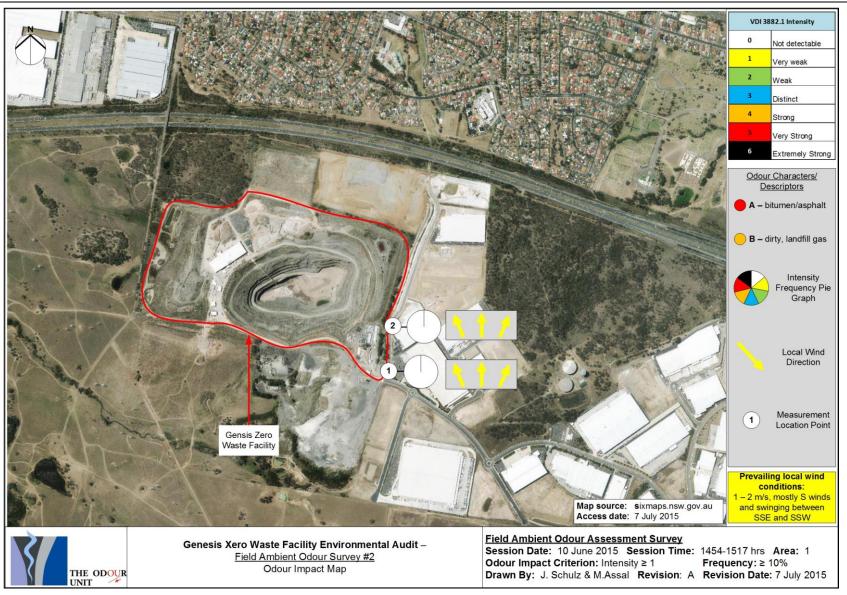
FAOA Survey Map Plot 5.2 - FAOA Survey No. 2: 10 June 2015 between 1454 hrs and 1517 hrs
