BINGS INDUSTRIES

2019 Annual Environmental Review -

Eastern Creek Recycling Ecology Park

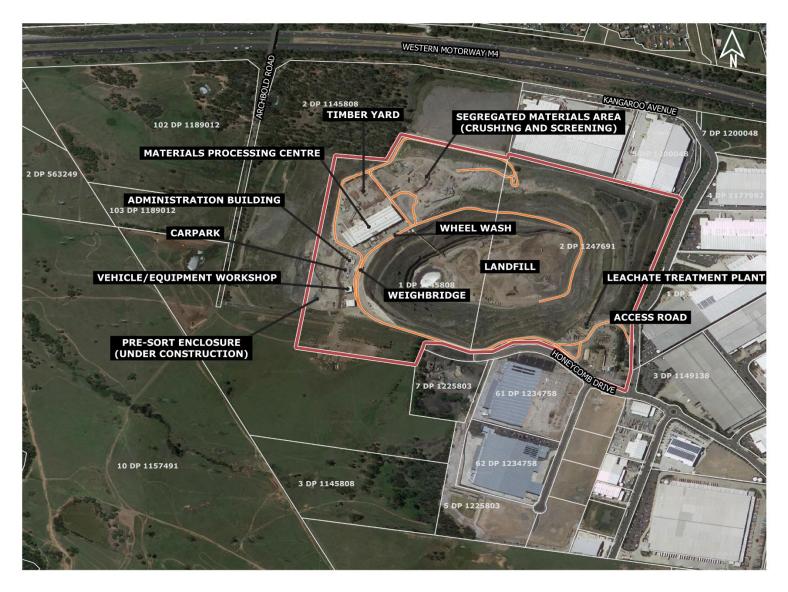
Figure 3-1: Site Layout

The landfill (former quarry) pit represents the central feature of the site area. The MPC, timber waste, green waste, sales yard, crushing and screening area and workshop area are situated in the west and north-west sectors of the site. The operational areas of the site are surrounded to the east, west and north by an environmental bund constructed of overburden from the former quarry which shields receptors from views of, and noise generated from, the facility.

The operations area of the site, including the surface area of the quarry, is approximately 60 hectares (Ha). The current layout of the facility is illustrated in Figure 3.1.

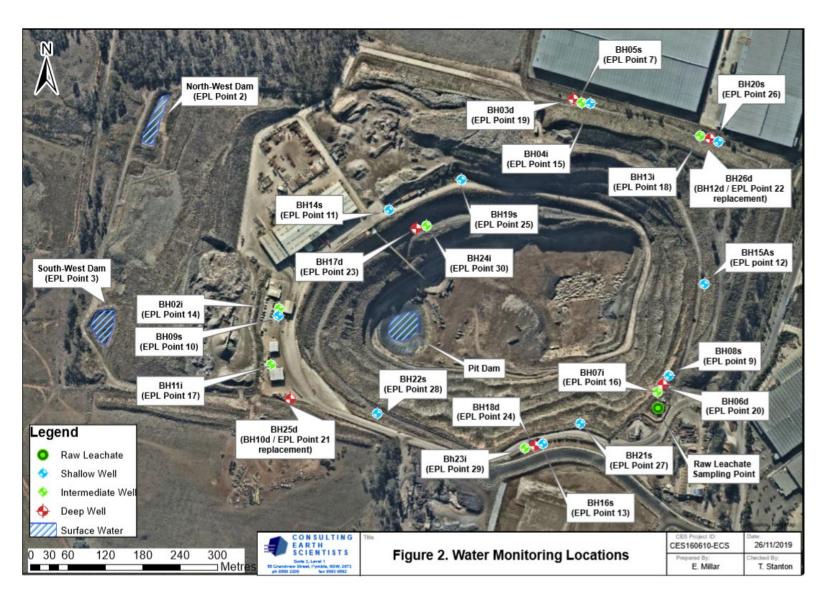
Figure 5-1: Water Monitoring Locations

The Soil, Water and Leachate Management Plan also outlines the surface water, groundwater and leachate monitoring program which is undertaken in order to effectively monitor and report water character from the site, and ensure early detection and reporting of possible pollution of water. The monitoring program is consistent with the monitoring requirements of Condition M2 of EPL 13426 at all the locations listed in Condition P1.2 of EPL 13426 and P1.3 of EPL 20121.

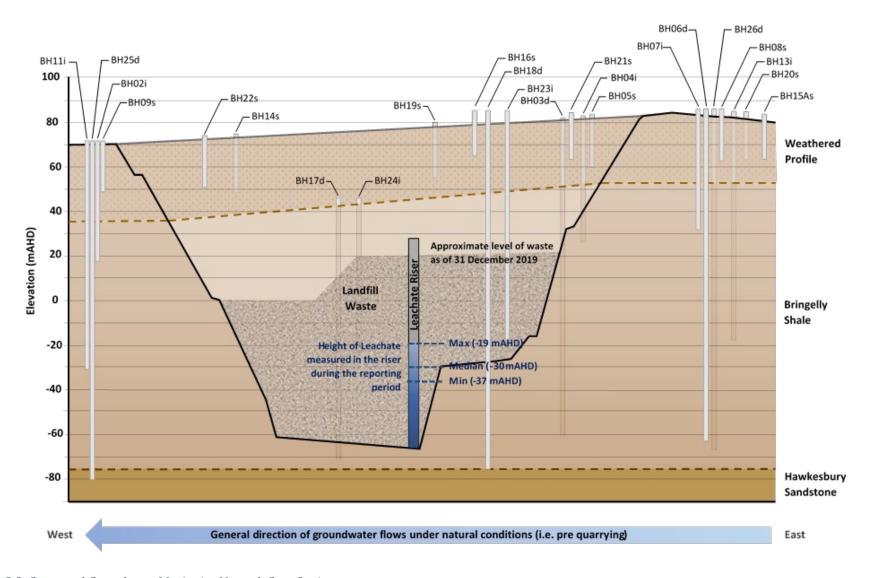
Figure 5-2: Conceptual Groundwater Monitoring Network Cross Section

Aquifer unit	Approximate Depth (mAHD)	Description	Hydraulic Conductivity	Formation
Shallow	70 to 40	Residual clay generally to 5m to 20m depth underlain by highly weathered shale and sandstone	Very low to low (0.003 to 0.25 m/d)	Bringelly Shale (weathered)
Intermediate	40 to -30	Poorly fractured (intermediate) bedrock strata. Limited evidence that fracture zones are extensive or interconnected	Negligible or very low (0.004 to 0.043 m/d)	Bringelly Shale
Deep	-30 to -80	Poorly fractured (deep) bedrock strata	Negligible or very low (0.004 to 0.011 m/d)	Bringelly Shale

All groundwater bores are required to be sampled on a quarterly basis in accordance with EPL13426. Water quality monitoring has been undertaken for the project since October 2012. Sampling of groundwater is undertaken by an external contractor, during the reporting period there were four sampling events undertaken by CES.

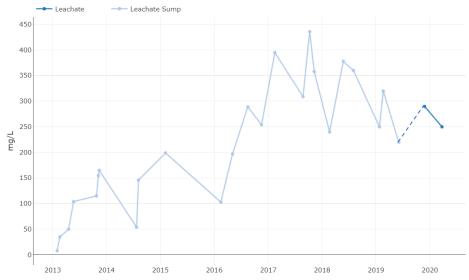
Figure 5-3: Ammonia concentrations in landfill leachate

Ammonia concentrations found in the leachate are presented in Figure 5-3. The ammonia concentrations in leachate are typical of a construction and demolition waste landfill of this age. Ammonia concentrations increased during the early years of the operations but have stabilised over the past two to three years.

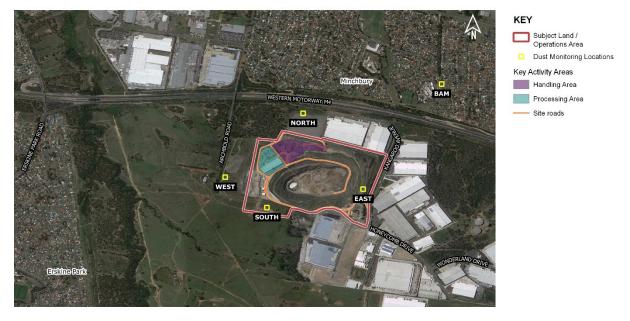
Figure 5-4: Dust Monitoring Locations

The facility and the dust monitoring locations are shown in **Figure 5-4**. The facility is surrounded by commercial and industrial developments to the east and south and residential areas to the west and the north. The residential receivers on the west side are in the Erskine Park suburb which is located approximately 1 km from the site boundary and the residential receivers on the north are from the suburb of Minchinbury which is 160 m from the site boundary (separated by the M4 motorway).

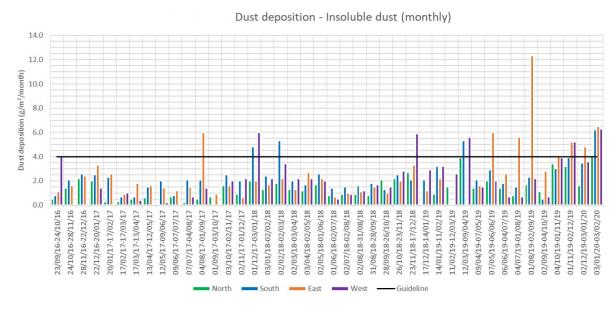
Figure 5-5: Monthly Dust Deposition – Insoluble dust (23/09/16 to 03/02/20)

The monthly insoluble dust deposition results for all the sites (including historical data for additional context) are presented in **Figure 5-5**. Monthly insoluble dust deposition values were generally below 4 g/m²/month. The 4 g/m²/month value was exceeded on 9 occasions (18.75% of samples) during the reporting period, 6 of which related to the East DDG. It must be noted that these do not count as exceedances as the 4 g/m²/month guideline refers only to the annual average.

The highest monthly deposition values at North (3.9 g/m²/month), South (5.3 g/m²/month) and West (5.6 g/m²/month) were all recorded during March (12/03/19 - 09/04/19). The highest deposition value at East (12.3 g/m²/month) was recorded during August (01/08/19 - 02/09/19).

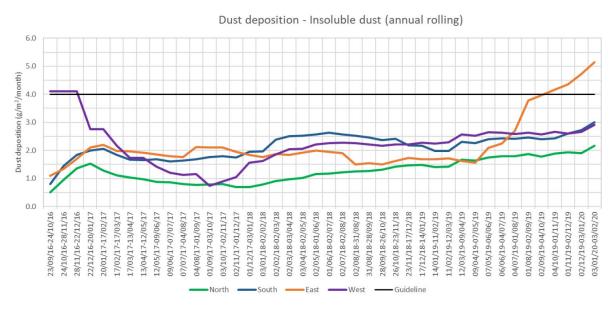
Figure 5-6: Annual Rolling Average Dust Deposition – Insoluble dust (23/09/16 to 03/02/20)

Historical rolling average insoluble dust deposition data from start of monitoring on 23 September 2016 are also presented in **Figure 5-6** for historical perspective.

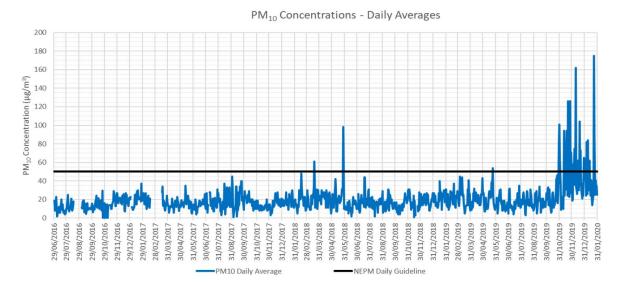
Figure 5-7: Daily Average PM10 concentrations (29/06/16 to 31/01/20)

The daily average (24-hour) PM₁₀ concentrations are graphed in **Figure 5-7** and the Annual rolling average PM₁₀ concentrations in **Figure 5-8**. Historical data from start of monitoring on 29 June 2016 are also shown for historical perspective. There were no PM₁₀ data losses for the reporting period. Daily data capture since monitoring started on 29 June 2016 was 95%.

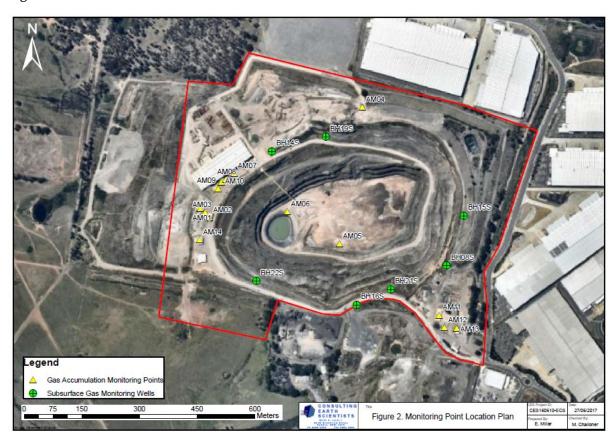
Figure 5-9: Landfill gas monitoring locations

The programme consists of the monitoring of landfill gas in seven (7) monitoring wells around the perimeter of the former quarry pit (i.e. landfill), gas accumulation monitoring in 13 locations and a surface gas survey across the surface of the active landfill. Sub-surface gas monitoring, surface gas survey and gas accumulation monitoring is undertaken at the site on a quarterly basis. These quarterly monitoring events are undertaken in March, June, September and December.

The subsurface gas monitoring locations and gas accumulation monitoring locations are shown in Figure 5-9.

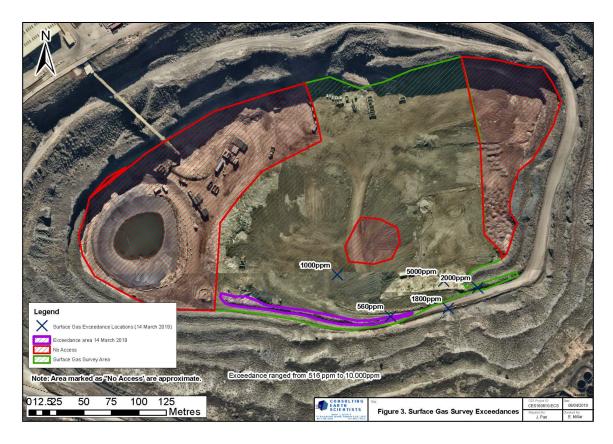
Figure 5-11: Surface gas survey exceedances recorded in March 2019 (Q1)

Monitoring Period	Description of Exceedance	Corrective Action
March	Six (6) locations were identified (5 localised points and 1 area). The area of exceedance had multiple cracks in the landfill capping indicating the release of methane gas.	Corrective measures were implemented immediately by placing extra cover material and compacting existing cover material in the affected area while CES staff were still onsite.
June	Five (5) locations were identified (2 localised points and 3 areas). It was observed that the southern bund wall, where an exceedance was recorded, had multiple cracks in the landfill capping.	CES staff immediately notified and identified these exceedances to Bingo staff. Corrective measures were implemented immediately by placing extra cover material and compacting existing cover material in the affected areas

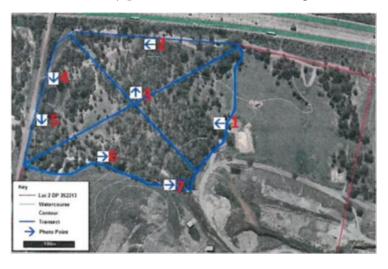
Figure 5-13: Conservation Zone – Monitoring Points

Public access to the Conservation Zone and the Riparian Corridor is restricted to maintain the integrity of the environment. Monthly photo audits are undertaken in the Conservation Zone and Riparian Zone to ensure management and mitigation measures are operating effectively.

Monitoring locations for the monthly photo audits are shown in Figure 5-13 and Figure 5-14.

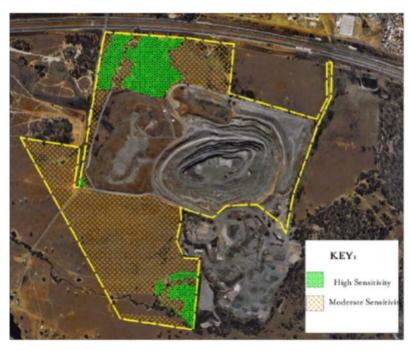
Figure 5-15: Assessed archaeological sensitivity zoning within the project boundaries (from JMcD CHM, 2005) – non-hatched areas are Zone 3

- **Zone 1** (Conservation Areas) has high archaeological sensitivity;
- Zone 2 (Cleared but Undeveloped Areas) has moderate archaeological sensitivity; and
- **Zone 3** (Operations Area) has low archaeological sensitivity.
- It is noted, whilst the Zone 1 (Conservation Areas) and the majority of Zone 2 (Cleared but Undeveloped Areas) areas no longer sit within the operational area owned by Bingo, the areas are still subject to the conditions of the consent.
