RE: SHORT TERM RISKS IN QUARRY

This letter presents the results arising from an inspection of the Wallgrove Quarry on 18th October 2006.

RE: LONG TERM RISKS IN QUARRY

This letter presents the results arising from an inspection of the Wallgrove Quarry on 18th October 2006. The quarry was inspected in the company of Mr Bassos of Hanson.

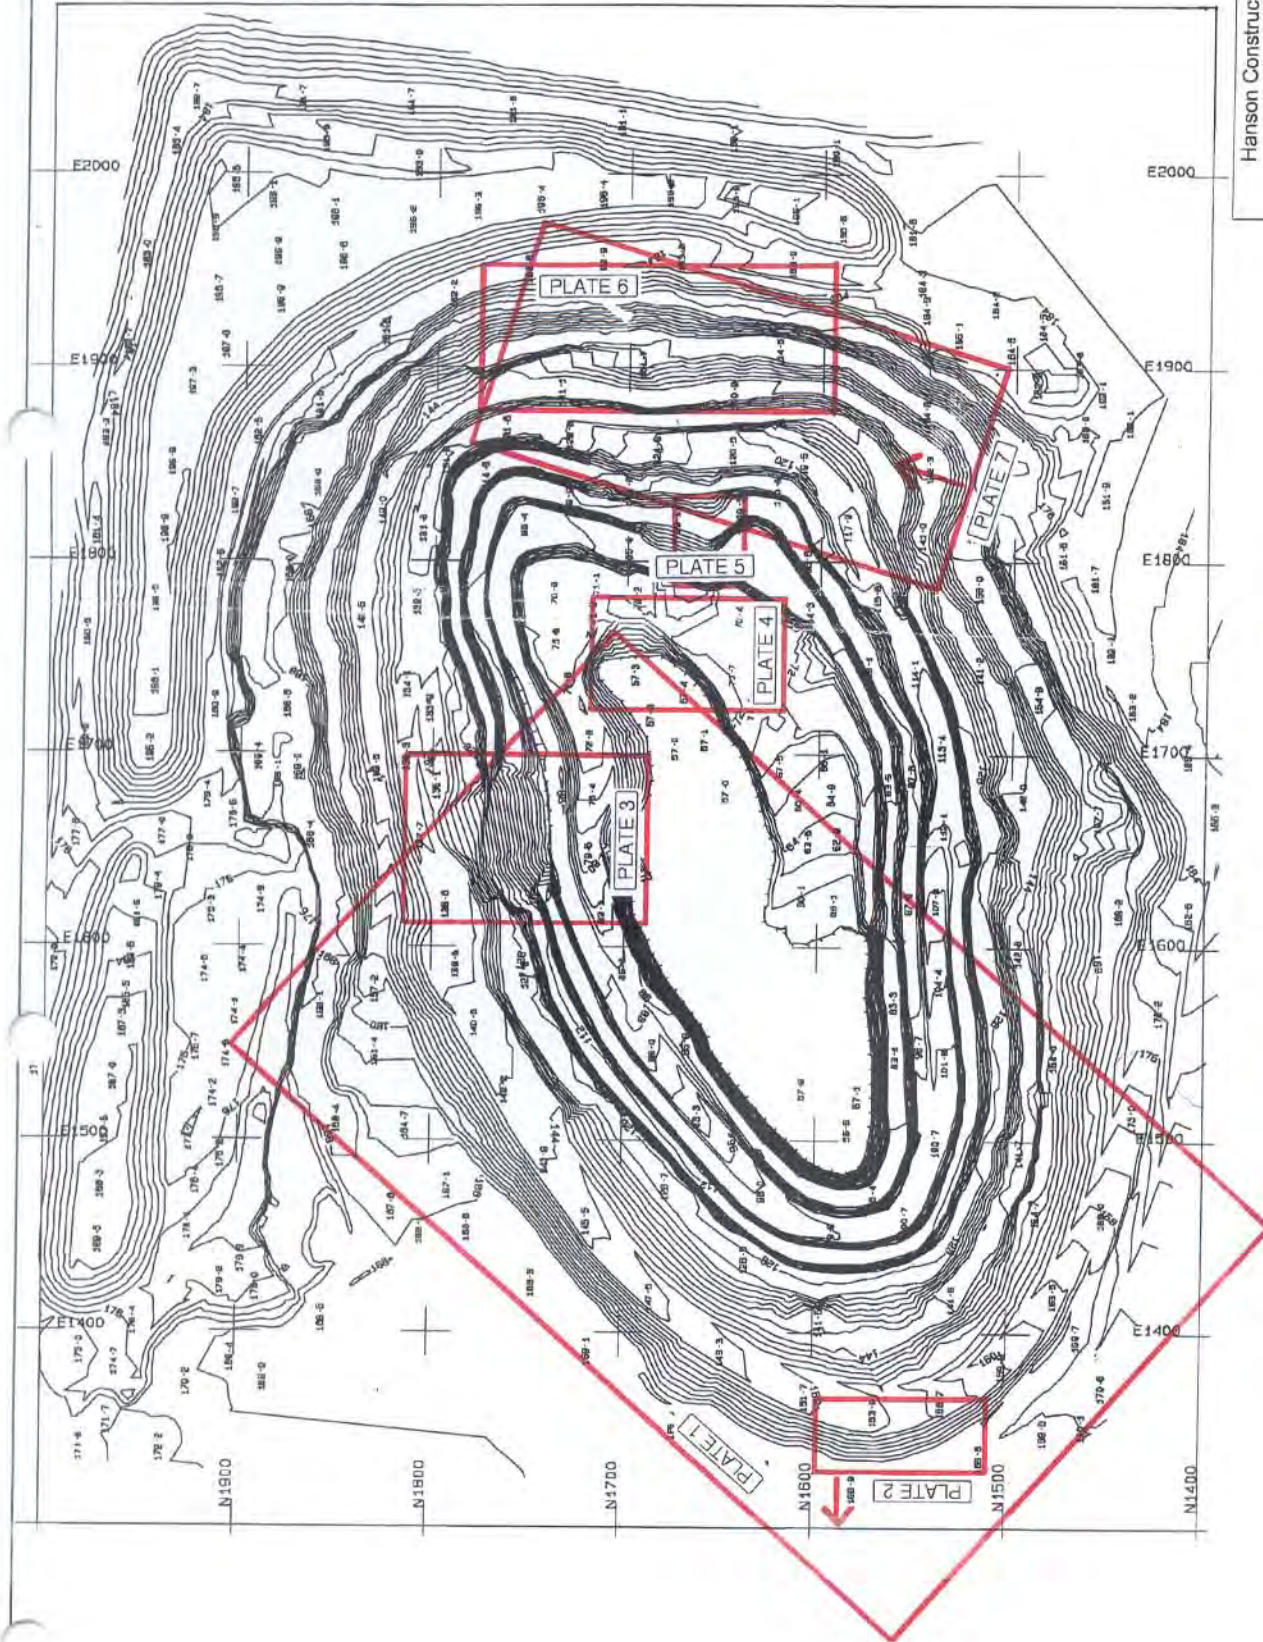
The upper part of the east wall presents the area of highest potential concern at the quarry. The sandstone ledge within the upper most bench is undercut along a substantial length, Plate 6, and with narrow berm widths in key areas, Plate 7. Furthermore, there have been recent large block fall outs, Plate 7, and evidence of cracks within the sandstone unit to suggest that further block fall out could readily occur. Ongoing visual monitoring of this area is recommended. However, the risk to personnel utilising the haulroad remains as low to moderate.

Plate 7 : West wall looking to the north, highlighting undercutting of sandstone bed, narrow berms below, recent failure and cracks within sandstone bed.
