Genesis Facility (Landfill)

Final Compliance Audit Report – Waste Disposal by Application to Land Audit Program

EPL 13426

March 2019

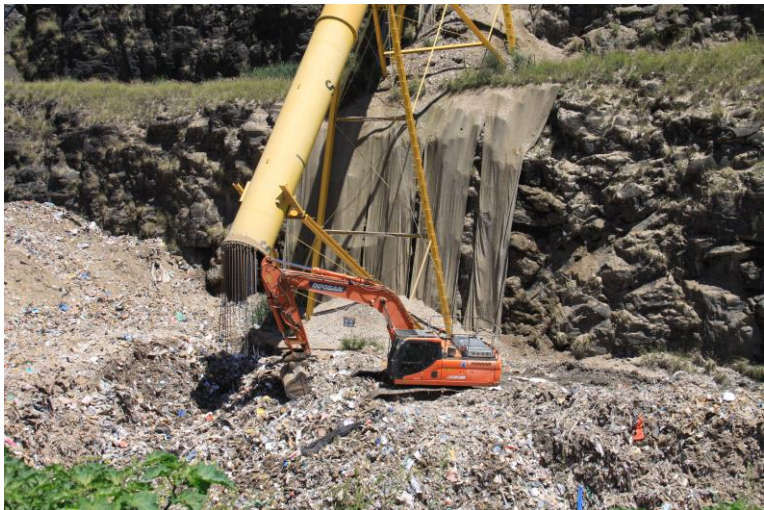
L3.4	No Code Yellow	<p>Disposal of waste offsite</p> <p>The licensee was not disposing of all outputs produced from the waste processing and /or resource recovery facility at the landfill.</p> <p>On the day of the audit inspection the auditors observed crushed/screened waste material from the waste processing and recovery facility being</p>	The licensee must comply with the condition. The licensee must provide the EPA the following information:	<p>Point 1 – Correct. Majority of outputs are disposed of at Genesis landfill EPL13426. The balance being disposed of at Greenspot landfill QLD</p>

Condition Number	Compliance / Risk assessment	Comment	Action required by licensee	Licensee Comments
		<p>deposited into the landfill via the chute. Waste material from the recycling facility is weighed continuously with weigh belt conveyors (contains two separate weigh belts) before it is transported to the bottom of the tip via the chute. During the time the auditors were on site, significant amount of waste had accumulated at the bottom of the chute (Photo 3). The licensee representative indicated that a substantial amount is transported by rail for disposal at a Queensland landfill – Greenspot.</p> <p>He also indicated that some waste was buried on site depending upon current economics. He further explained that only 'one week's supply' of waste material is stockpiled at the site near chute. This could not be verified, as it is not clear how much waste is dumped on site, and how much is transported off site. During the inspection only, small quantities (3 – 4 loads) approximately around 50 cubic meters were transported to the tip for disposal. There were 13 shipping containers stored on site and loaded during the day. No shipping containers were observed leaving the site.</p>

Condition Number	Compliance / Risk assessment	Comment	Action required by licensee	Licensee Comments
		<p>Photo 2: Large mountain of crushed waste at bottom of chute.</p> <p>The deposited material contained large quantities of, plastics, shredded paper, pieces of wood and is considered a fire hazard.</p> <p>An analysis of weighbridge dockets provided to the EPA, indicate that waste is transported from the landfill to Queensland (see assessment of condition L5.1).</p> <p>Based on the advice provided to the auditors by the licensee's representative, the waste material that is transported is landfilled. This condition does not allow the licensee to dispose of any waste produced from the output of the waste processing facility, other than for purposes prescribed in the condition.</p> <p>The EPA is concerned that the licensee is not complying with the condition as no waste is permitted to be disposed offsite, other than for purposes specified in the licence. The EPA is also concerned that the licensee is storing large quantities of waste increasing the likelihood of fire.</p>

<ul style="list-style-type: none"> The final destination of the waste with records of acceptance from the destination The total amount of waste that has been transported for the period 2 March 2017 to 1 March 2018. Evidence that the waste transported is being landfilled. 	<p>(EPA Permit EPPR00706313).</p> <p>Point 2 – Correct, however the volume of waste captured in photo 3 is indicative of landfill floor build up in preparation for the removal of one section of the chute tube.</p> <p>Point 3 – As per previous point; due to floor build up requirements, only small amounts per hour were required to move from chute base to tip base.</p> <p>Point 4 – Licensee was under the opinion that approve alternate cover (con cover) was still permitted for use. Stockpile was covered with con cover.</p> <p>Point 5 – The licensee believes we are compliant with this condition. We are disposing all the outputs from license 20121 at the landfill i.e. EPL13426 and Greenspot permit EPPR00706313.</p>

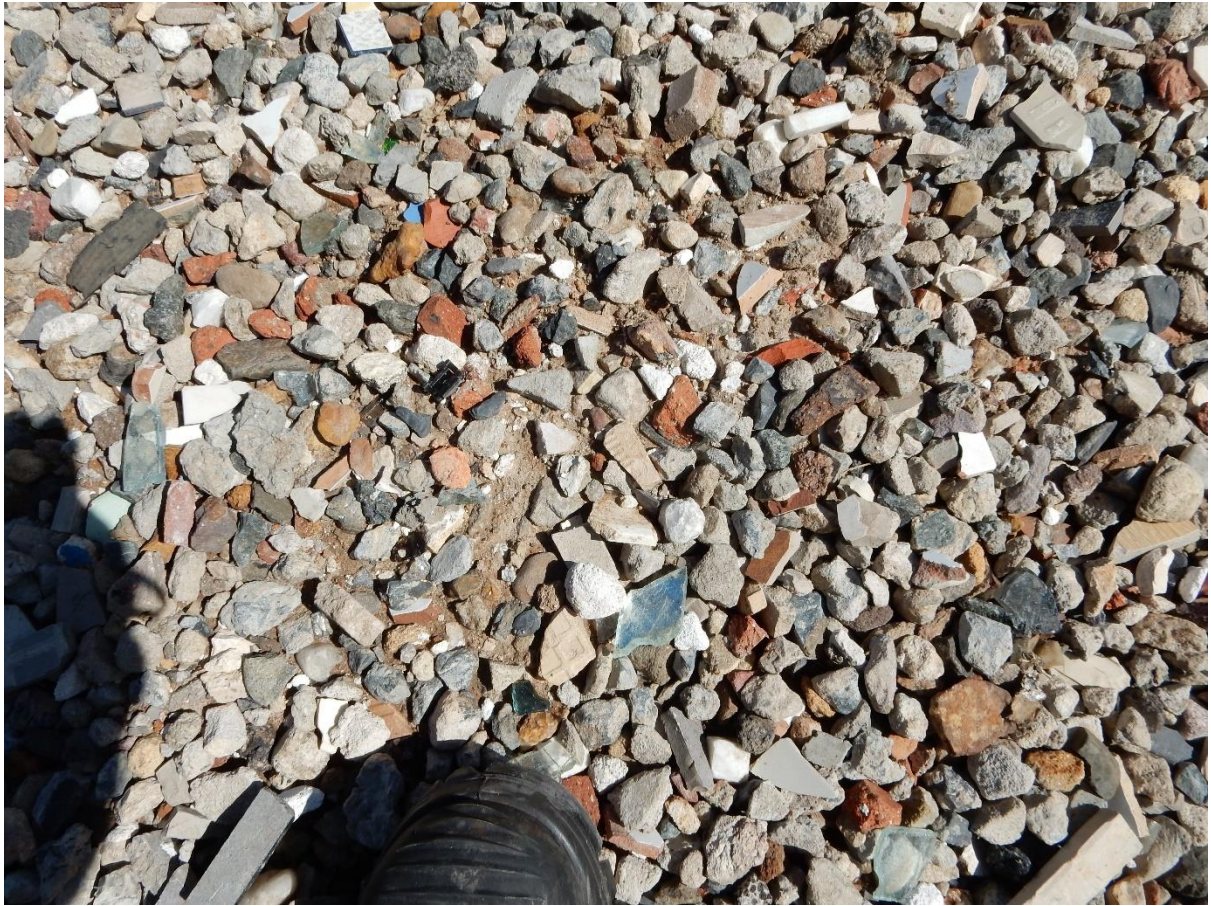
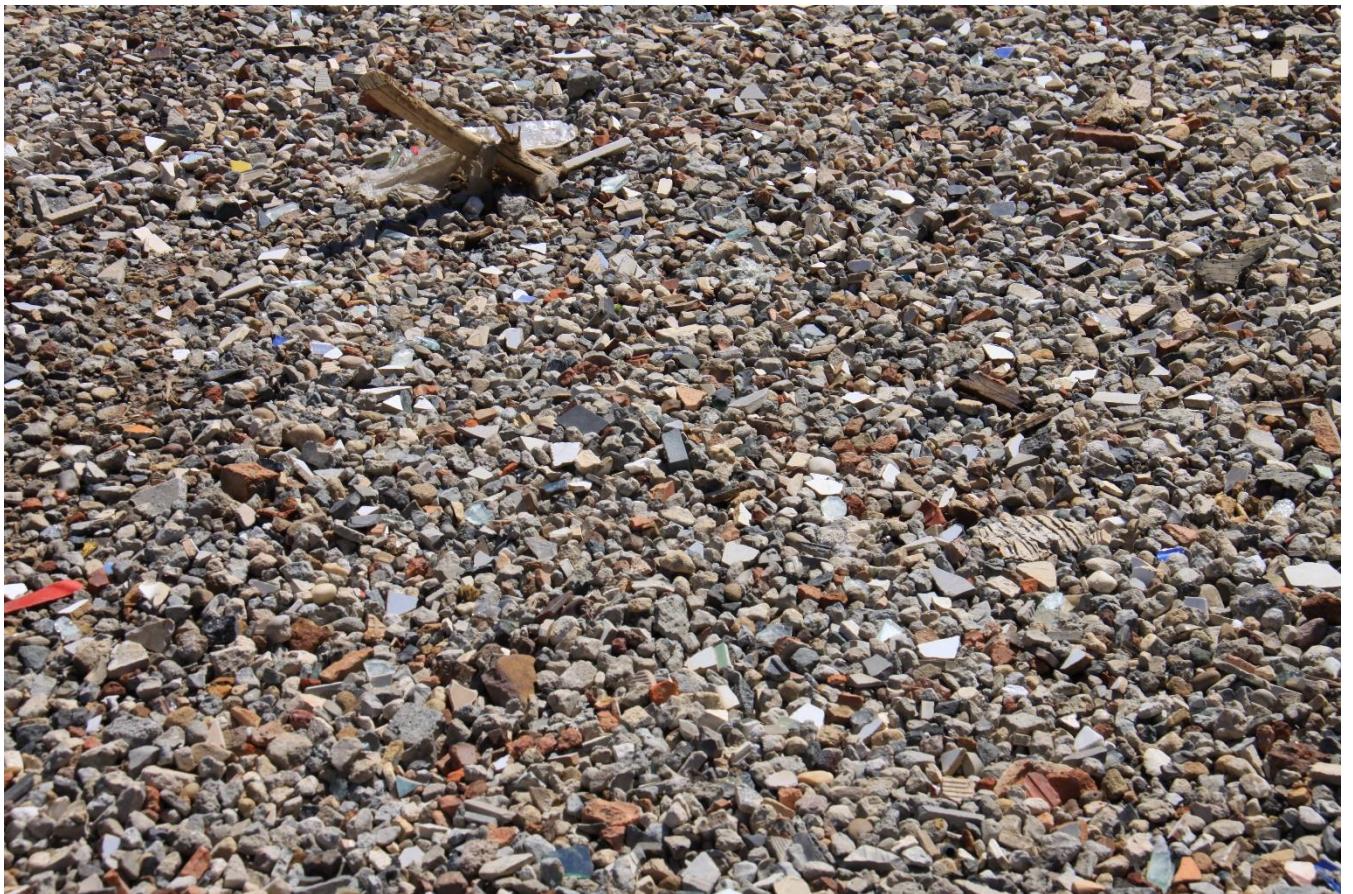
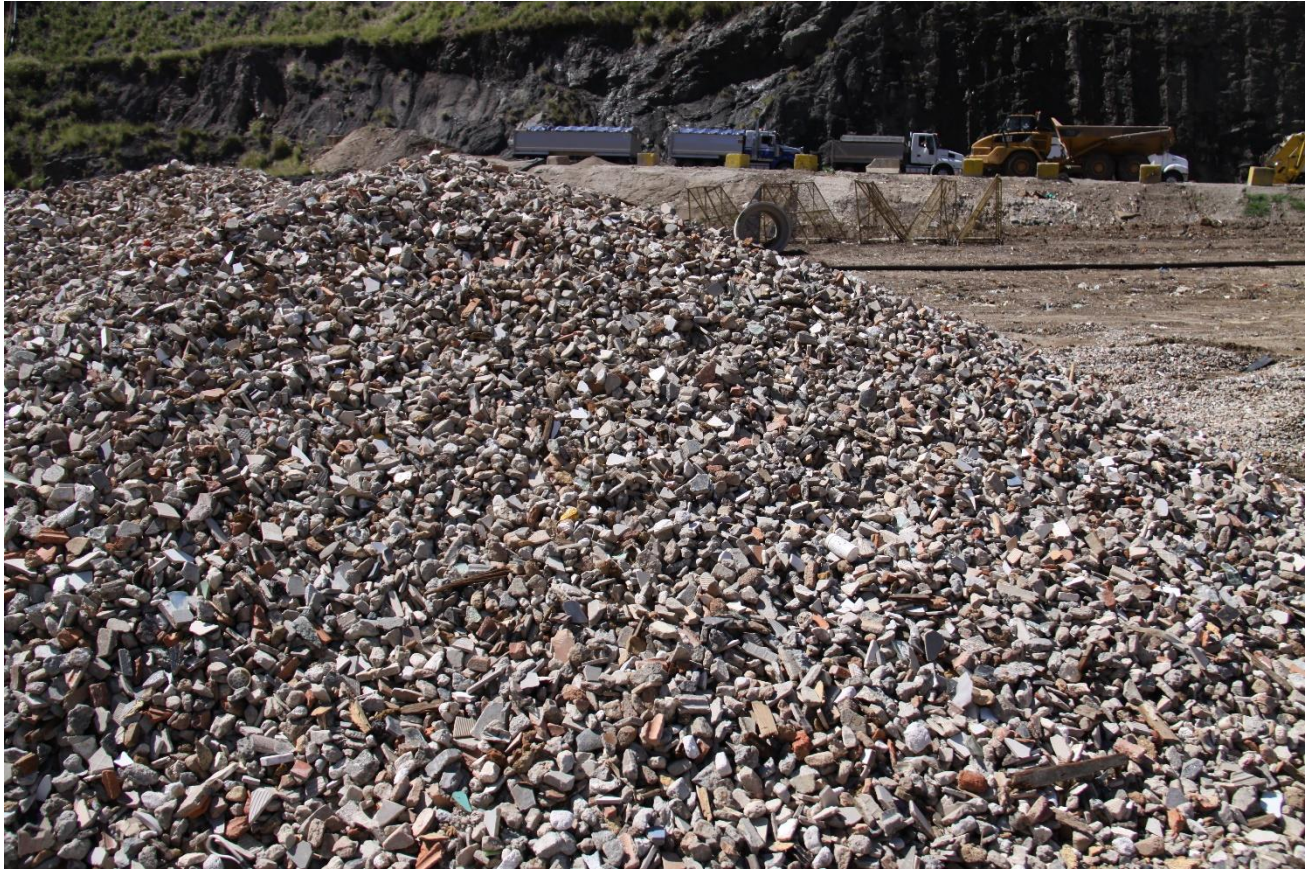
The licensee's representative was present and as stated in the draft report, measured the alternative cover material and at no time did he disagree with the auditors at that time. The attached photos clearly indicate that this material is alternative cover material consisting of crushed concrete, crushed bricks, crushed clay tiles and crushed glass.

The EPA would also like to point out that the specification for the drainage material as referenced in condition O5.23 requires that the material be a minimum of 20mm and a maximum of 40mm and must not be angular. If this was drainage material, then the licensee is in breach of the specification of the drainage material.
