# Light Horse Business Centre, Eastern Creek, NSW, Australia

Groundwater Assessment

ThaQuarry Pty Ltd

August 2008

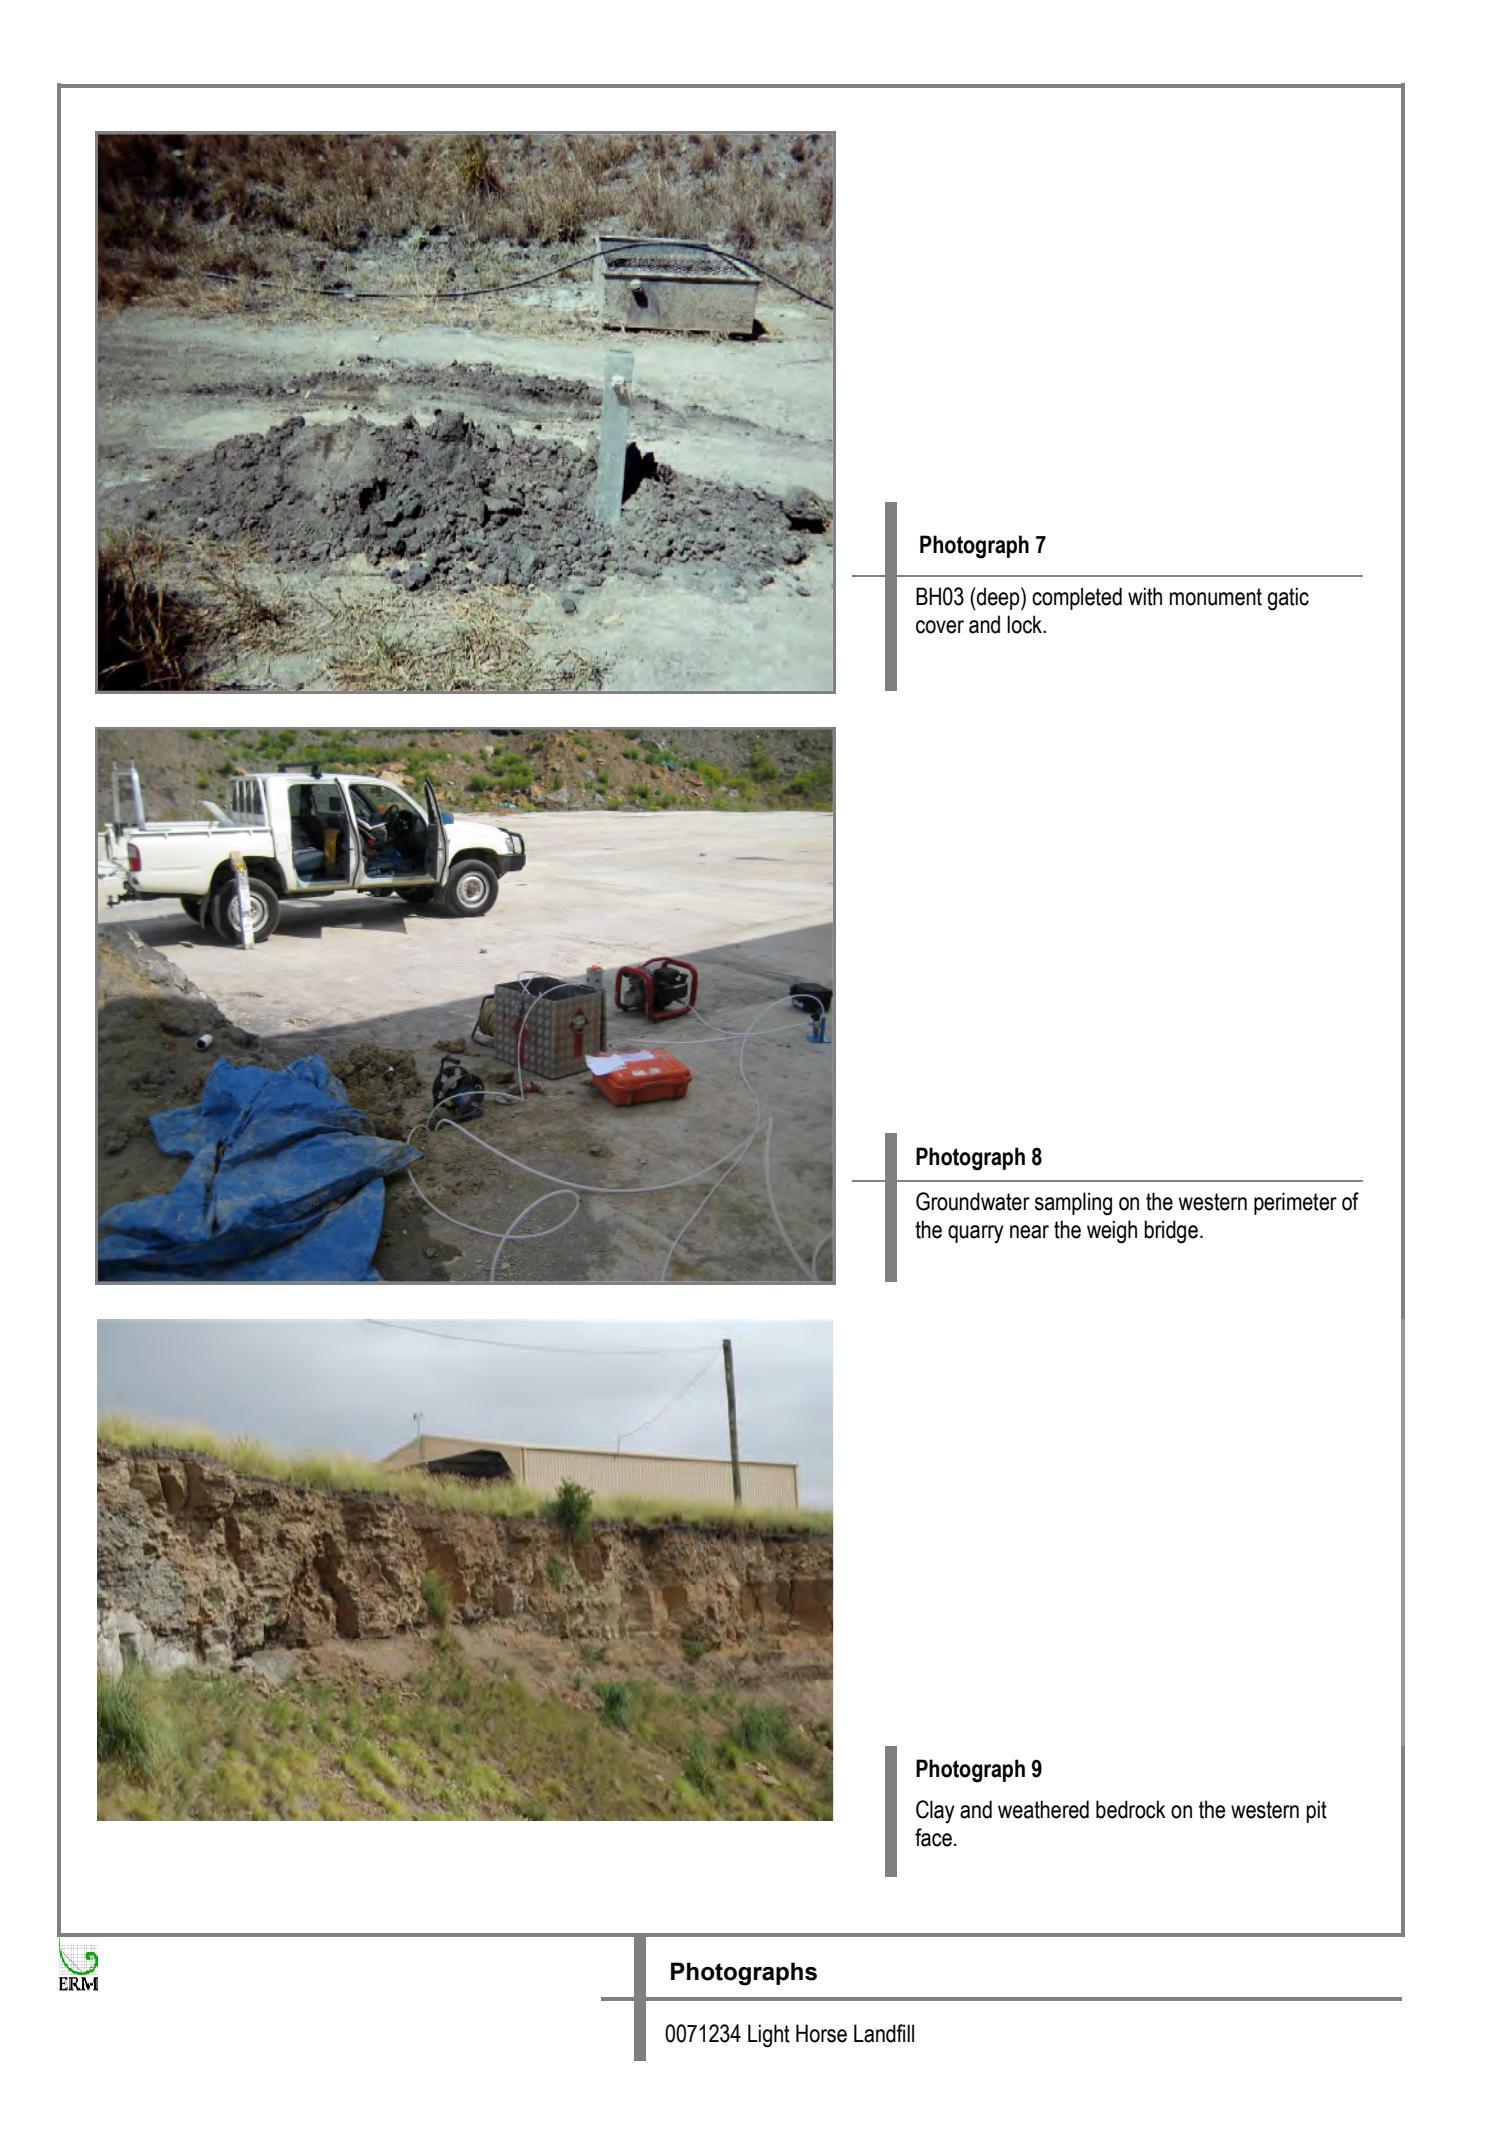
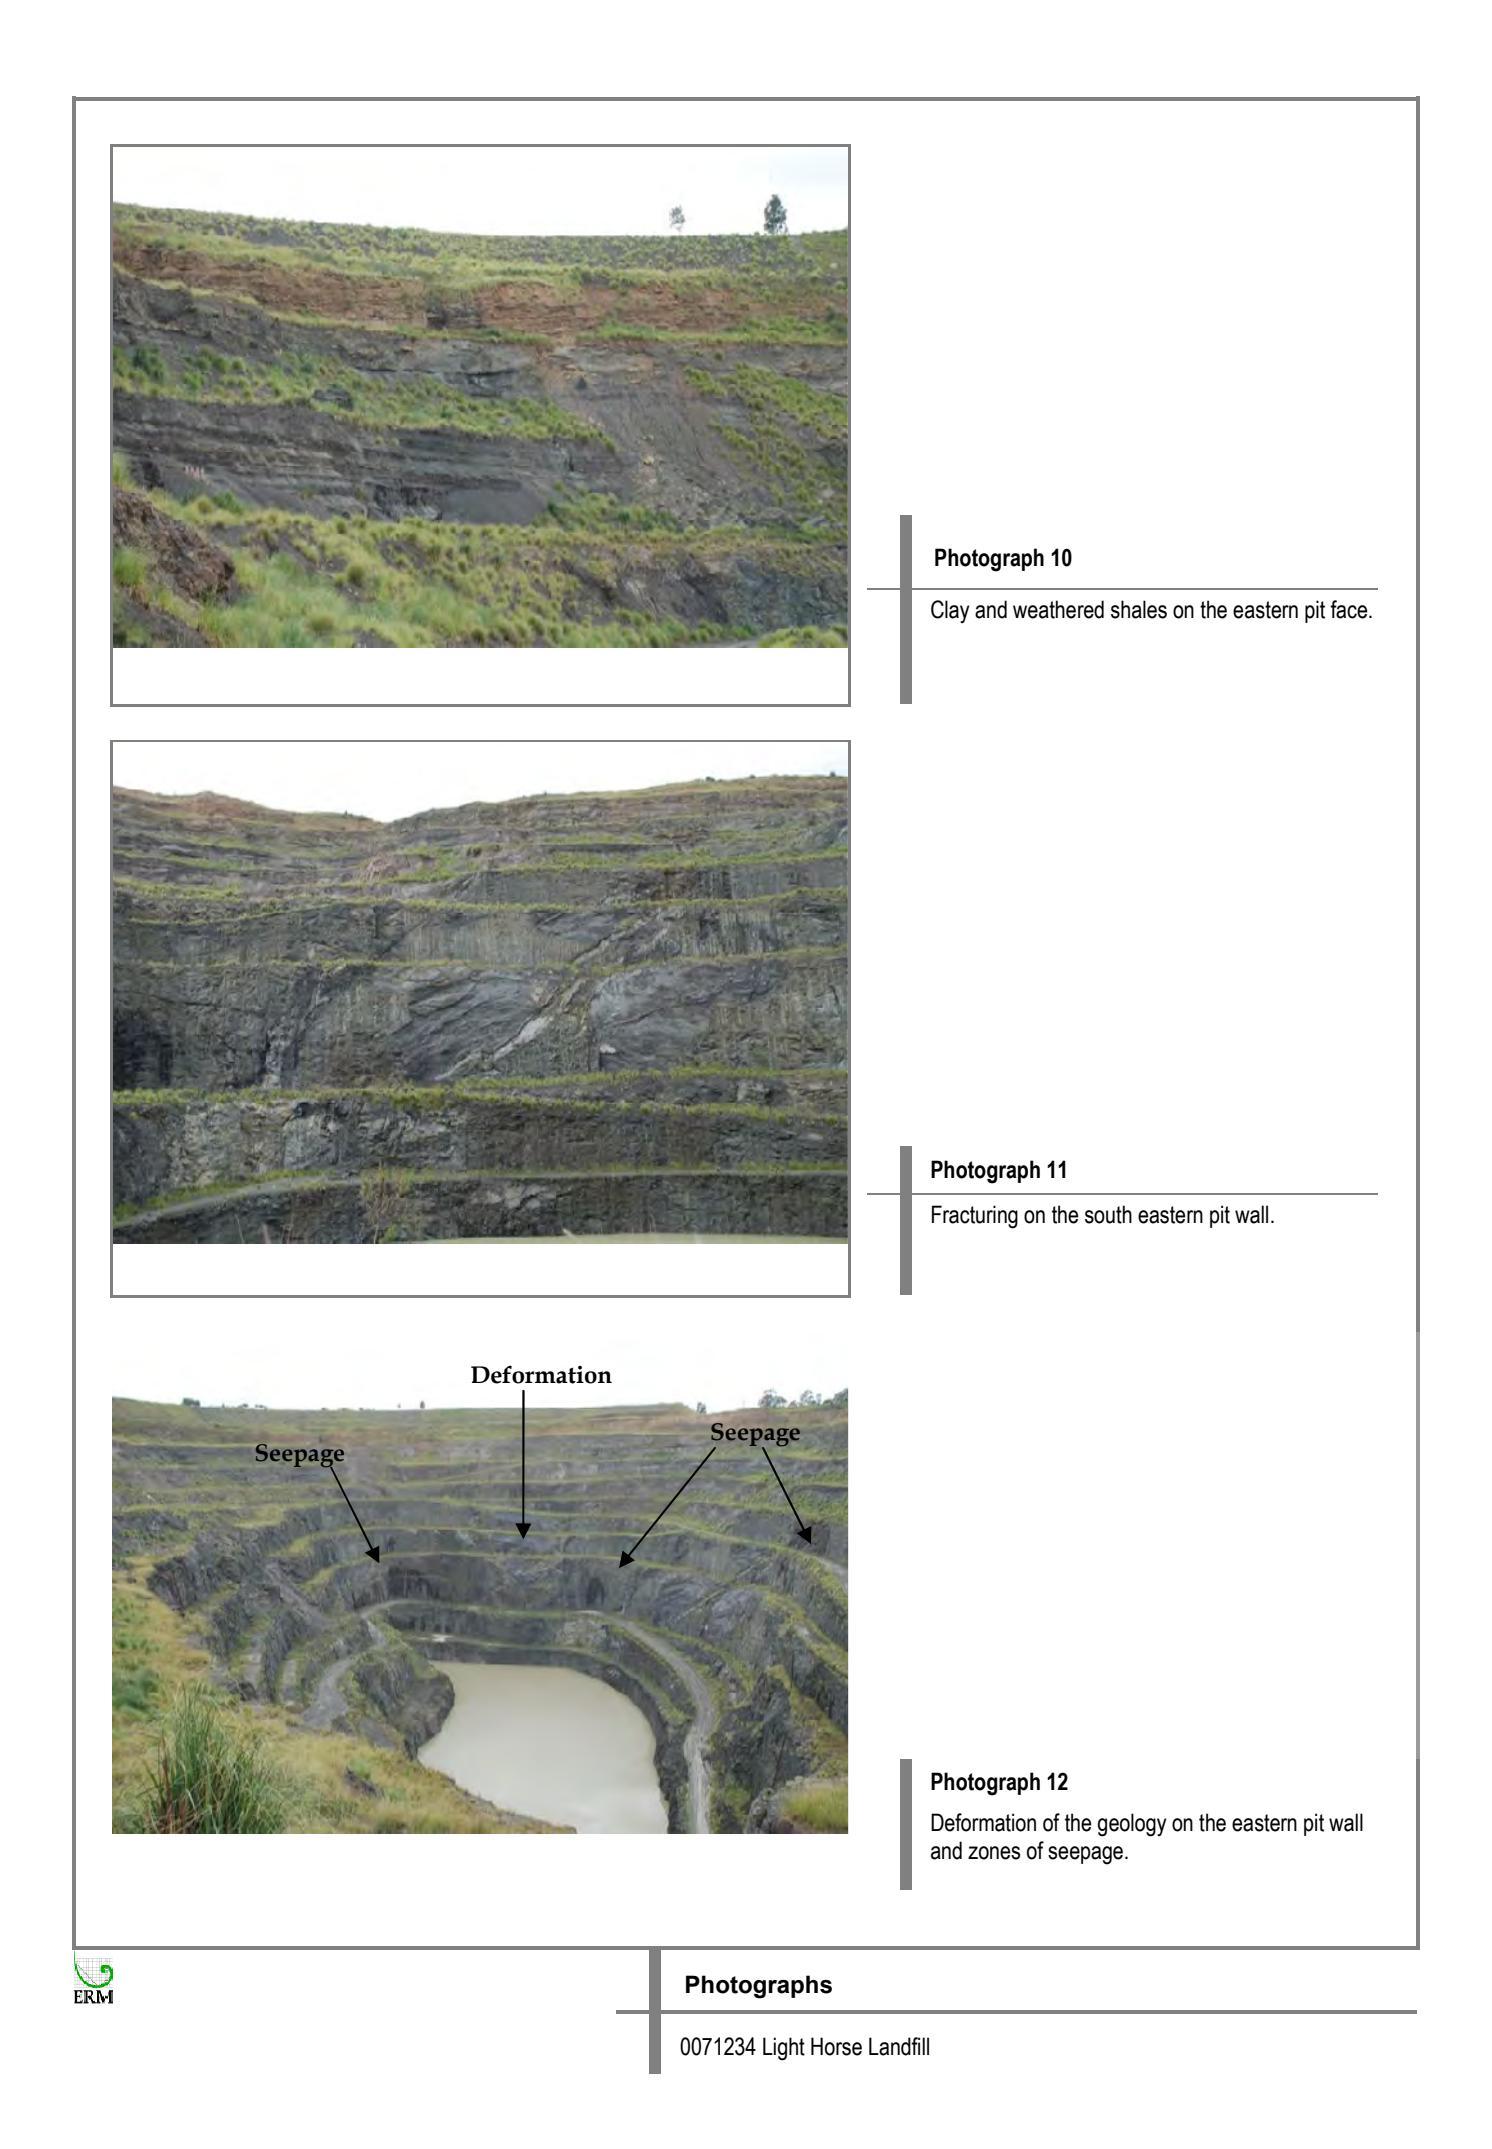
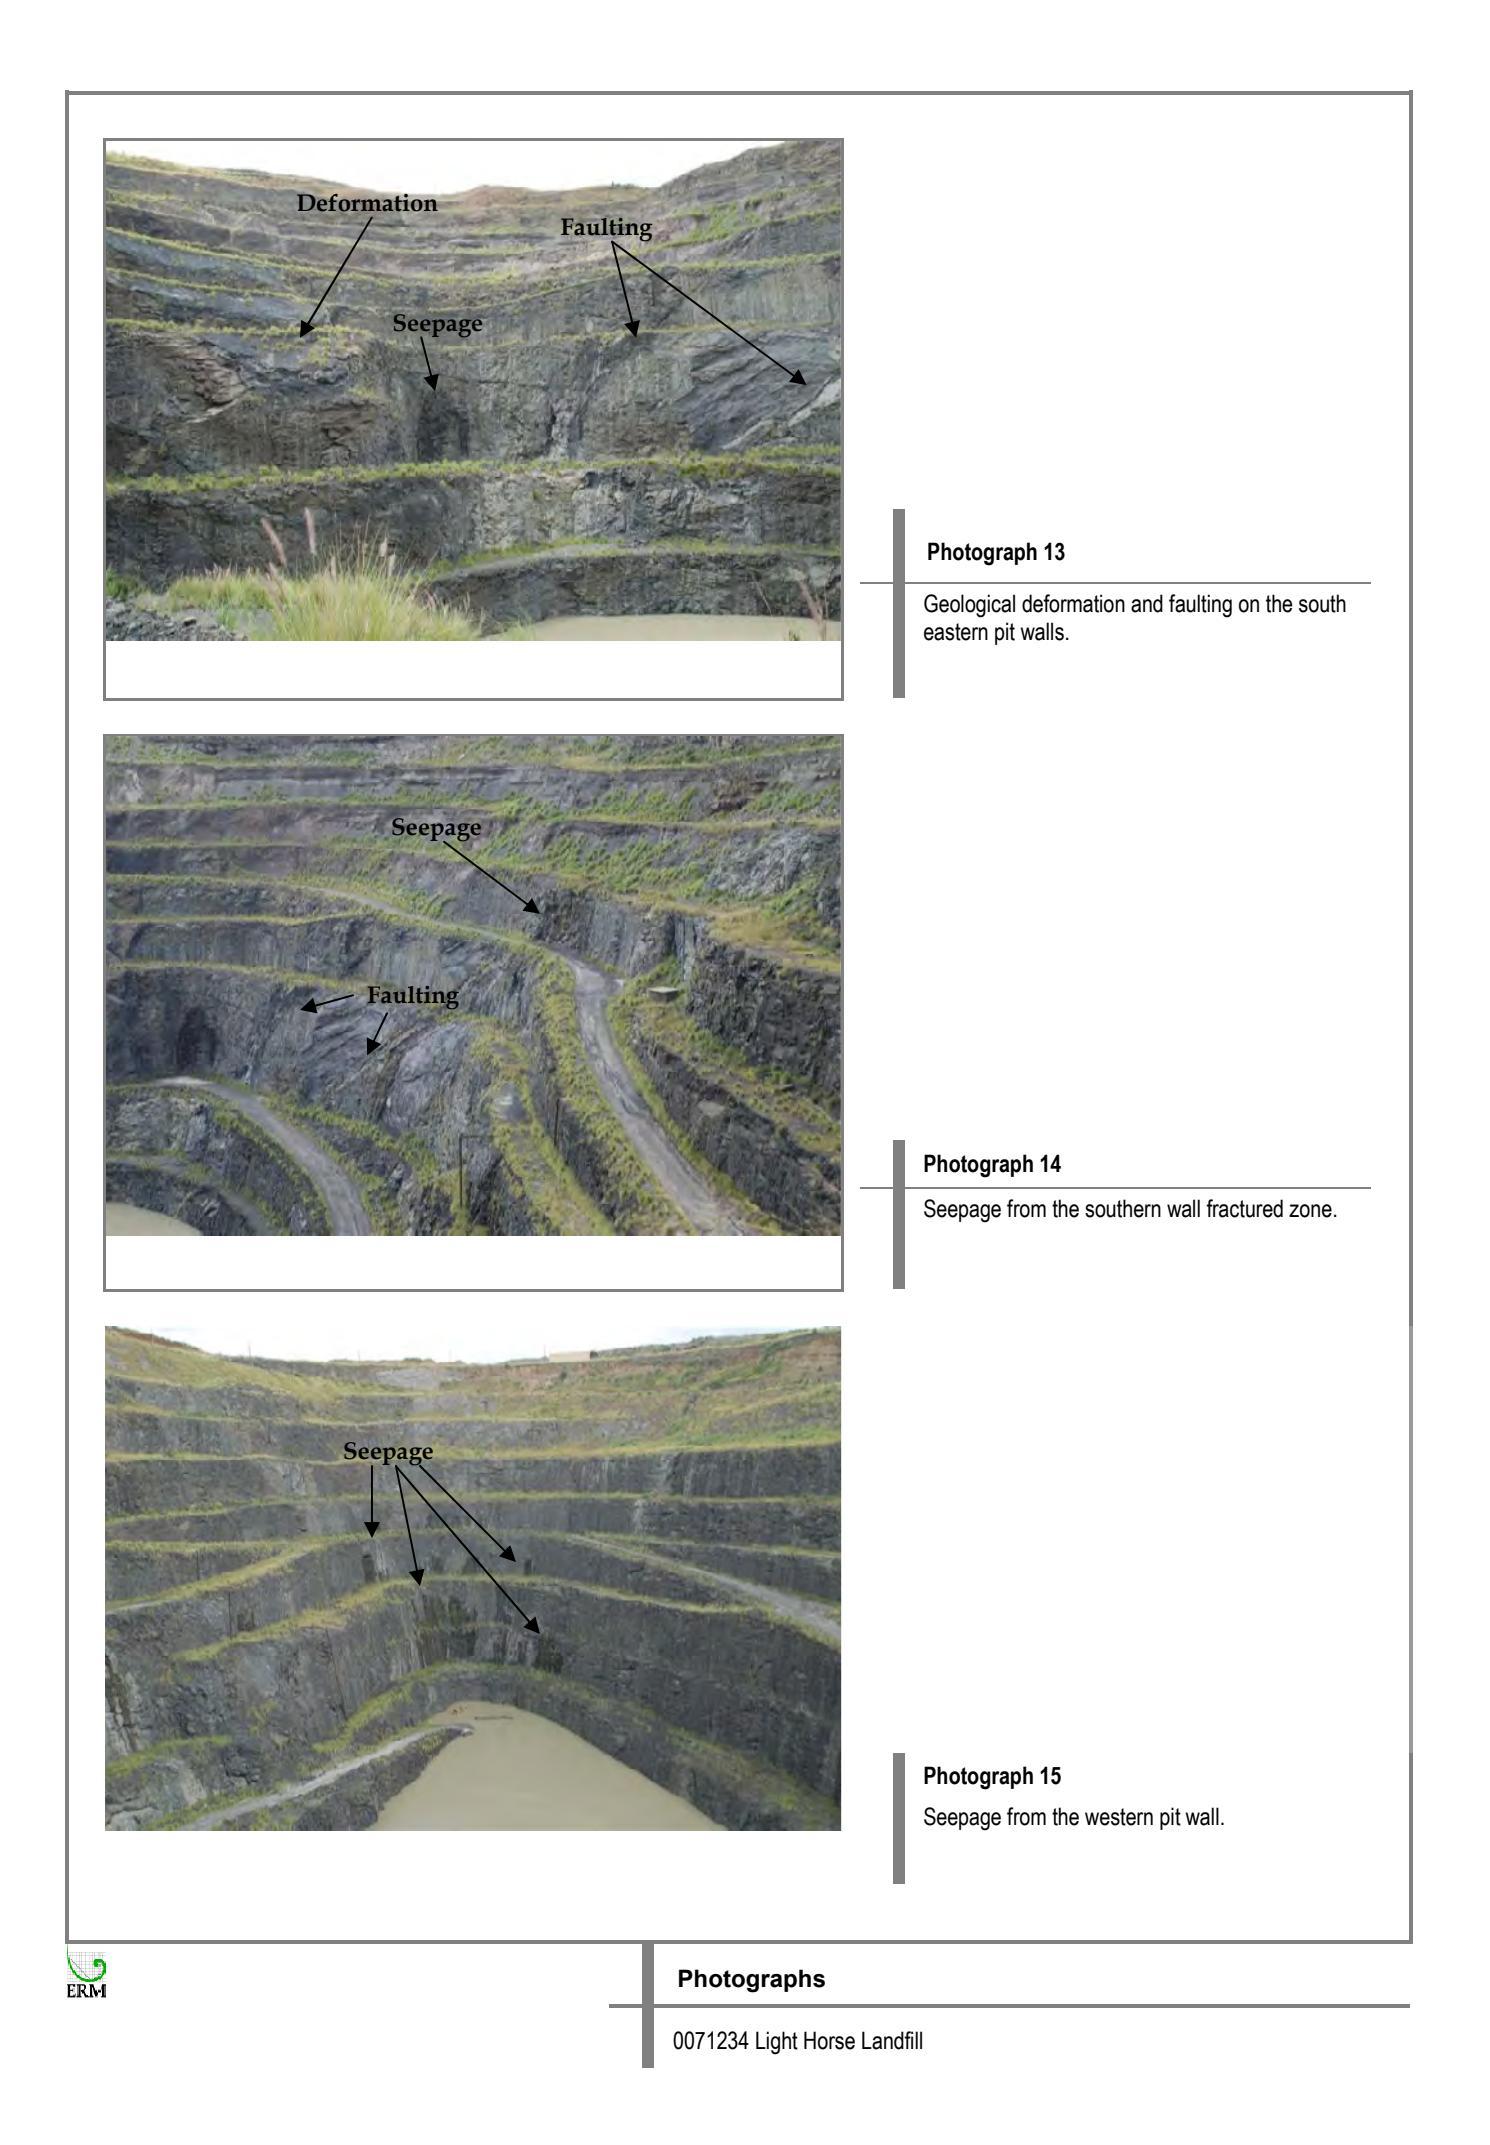
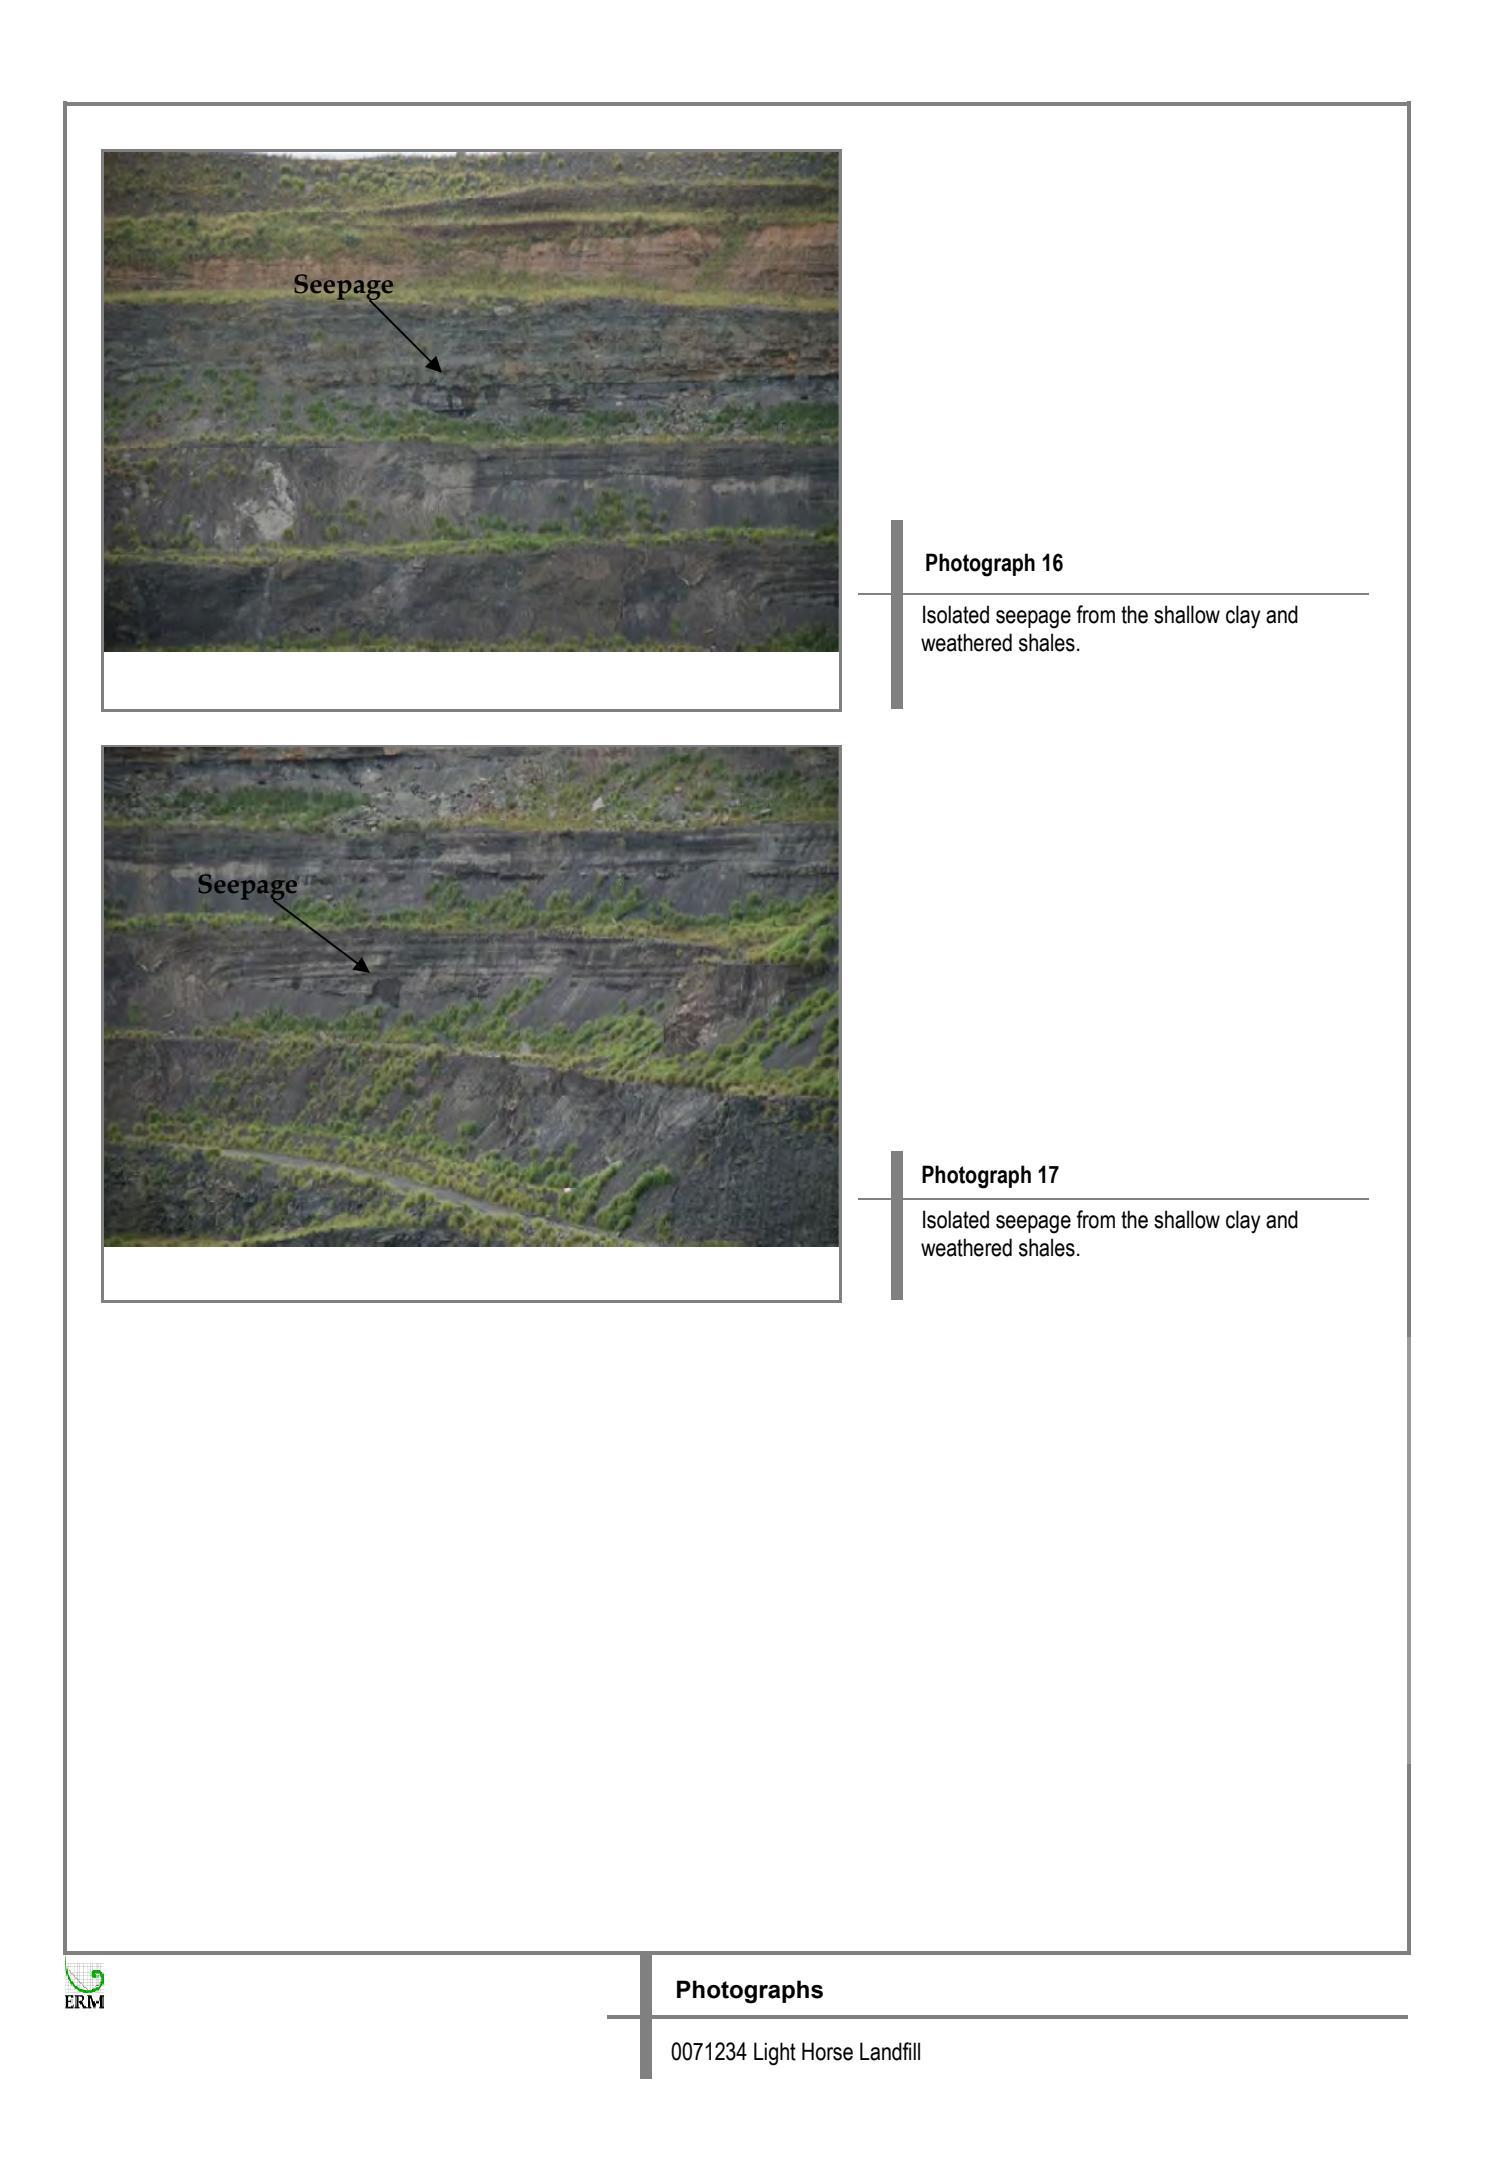
- *photographs 12 to 17* of *Annex B* present the locations of seepage within the pit. Seepage was observed to be very isolated from the exposed unconsolidated clay and weathered shale faces. Seepage from the deeper shale units was more substantial but was generally observed to be isolated and insufficient to induce flow or surface ponding at the bottom of each of the seepage faces. However, seepage from the fractured zone on the southern wall did initiate ponding and minimal surface flow. Overall the seepage was observed to be very low and likely to be less than 10 m<sup>3</sup>/day; and

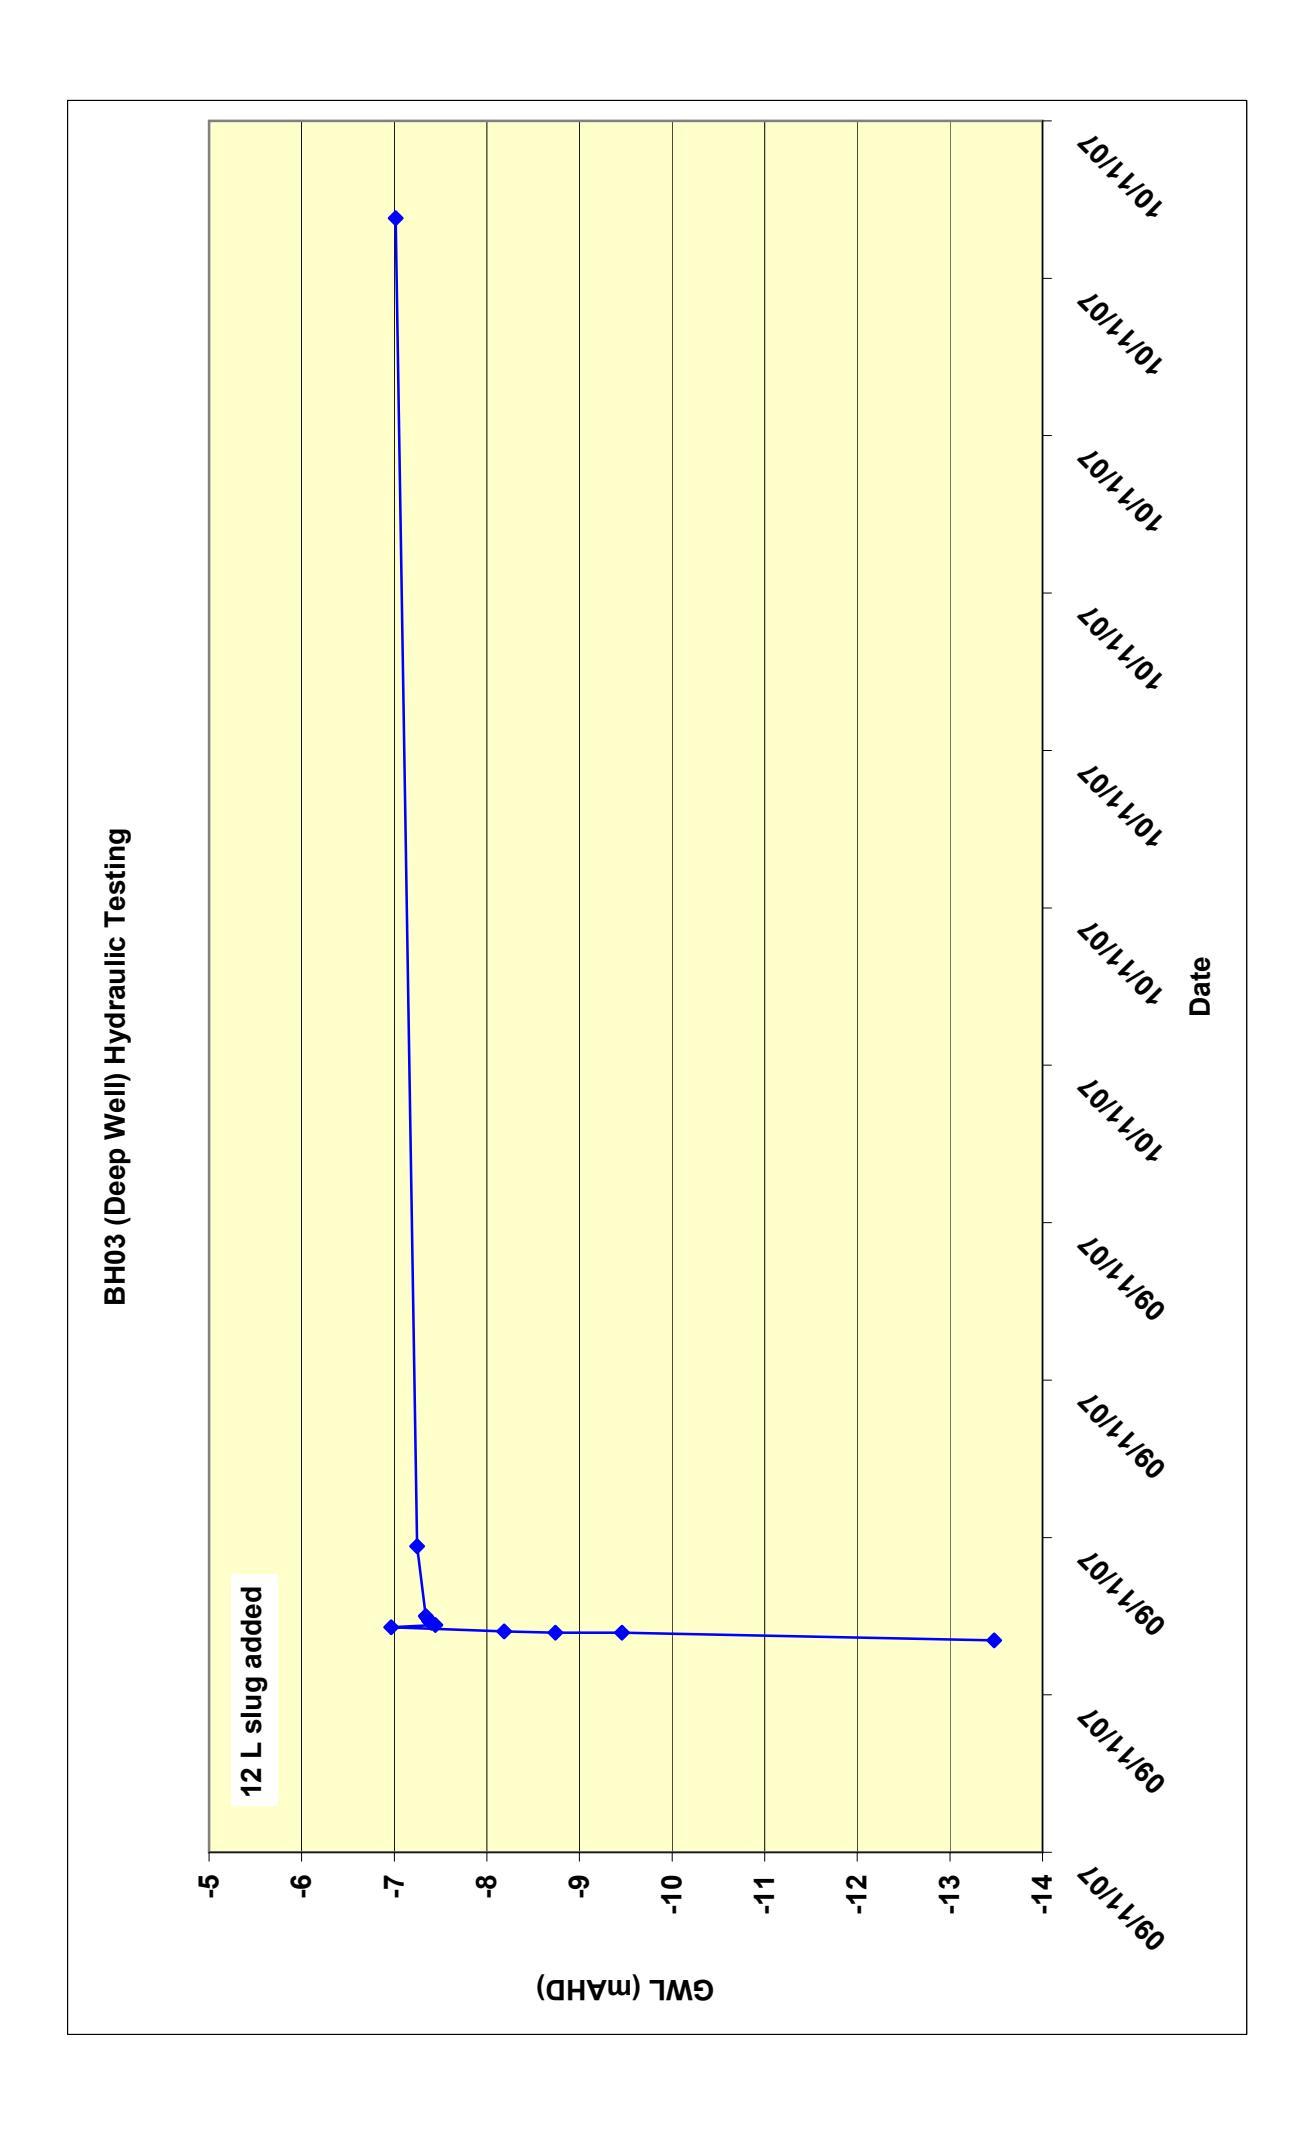
В	H03 (Hvorslev)					
0	2122	2452 4	Time [s]	6367356	8489808	10612260	BH03	
ΟΨ/Ψ								
Test name: BH03								
Analysis method: Hvorslev								
Analysis results	<u>::</u>			Conduct	ivity:	2.03E-1	11 [m/s]	
Test parameter	: Test well:		BH03	Aquifer t	Aquifer thickness:		120 [m]	
	Screen radi	ius: (	0.05 [m]					
	Screen leng	gth: 0	6 [m]					
	Casing radi	us: (	0.025 [m]					
Comments:								
						Evaluated by: Date:	17/03/2008

The observed data and analytical results for each well are provided in *Annex E. Table 5* of *Annex H* also presents the calculated hydraulic parameters for the slug tests completed. The data are summarised as follows:

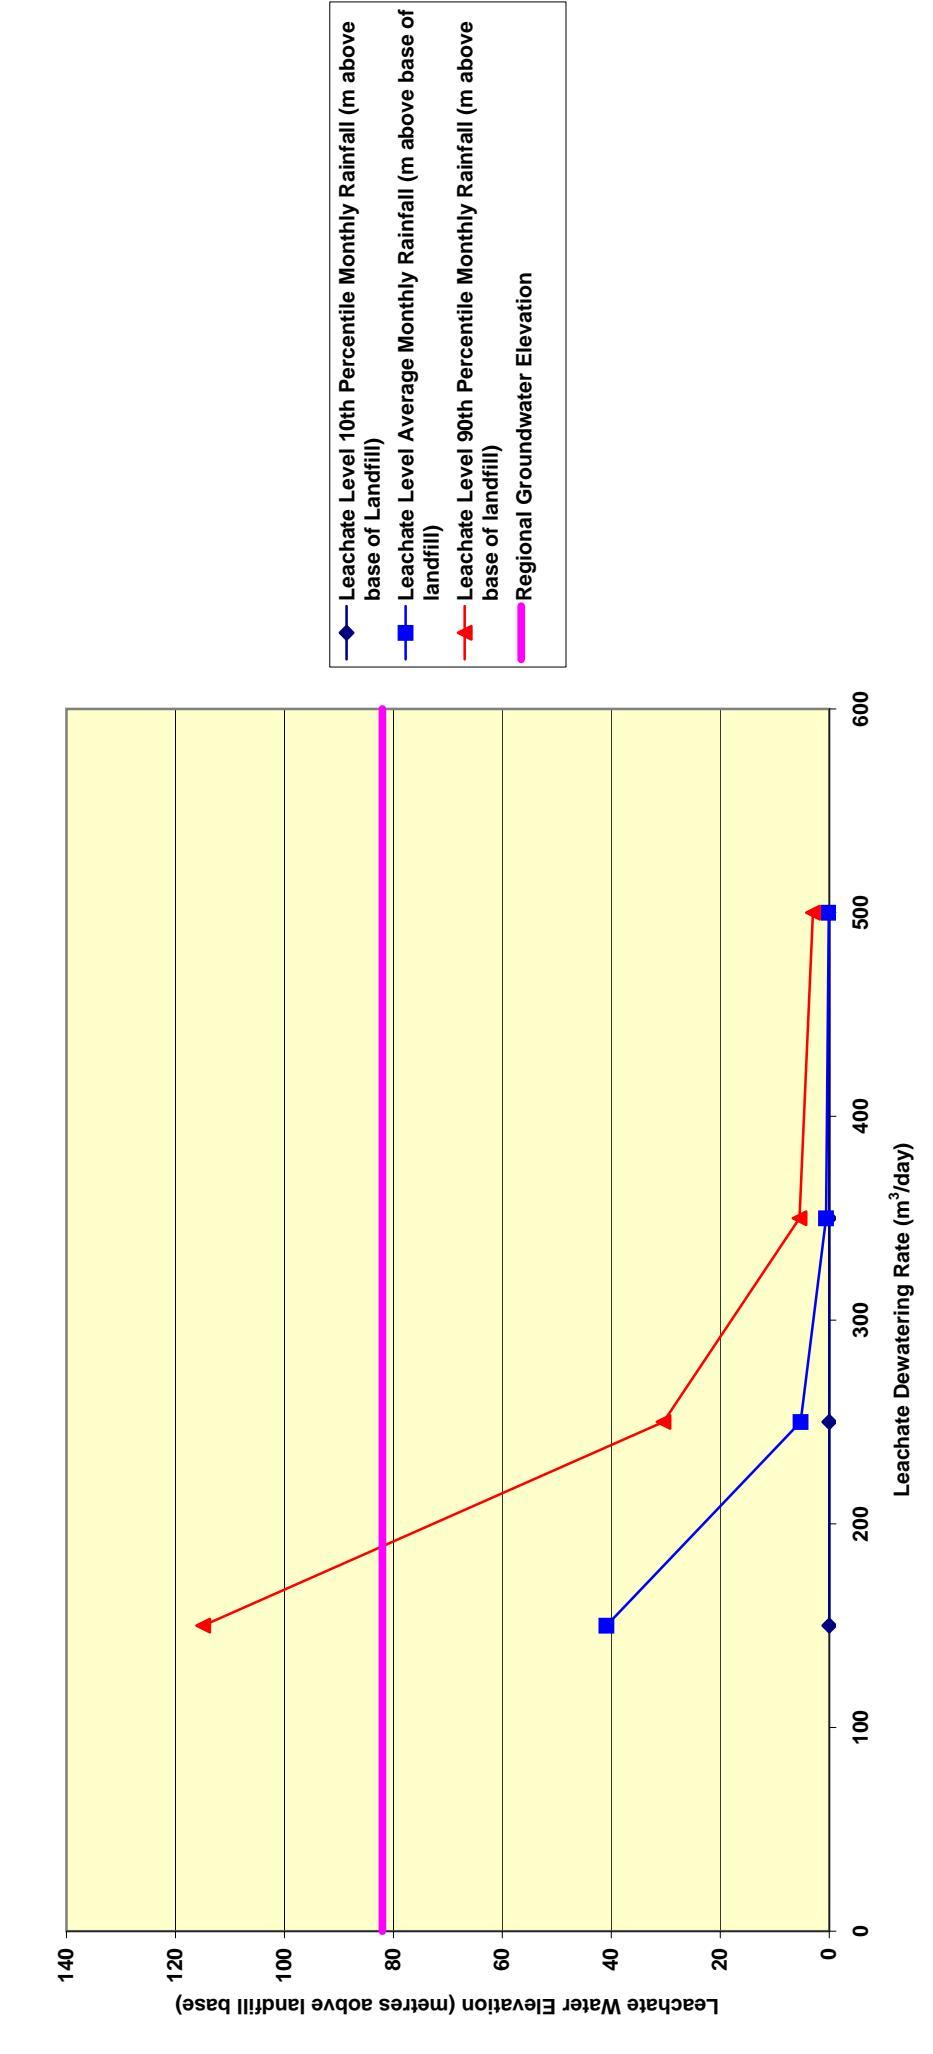
Figure 6: Changes in Landfill Leachate Water Elevations with Changes in Leachate Dewatering Rates

Leachate Level 10th Percentile Monthly Rainfall (m above base of Landfill)	0	0	0	0		
Pumping rate (m3/day)	150	250	350	500		140
